Overall Information

Document Number: DPF2015091/1

Date: 13/Aug/2015

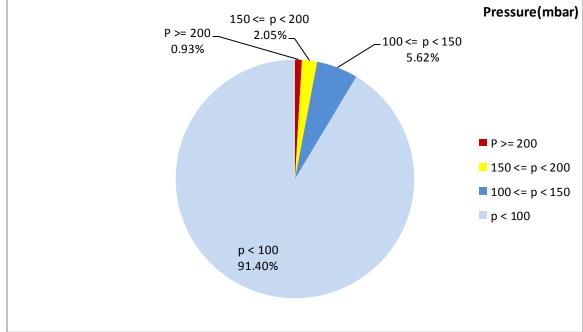
Figure 1- Pressure distribution over the working hours

- As depicted in figure 1, 0.93% of total working time pressure is above 200 mbar and 2.98% above 150mbar.
- Figure 2 displays flow temperature distribution for DPF's upstream. It can be
 obviously observed that 3% of total working time temperature is above 400°C.
 Considering temperature distribution of this line's buses (T400<<1%), it is clear this
 distribution was because of high back pressure.

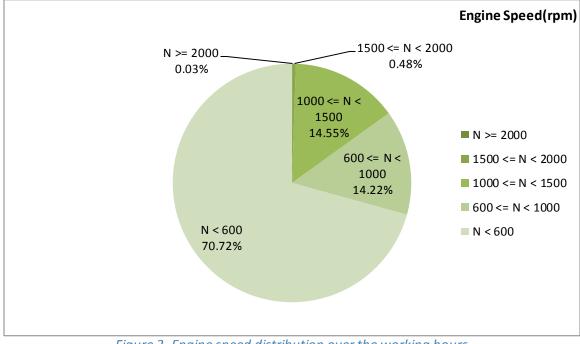
Figure 3- Engine speed distribution over the working hours

Notice: RPM sensor got problem during this period. So some related parameters and information are unreliable.

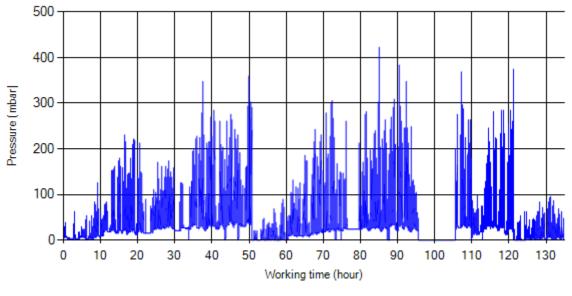
Notice: backpressure distribution was shown into two diagrams. As obvious in figure 5, stopworking periods were eliminated and pressure was displayed along working hours.

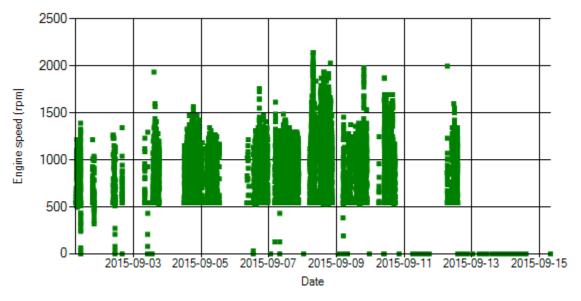
Figure 11- Engine speed diagram for calculating CPK's working days

Notice: RPM sensor got problem on Sep 12th.

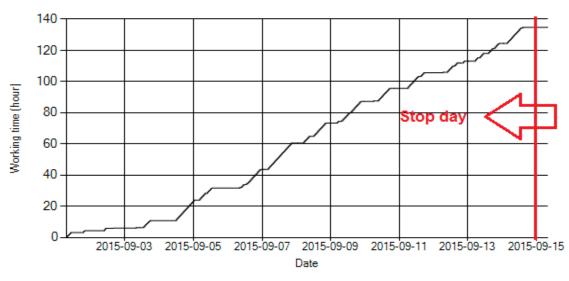
Figure 12- Time diagram for calculating CPK's working days

Notice: Data logger sampling time can be calculated from Figure 12. The lines parallel with Date axis show days without data logger data.

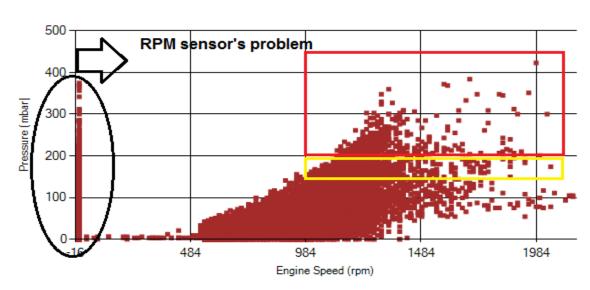
Figure 13- Pressure against engine speed

Notice: Red alarm (pressure>200 mbar) and yellow alarm (200>pressure>150) ranges were indicated in figure 13.
