Overall Information

Vehicle plate number	33637 (34119)
CPK data logger number	LN: 001492, DN: 1933, Sim +989210000000
Bus line	Number 2 (west to east bus line)
Bus Terminals	Khavaran Bus Terminal - Western Bus Terminal
Total path distance	19 km
DPF producer company	Dinex_02 (Passive system with FBC)
Installation date	2/Jun/2015
Report period	3/Jun/2015 – 17/Jun/2015 (fifteen days)
K value – DPF's upstream	1.9 [<i>m</i> ⁻¹]
K value – DPF's downstream	$0.09 \ [m^{-1}]$

Date: 20/Aug/2015

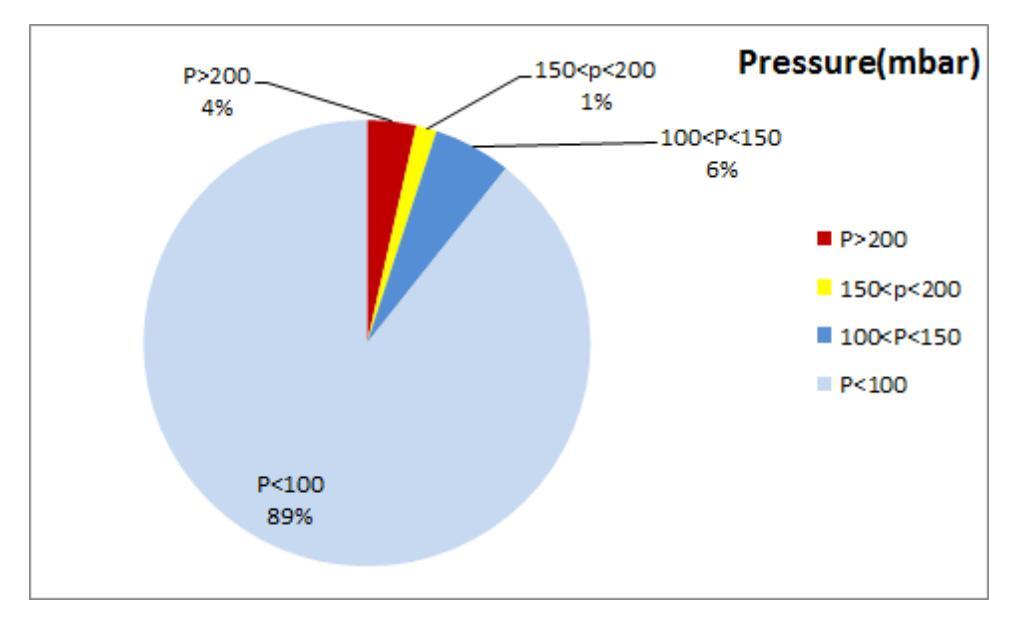
- As depicted in Figure 1, 4% of total working time pressure is above 200 mbar and pressure above 600 mbar can be seen during this period.
- Figure 3 displays flow temperature distribution for DPF's upstream. It can be obviously observed that 4 % of total working time, temperature is above 400°C. Considering Figure 3 it can be obtained that, high temperature distribution in figure 2 was the result of high backpressure. So this deceptive temperature distribution can't guarantee passive filter operation.
- The signed area in Figure 9 is a good reason to claim that this DPF need cleaning.
- Considering low additive dosing value for this period, cleaning and testing this system with more additive dosing can be valuable test.

Note:	Other parameters like additive consumption system and engine operation were checked.	
Filter operation status	Excellent 🗆	Good □
	Maintenance required ■	Failed□

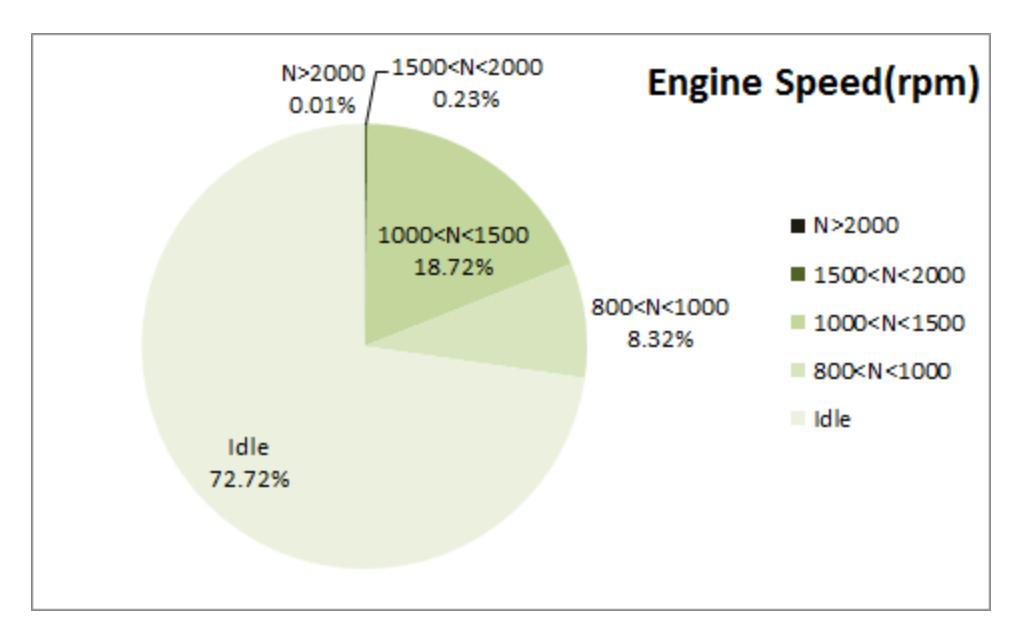
Figure 2- Engine speed distribution over the working hours

Notice: with using bus cooler system, idle rpm increase compare with working times without using ventilation system. So during hot months of year 800 rpm is considered as upper limit for idle engine speed.

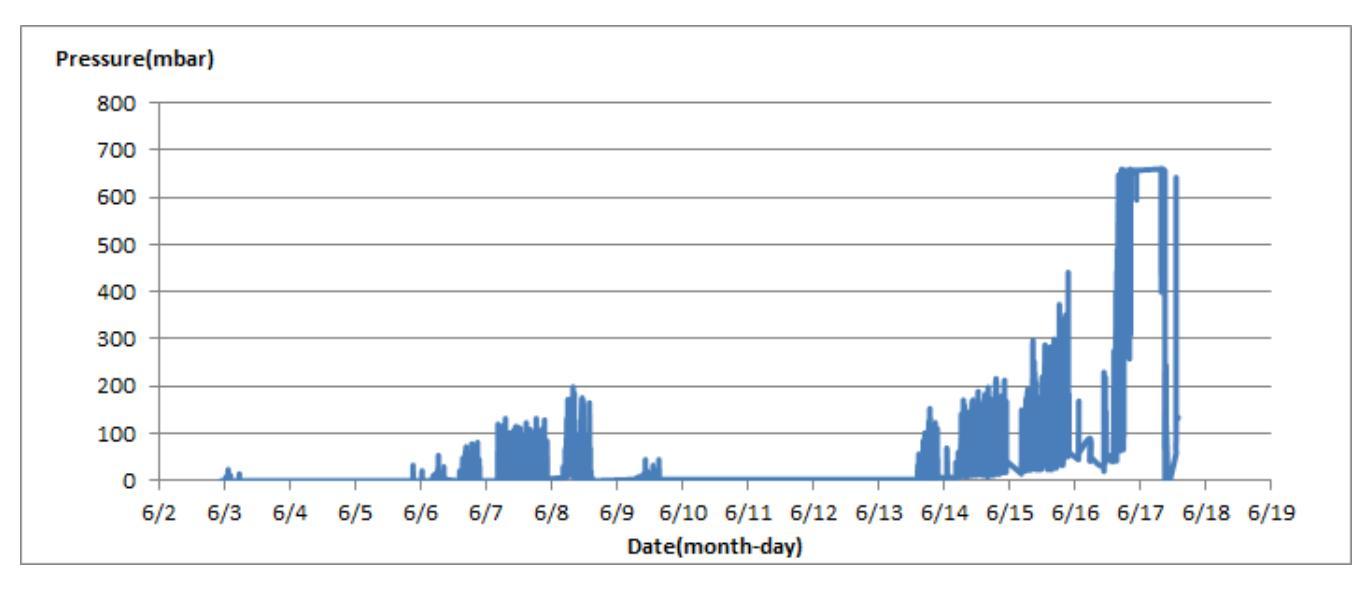
Figure 5- Pressure distribution over the fifteen days

Notice: backpressure distribution was shown into two diagrams. As obvious in figure 5, stop-working periods were eliminated and pressure was displayed along working hours.
