# Notice: System was working over this period without DPF.

### **Overall Information**

,	
Vehicle plate number	33637 (34119)	
CPK data logger number	LN: 001492, DN: 1933, Sim +989210000000	
Bus line	Number 2 (west to east bus line)	
Bus Terminals	Khavaran Bus Terminal - Western Bus Terminal	
Total path distance	19 km	
DPF company producer	Dinex_02 (Passive system with FBC)	
Installation date	02/Jun/2015	
Report period	01/Jul/2016 – 15/Jul/2016 (fifteen days)	
K value - DPF upstream	- [1/m]	
K value – DPF downstream	- [1/m]

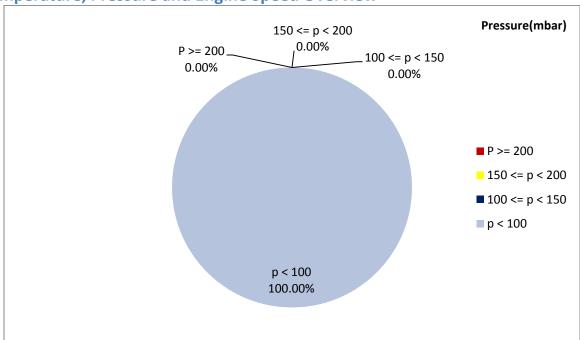
Figure 1- Pressure distribution over the working hours

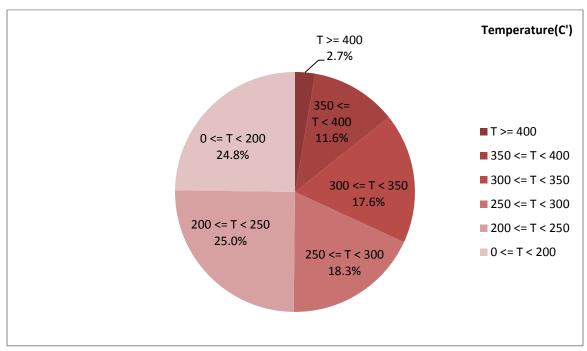
Figure 2-Temperature distribution over the working hours

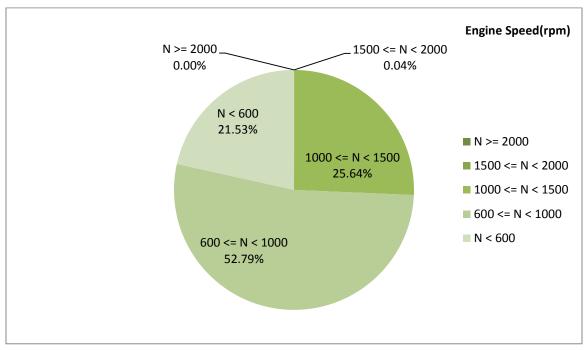
Figure 3- Engine speed distribution over the working hours

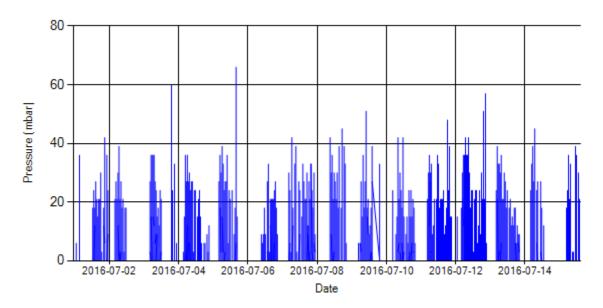
Figure 4- Pressure distribution over the period

Notice: backpressure distribution was shown into two diagrams. As obvious in figure 5, stopworking periods were eliminated and pressure was displayed along working hours.

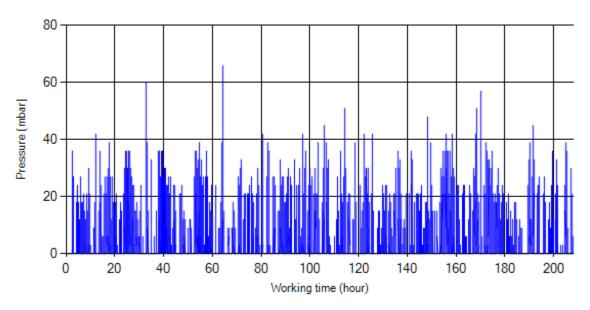
Figure 5- Pressure vs. working hours

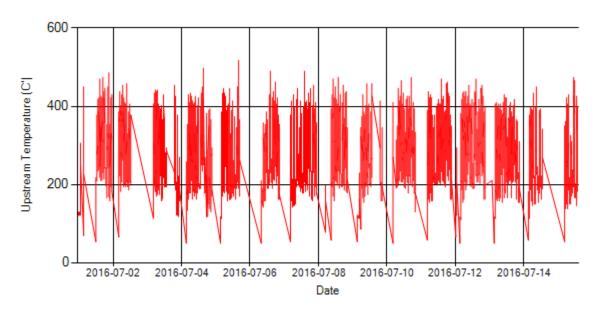
Figure 6- Temperature distribution over the period

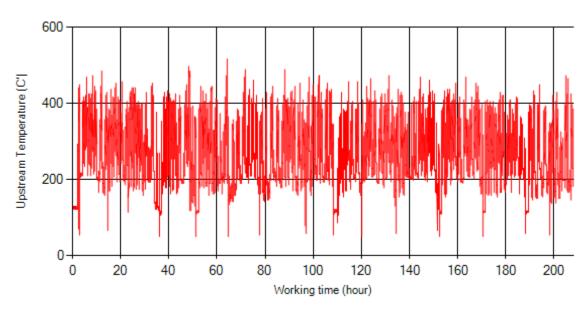
Figure 7- Temperature vs. working hours

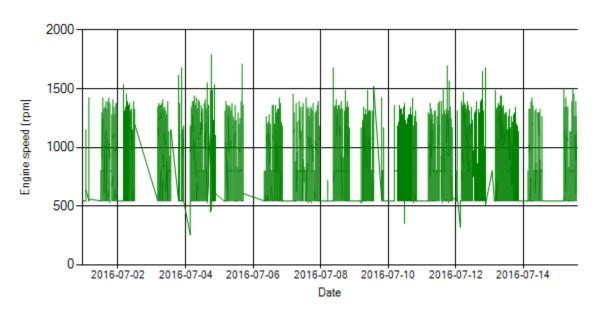
Figure 8- Engine speed distribution over the period

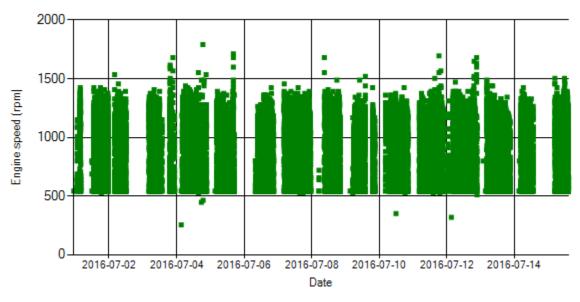
Figure 9- Engine speed diagram for calculating CPK's working days

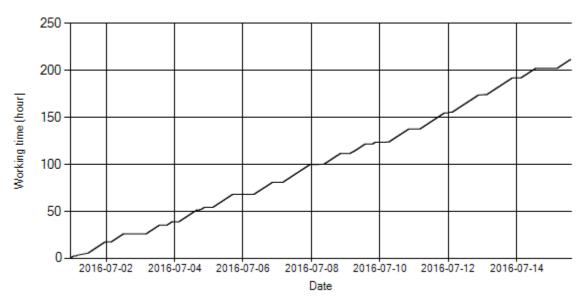
Figure 10- Time diagram for calculating CPK's working days

Notice: Data logger sampling time can be calculated from Figure 10. The lines parallel with Date axis show days without data logger data. As depicted in Figure 10 system was working all days.

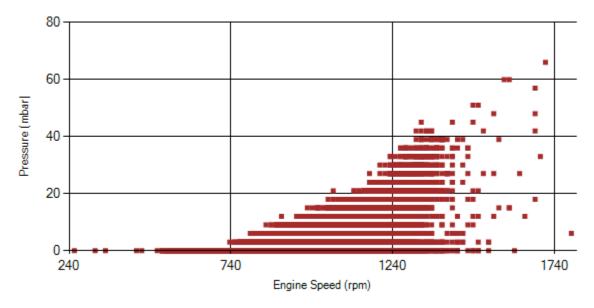
Figure 11- Pressure against engine speed

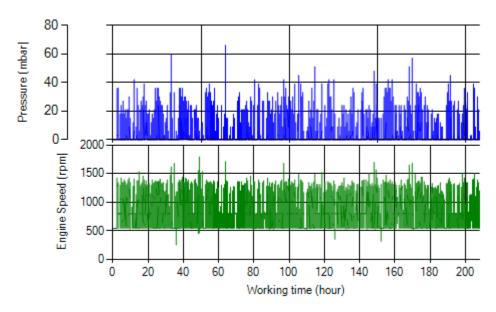
Figure 12- P, N distribution vs. working hours

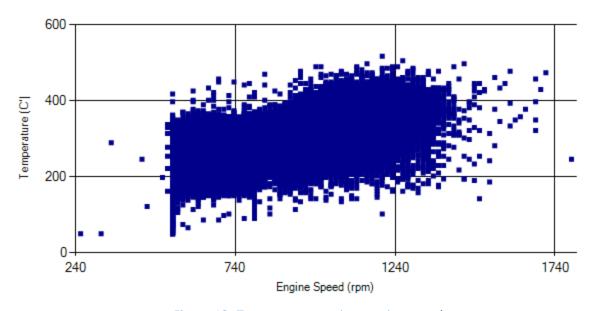
Figure 13- Temperature against engine speed

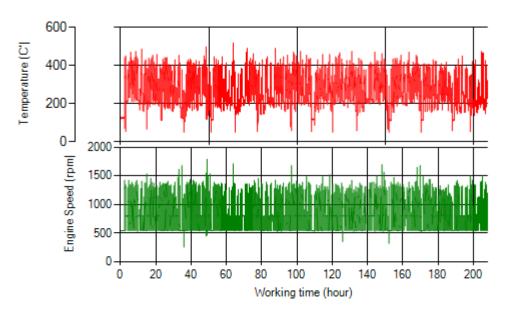
Figure 14- T, N distribution vs. working hours
