## Overall Information

Vehicle plate number	33637 (34119)
CPK data logger number	LN: 001492, DN: 1933, Sim +989210000000
Bus line	Number 2 (west to east bus line)
Bus Terminals	Khavaran Bus Terminal - Western Bus Terminal
Total path distance	19 km
DPF company producer	Dinex_02 (Passive system with FBC)
Installation date	02/Jun/2015
Report period	23/Aug/2015 – 01/Sep/2015 (ten days)
K value - DPF upstream	2.00 [1/m]
K value – DPF downstream	0.02 [1/m]

### Filter Operation Analysis

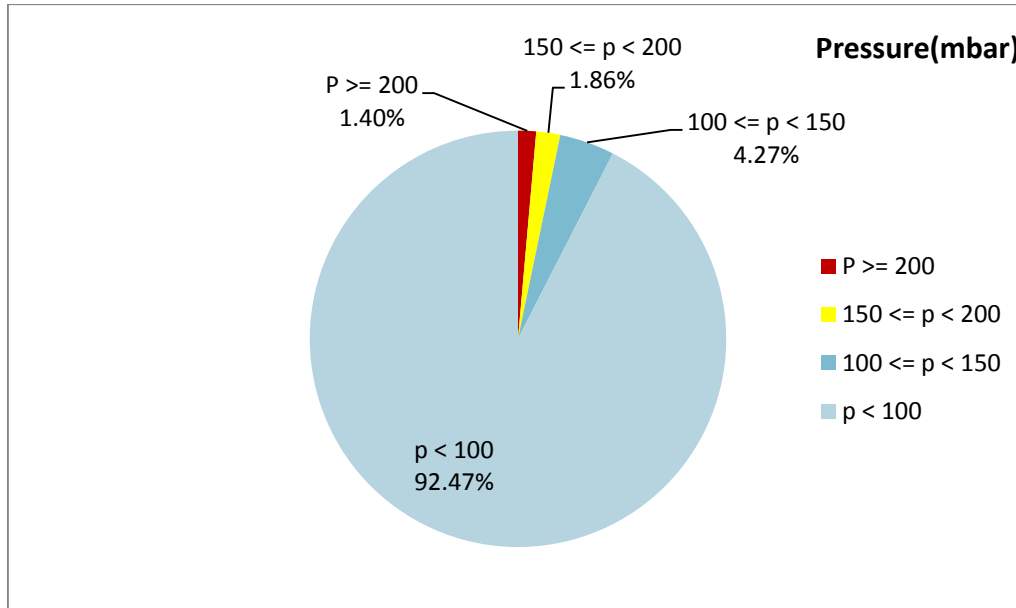
Figure 1- Pressure distribution over the working hours

- As depicted in figure 1, 1.14% of total working time pressure is above 200 mbar and 3.26% above 150mbar.
- Figure 2 displays flow temperature before the DPF. It can be obviously observed that 3% of total working time temperature is above 400 °C. Considering temperature distribution of this line's buses ( $T_{400} \ll 1\%$ ), it is clear this distribution was because of high back pressure.

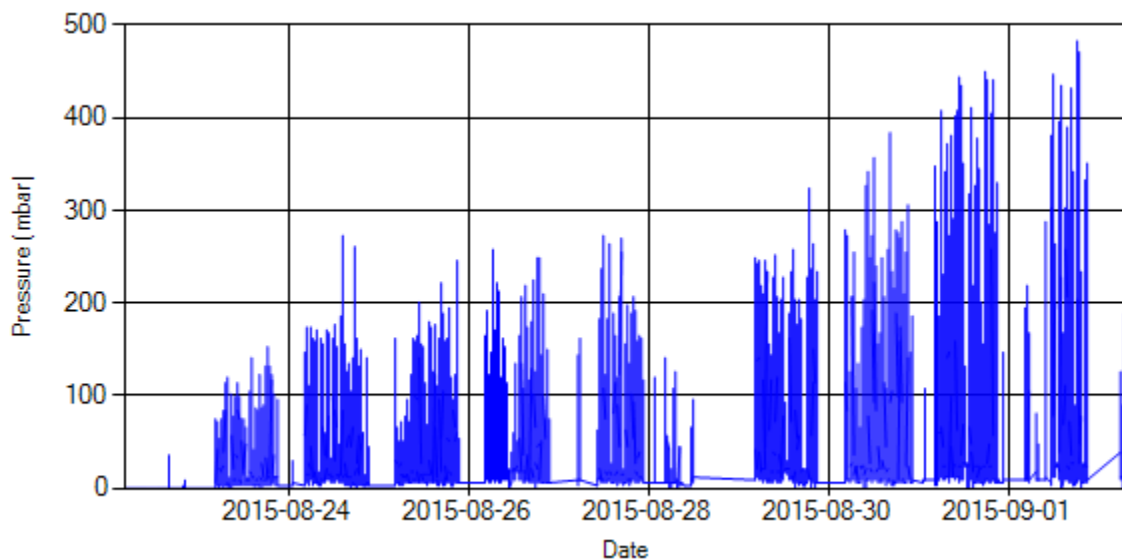
Figure 4- Pressure distribution over the period

Notice: backpressure distribution was shown into two diagrams. As obvious in figure 5, stop-working periods were eliminated and pressure was displayed along working hours.

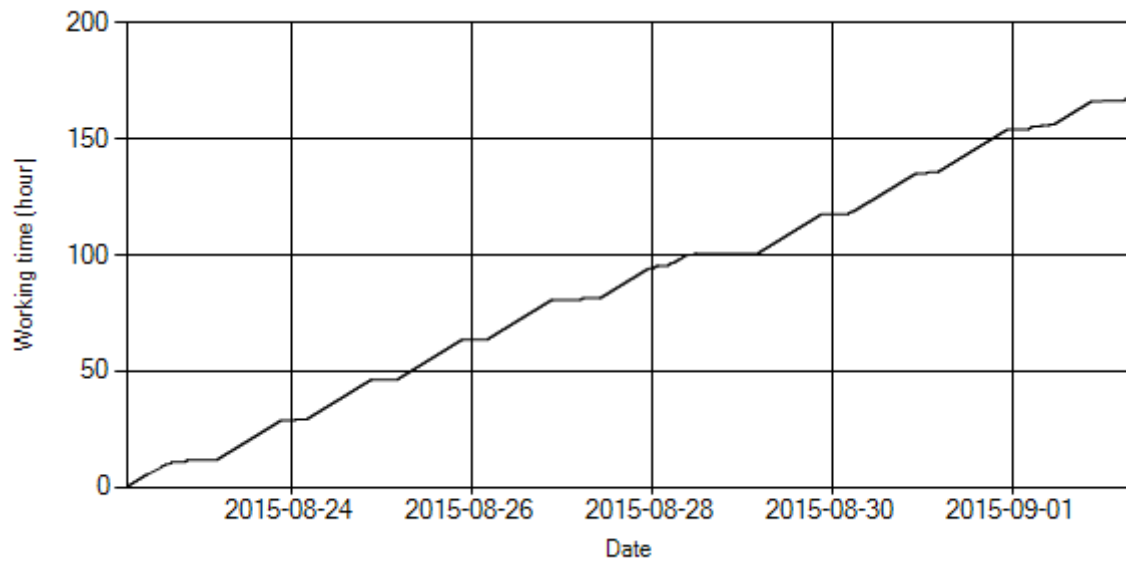
Figure 9- Time diagram for calculating CPK's working days

Notice: Data logger sampling time can be calculated from Figure 12. The lines parallel with Date axis show days without data logger data. As depicted in the picture, Aug 28<sup>th</sup> was stop day.

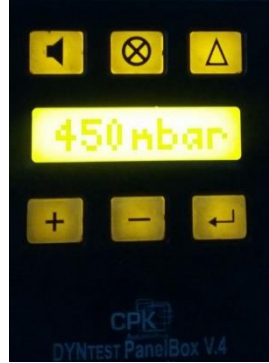
Figure 15. Medium Idle  
(N=1000 rpm)

- Pressure test was done on low, medium and high idle speed. Following pictures show the outcomes.

Engine Speed	Pressure
Low Idle (550 rpm)	72 mbar
Medium Idle (1000 rpm)	450 mbar
High Idle (1500 rpm)	600 mbar

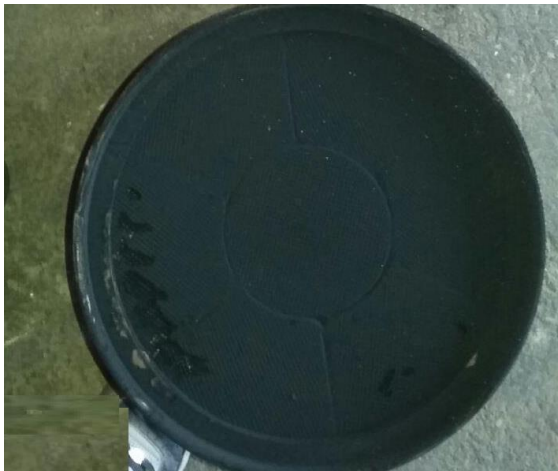
Figure 17. Before cleaning

- 1- Due to increasing back pressure engine worked at very bad mood. (abnormal engine noise)
  - 2- DPF was fully plugged and some black smoke was detected from joints.

- After data analysis during period and considering final pressure test, DPF was removed and cleaned on Sep 4<sup>th</sup>.
