Overall Information

Document Number: DPF2015102/1

Filter Operation Analysis

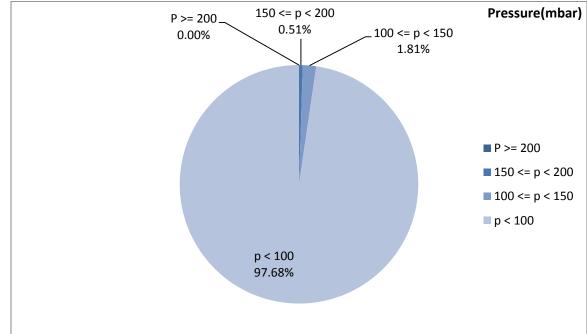
Figure 1- Pressure distribution over the working hours

- As depicted in Figure 1, pressure above 200 couldn't be observed and only 0.50% of total working time pressure is above 150mbar.
- Figure 2 displays flow temperature before the DPF. It can be obviously observed that 8% of total working time temperature is above 400 °C and 15% above 350°C. This high temperature distribution is one of the important factors for filter excellent operation during the period.

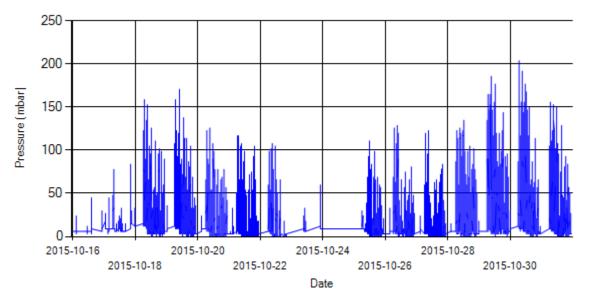
Figure 4- Pressure distribution over the period

Notice: backpressure distribution was shown into two diagrams. As obvious in figure 5, stopworking periods were eliminated and pressure was displayed along working hours.

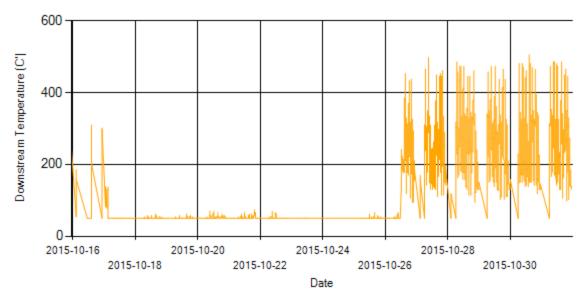
Figure 7- Temperature distribution over the period

Notice: Temp 2 sensor got problem on Nov 16th and was fixed on Nov 26th.

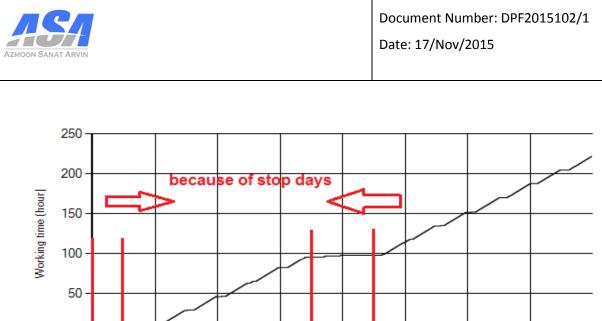
Figure 12- Time diagram for calculating CPK's working days

Notice: Data logger sampling time can be calculated from Figure 12. The lines parallel with Date axis show days without data logger data.

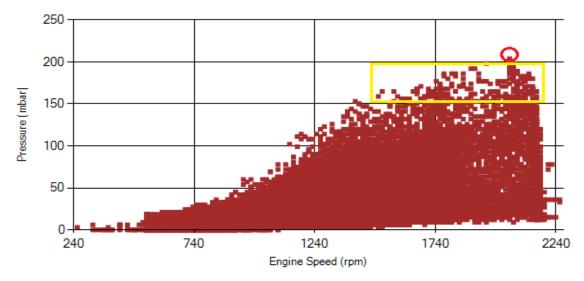
Figure 13- Pressure against engine speed

Notice: Red alarm (pressure>200 mbar) and yellow alarm (200>pressure>150) ranges were indicated in figure 13.
