Overall Information

in injerimenen	
Vehicle plate number	85182	
CPK data logger number	LN: 001502, DN: 1999	
Bus line	Number 10 (south to north Bus line)	
Bus Terminals	Azadi square - Daneshgah square	
Total path distance	10.7 km	
DPF producer company	Tehag_01 (Catalyzed DPF)	
Installation date	24/Sep/2015	
Report period	01/Feb/2016 – 15/Feb/2016 (fifteen days)	
K value - DPF upstream	1.85 [1/m]	
K value – DPF downstream	0.04 [1/m]

Temperature, Pressure and Engine Speed Overview

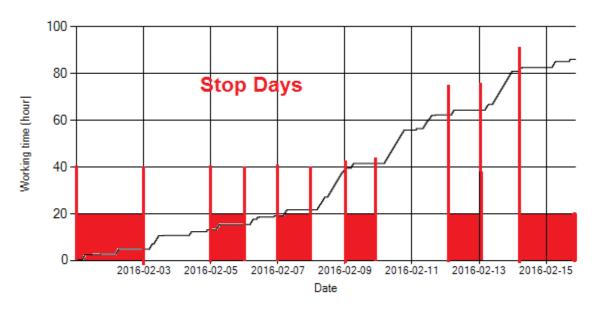
Figure 12- Time diagram for calculating CPK's working days

Notice: Data logger sampling time can be calculated from Figure 12. The lines parallel with Date axis show days without data logger data.
