# DPF FEASIBILITY STUDY REPORT

**TEHRAN-IRAN**

## DPFs' Monthly Operation Report

**Report Period:**  
**01/Jun/2015 –**  
**30/Jun/2015**  
**(second edition)**

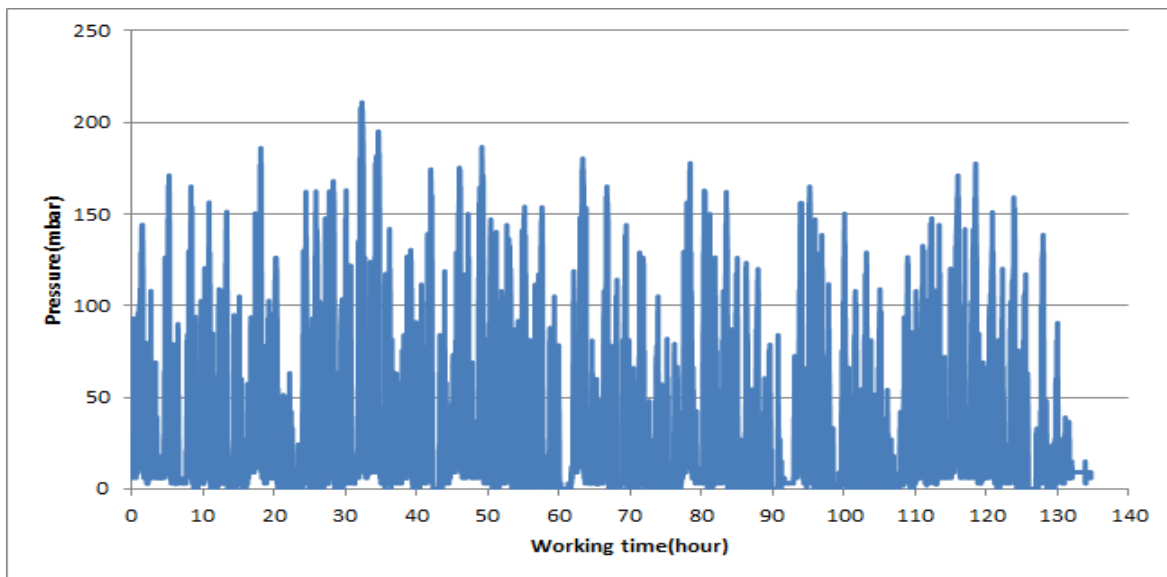
Figure 5- Pressure vs. working hours

Notice: backpressure distribution was shown into two diagrams. As obvious in figure 5, stop-working periods were eliminated and pressure was displayed along working hours.
