DPF FEASIBILITY STUDY REPORT

TEHRAN-IRAN

DPFs' Monthly Operation Report

Report Period:
01/Sep/2015 –
30/Sep/2015

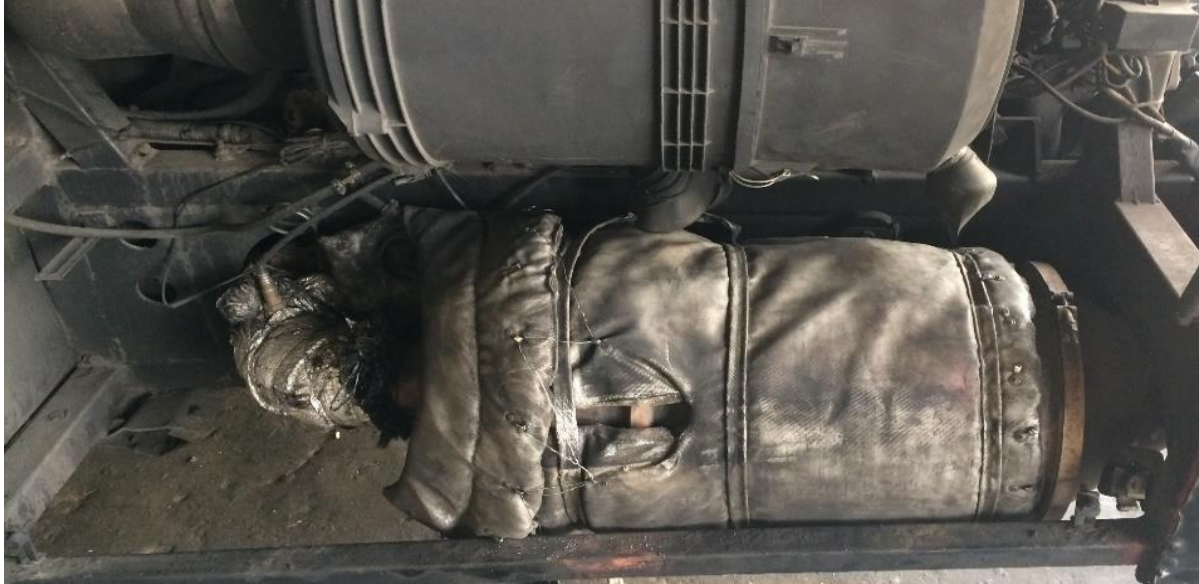
- It is worth-mentioning DPF isolation was not suitable and air filter melted because of very high temperature distribution.
- For decreasing destructive effect of increasing temperature, special heat shield was designed and DPF will be installed on system after cleaning with designed heat shield.

Figure 1. Unsuitable filter isolation
