Diesel Particulate Filters' Feasibility Study Report

Report's Period:

2015/10/01 - 2015/10/31

Tehran - Iran

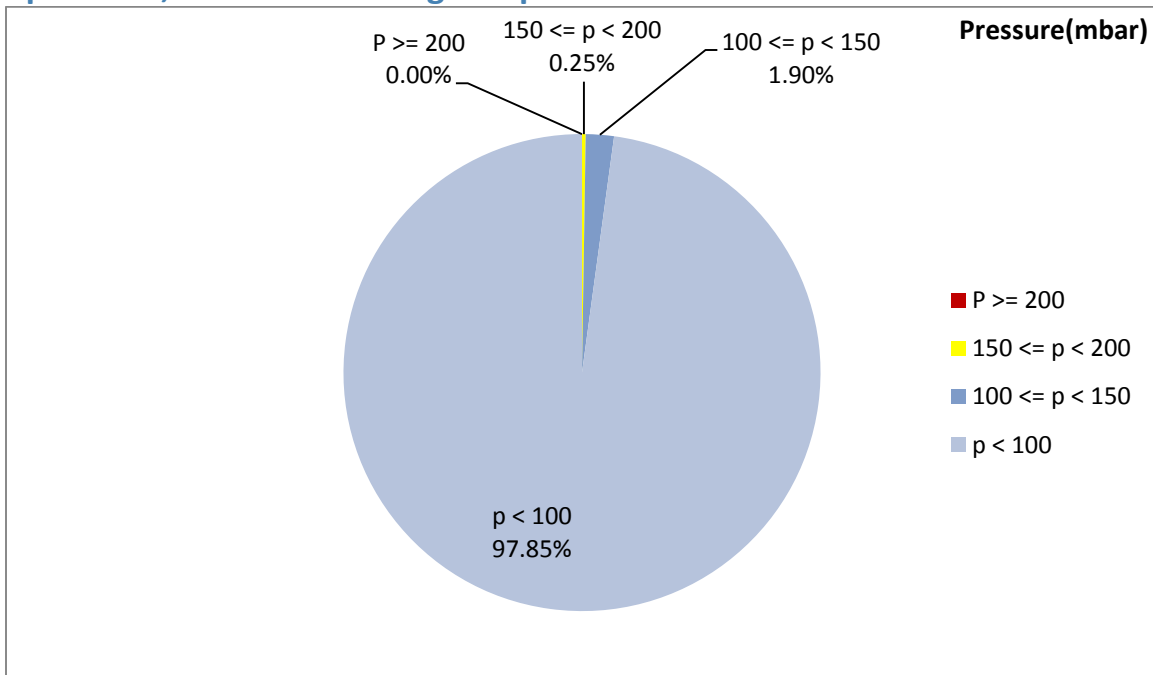
Figure 1- Pressure distribution over the working hours

- As depicted in Figure 1, pressure above 200 couldn't be observed and only 0.25% of total working time pressure is above 150mbar.
- Figure 2 displays flow temperature before the DPF. It can be obviously observed that 11% of total working time temperature is above 400 °C and 20% above 350°C. This high temperature distribution is one of the important factors for filter excellent operation during the period.

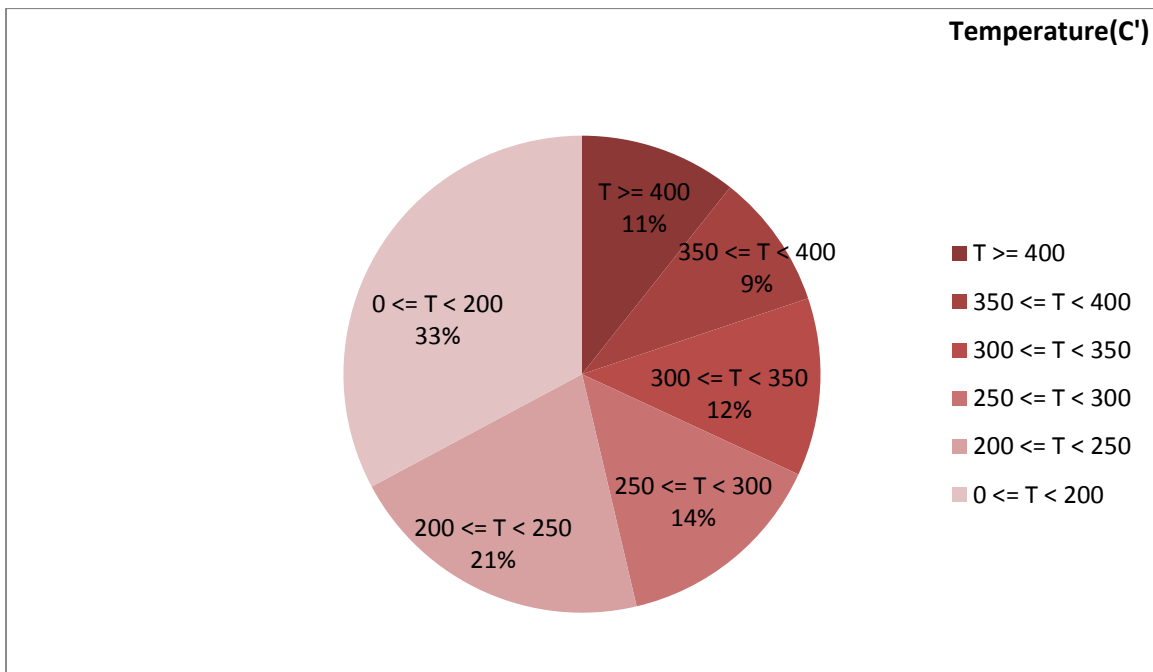
Figure 2-Temperature distribution over the working hours

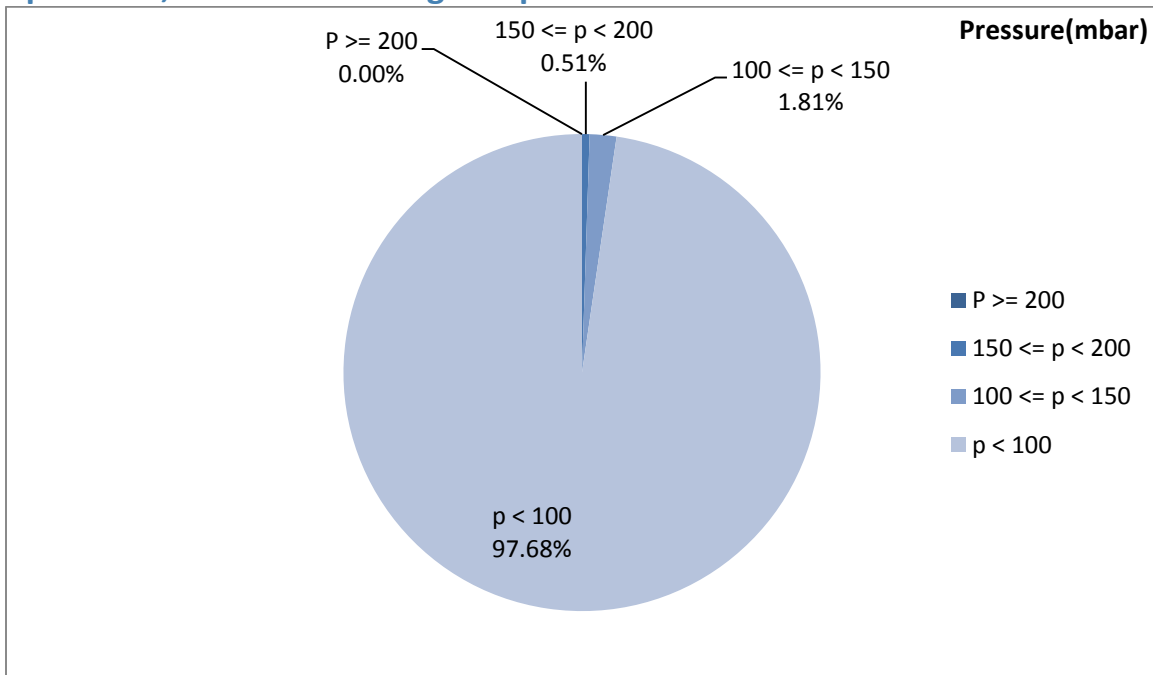
Figure 1- Pressure distribution over the working hours

- As depicted in Figure 1, pressure above 200 couldn't be observed and only 0.50% of total working time pressure is above 150mbar.
- Figure 2 displays flow temperature before the DPF. It can be obviously observed that 8% of total working time temperature is above 400 °C and 15% above 350°C. This high temperature distribution is one of the important factors for filter excellent operation during the period.

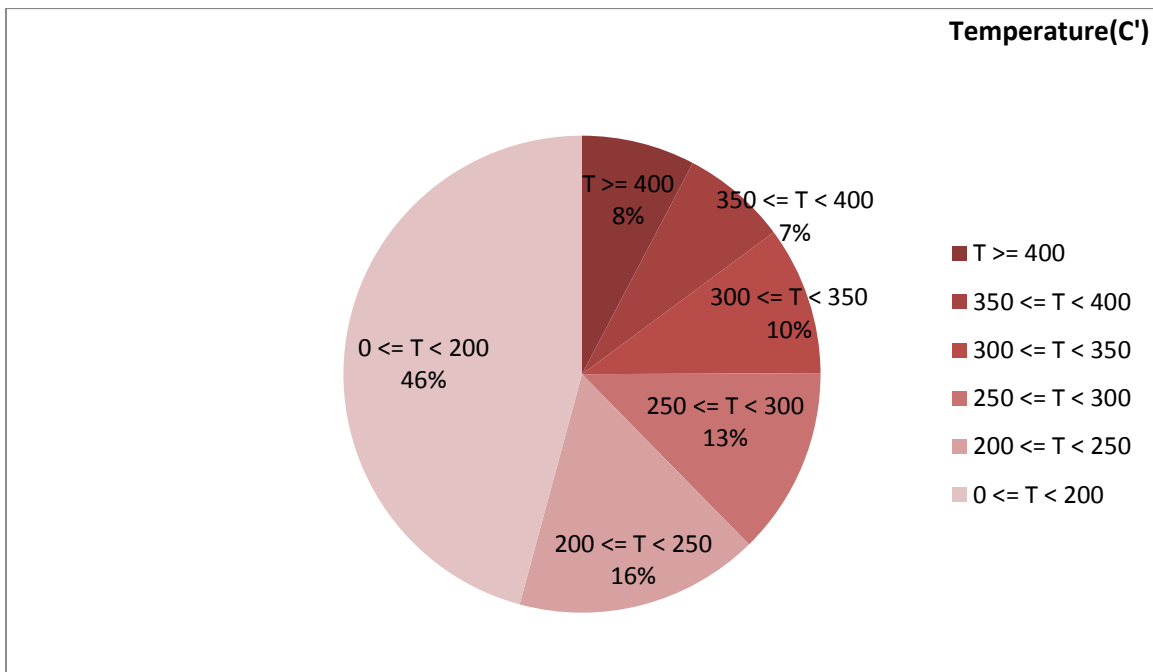
Figure 2-Temperature distribution over the working hours

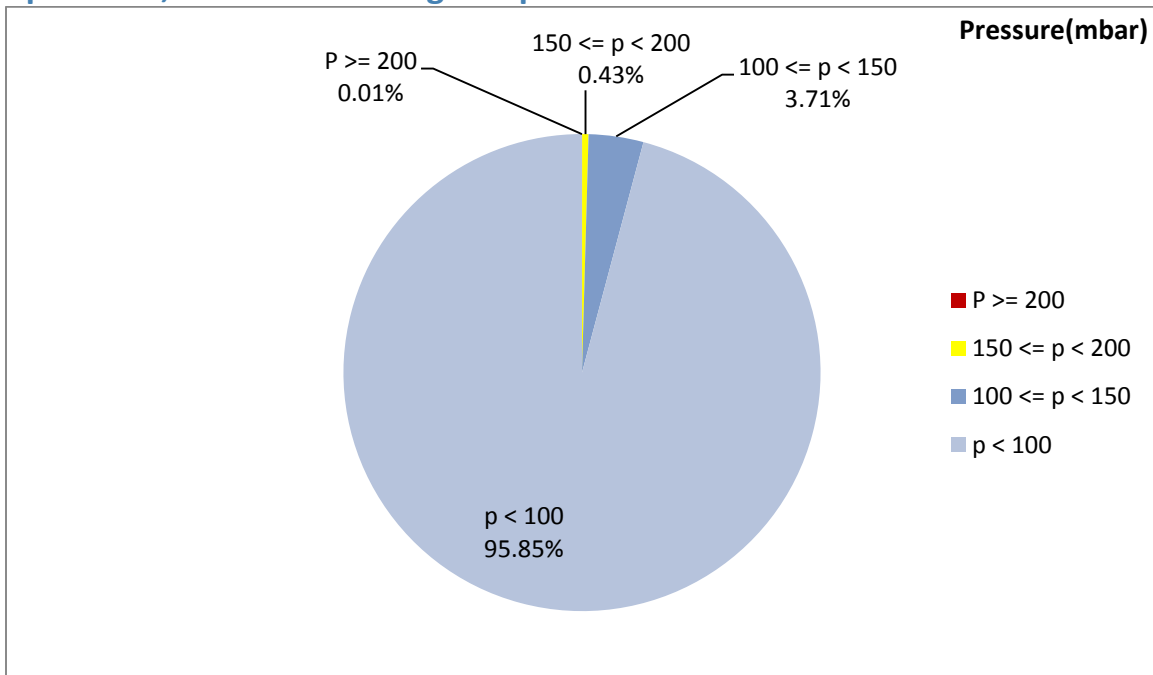
Figure 1- Pressure distribution over the working hours

- As depicted in figure 1, only 0.01% of time pressure was above 200 mbar and 0.44% above 150 mbar during this period.
- Figure 2 displays flow temperature distribution for DPF's upstream. It can be obviously observed that 12% of total working-time temperature is above 400 °C and 19% above 350°C.

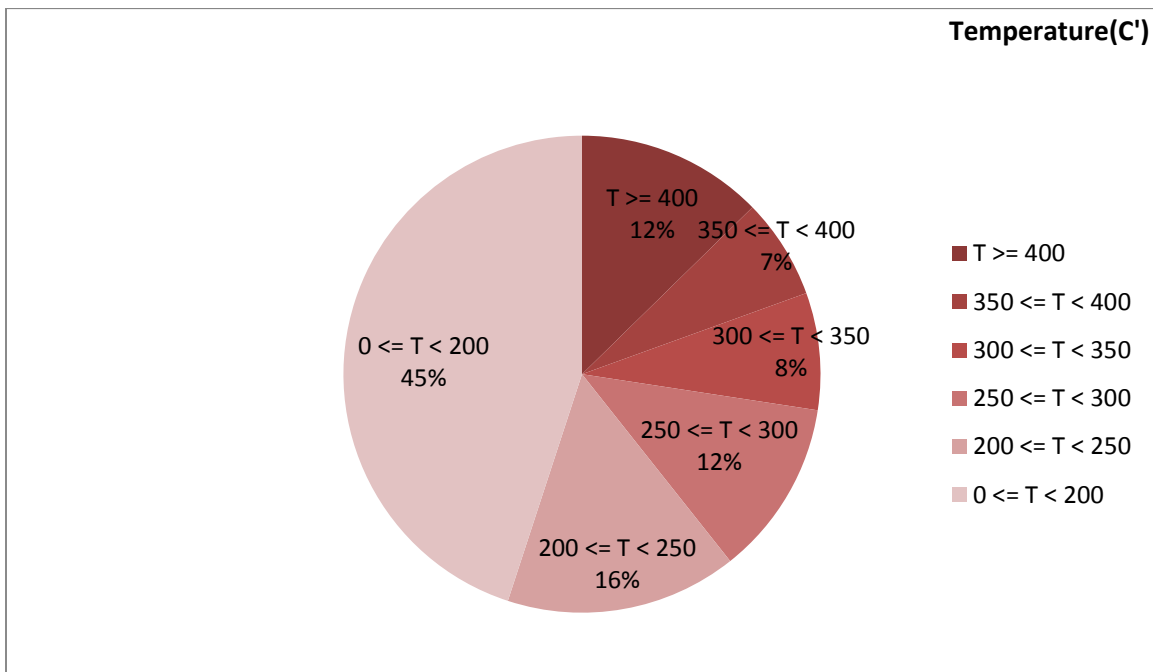
Figure 2-Temperature distribution over the working hours

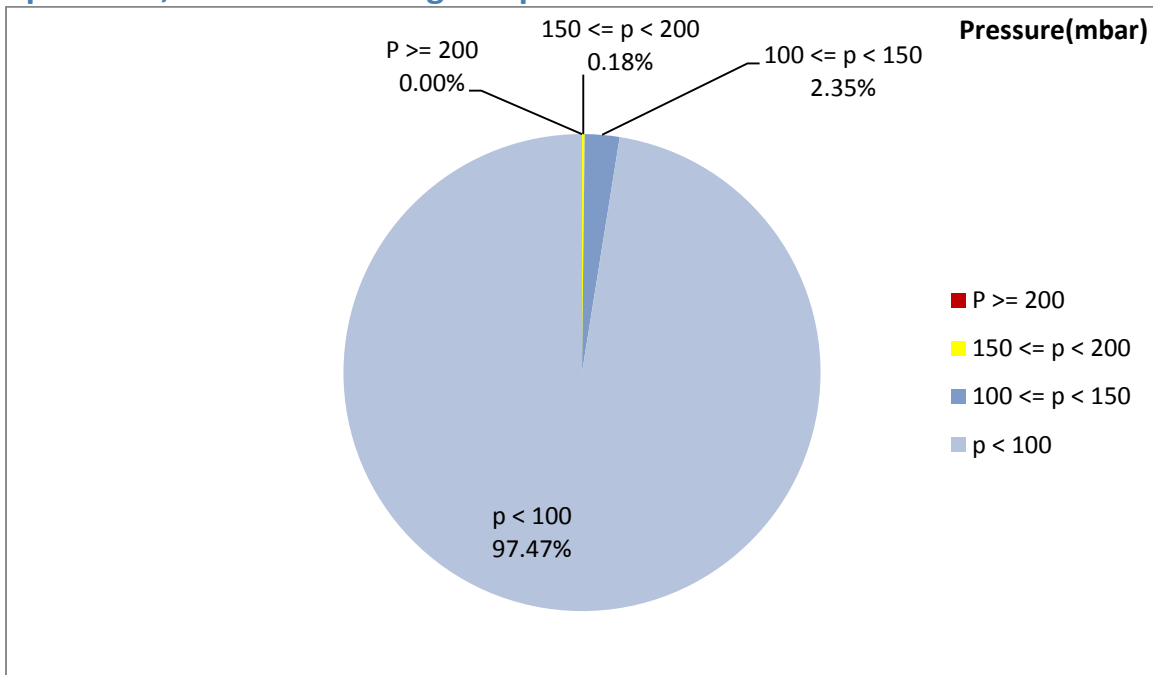
Figure 1- Pressure distribution over the working hours

- As depicted in figure 1, only 0.18% of time pressure was above 150 mbar and pressure above 200 can't be seen.
- Figure 2 displays flow temperature distribution for DPF's upstream. It can be obviously observed that 12% of total working-time temperature is above 400 °C and 19% above 350°C.

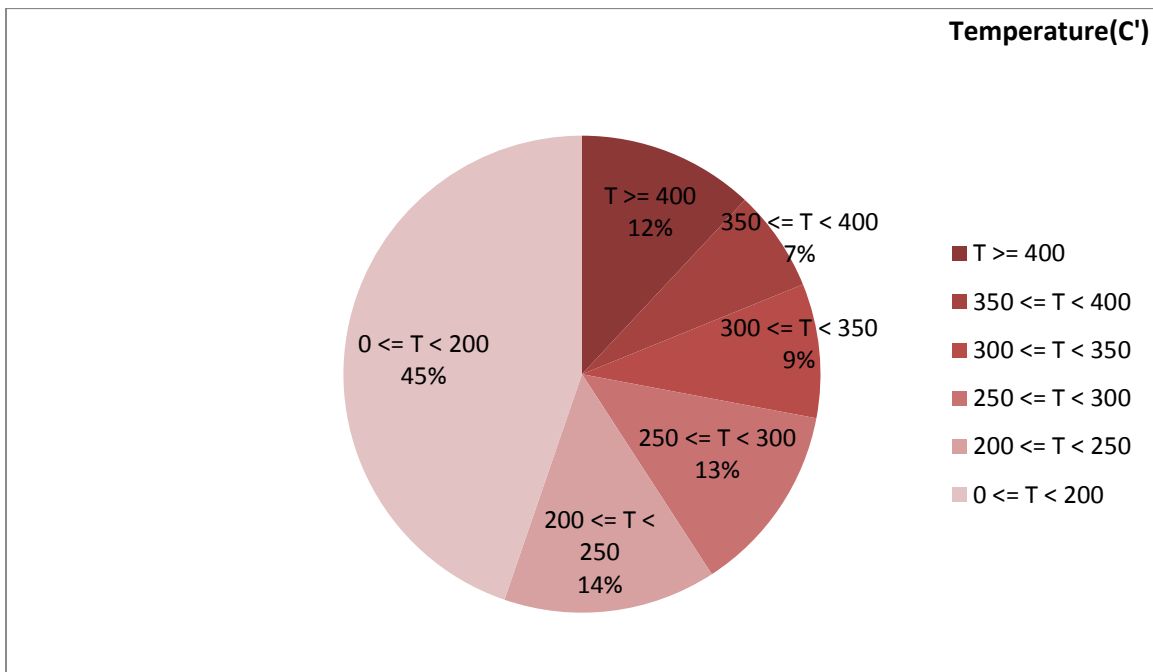
Figure 2-Temperature distribution over the working hours

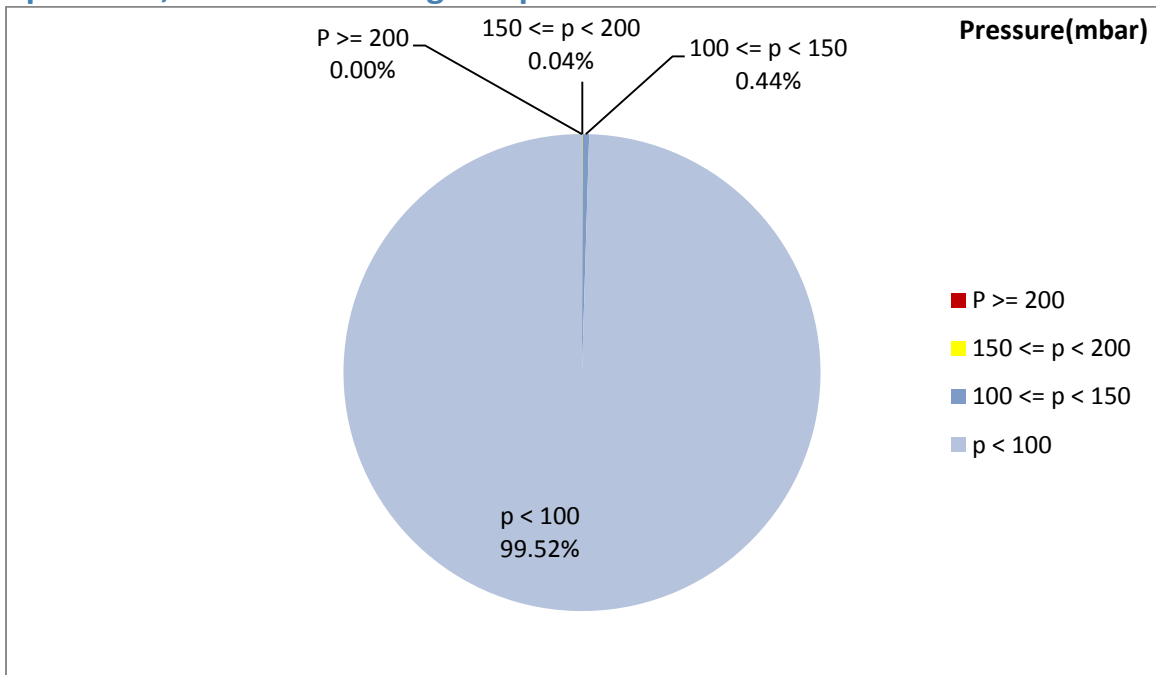
Figure 1- Pressure distribution over the working hours

- As depicted in figure 1, only 0.04% of total working time pressure was above 150 mbar during this period. This low pressure distribution was due to filter cleaning on Oct 5th.
- Figure 2 displays flow temperature distribution for DPF's upstream. It can be obviously observed that 0.39% of total working time temperature is above 400°C. And 3.23% above 350°C.

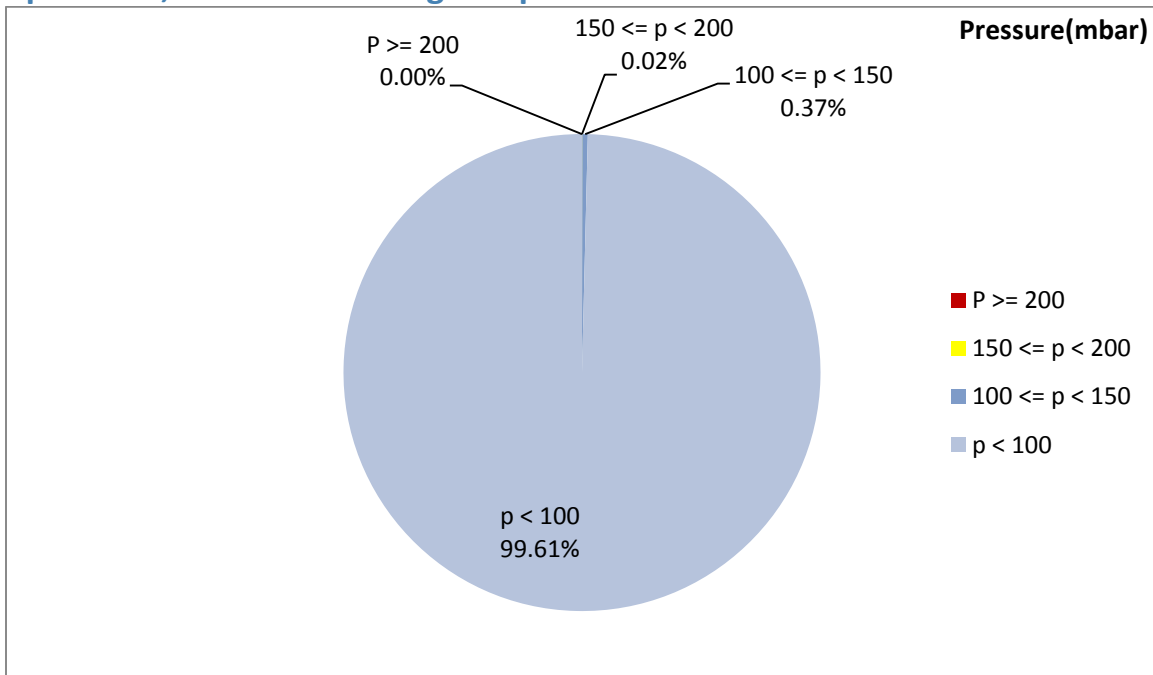
Figure 1- Pressure distribution over the working hours

- As depicted in figure 1, only 0.02% of total working time pressure was above 150 mbar during this period. This low pressure distribution was due to filter cleaning on Oct 5th.
- Figure 2 displays flow temperature distribution for DPF's upstream. It can be obviously observed that 0.12% of total working time temperature is above 400°C. And 1.43% above 350°C.

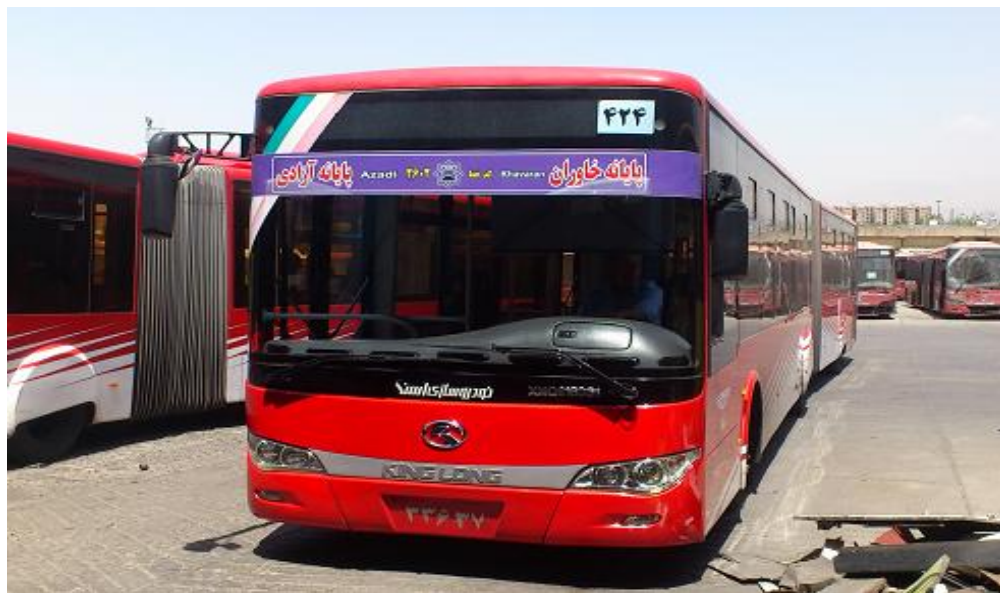
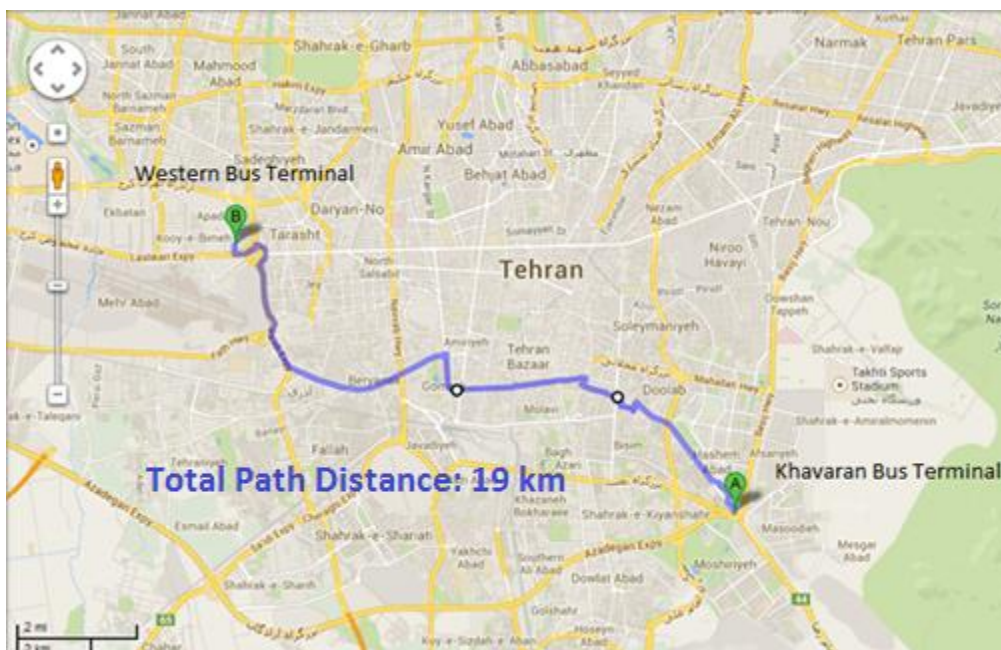
Vehicle plate number	33637 (34119)
Bus line	Number 2 (west to east bus line)
DPF producer company	Dinex_02 (Passive system with FBC)

Notice: System was working over this period without DPF.

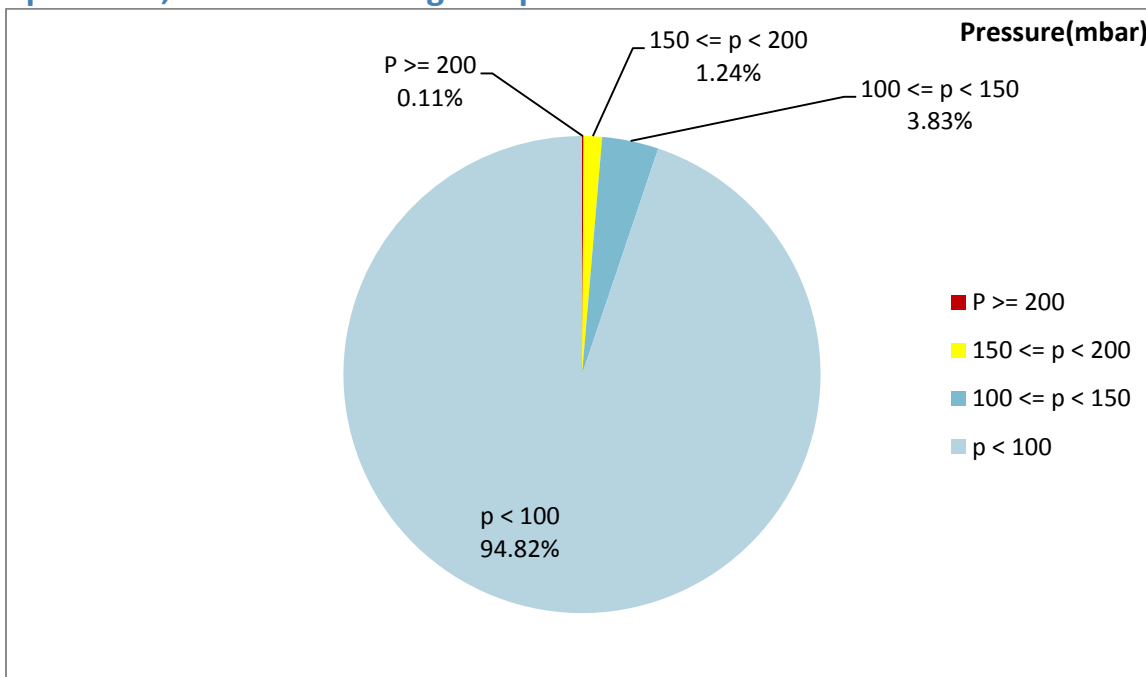
Figure 1- Pressure distribution over the working hours

- As depicted in figure 1, 0.11% of total working time pressure is above 200 mbar and 1.35% above 150mbar.
- Considering October first ten days (figure 2), It can be obviously observed that 11% of total working-time temperature is above 400 °C and 18% above 350°C.

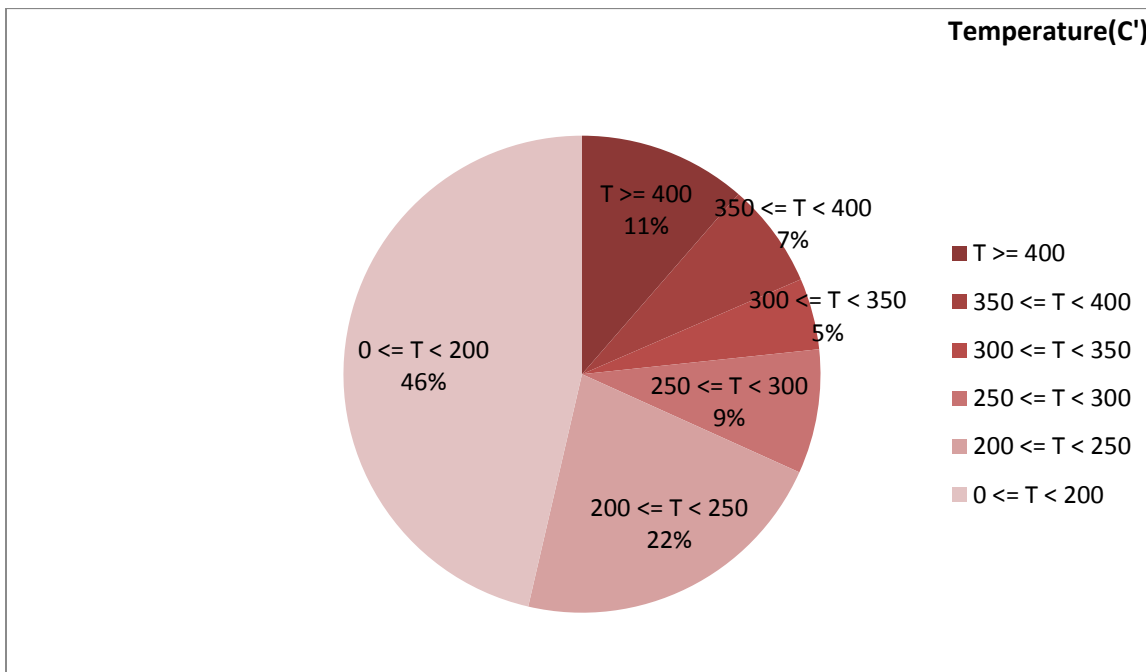
Figure 2-Temperature distribution over the working hours

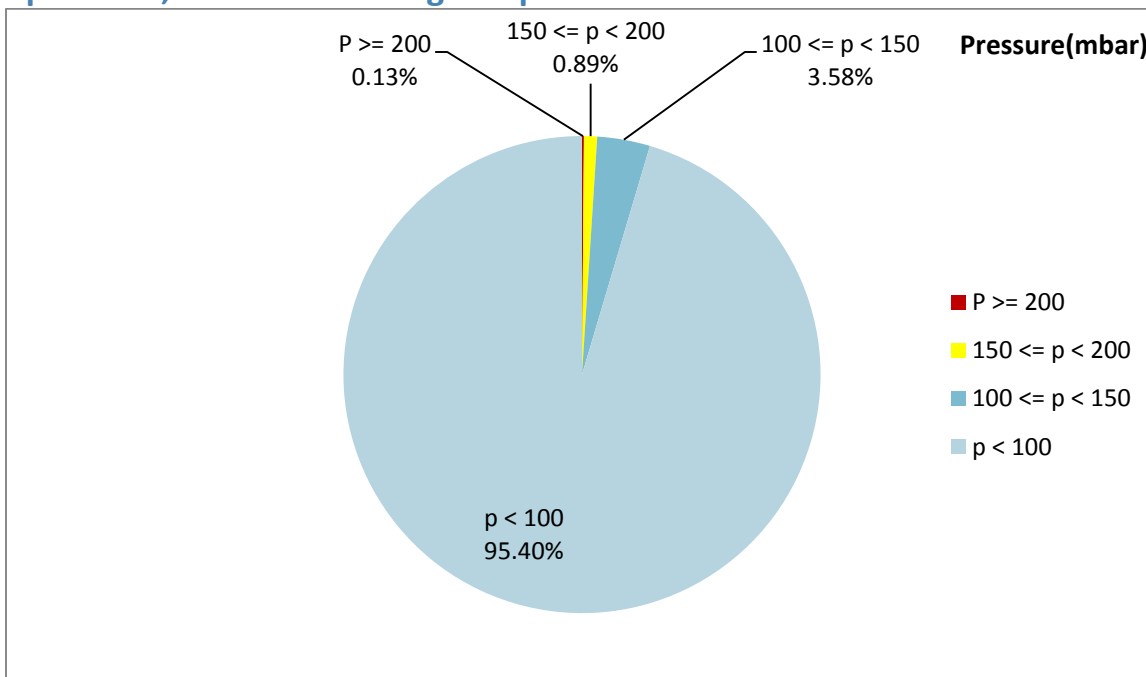
Figure 1- Pressure distribution over the working hours

- As depicted in figure 1, 0.13% of total working time pressure is above 200 mbar and 1.02% above 150mbar.
- Considering October last ten days (figure 2), it can be obviously observed that 11% of total working-time temperature is above 400 °C and 19% above 350°C.

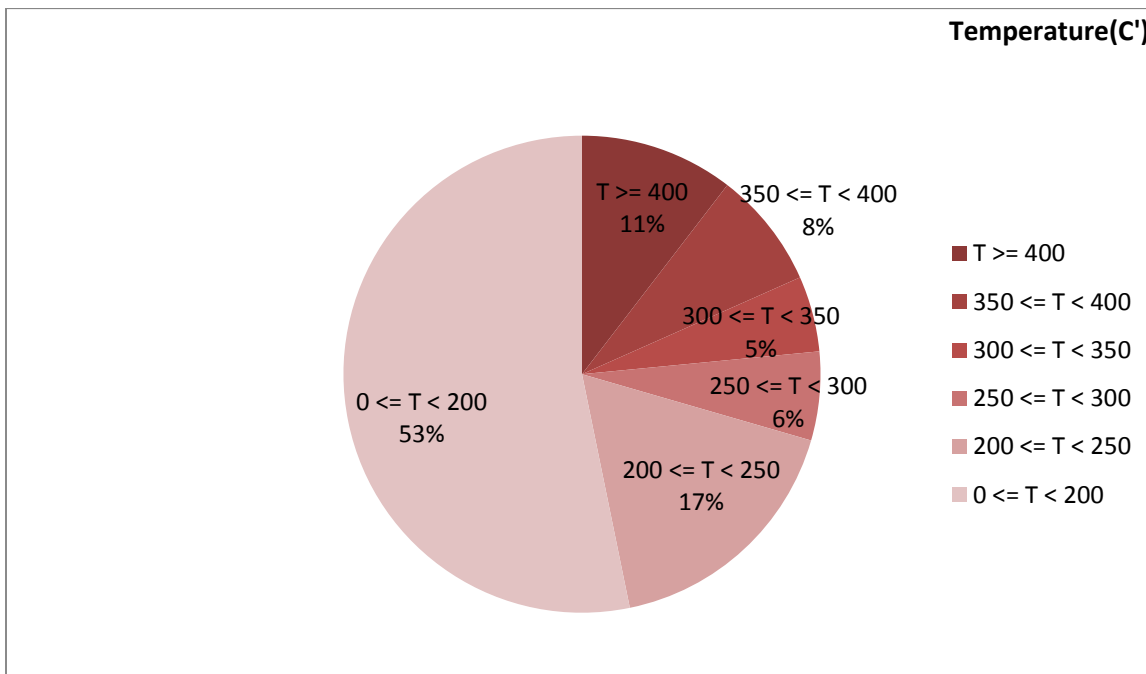
Figure 2-Temperature distribution over the working hours

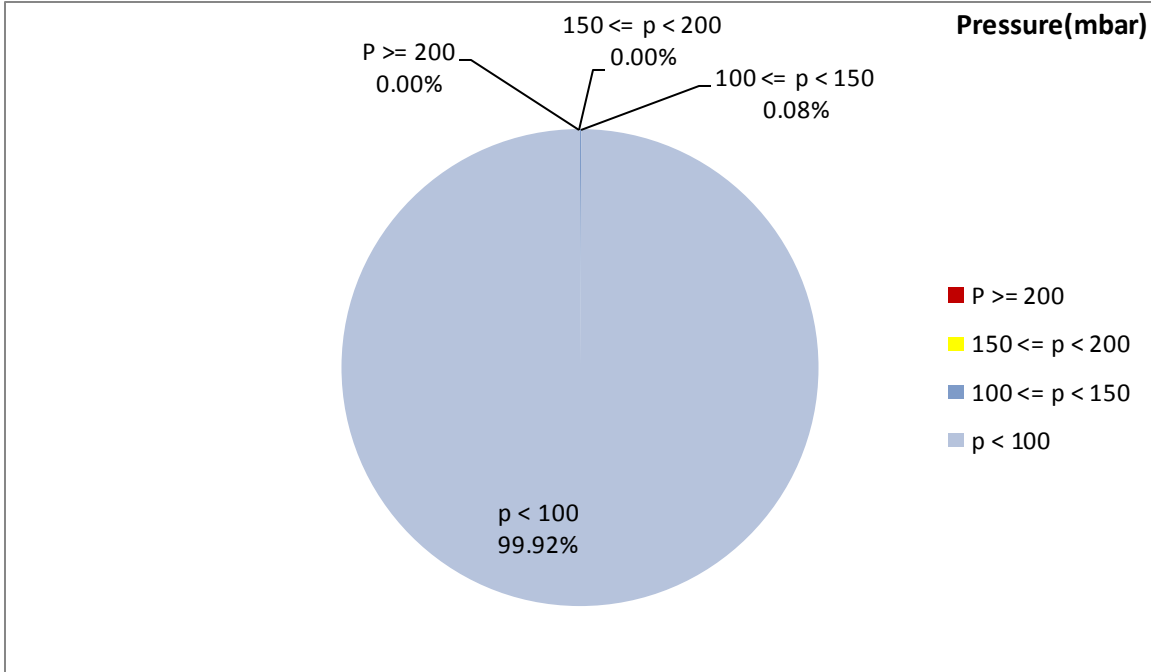
Figure 1- Pressure distribution over the working hours

- As depicted in figure 1, only 0.08% of working time pressure was above 100 mbar during this period.
- Figure 2, 17 display flow temperature distribution for DPF's upstream. It can be obviously observed that 9% of total working-time temperature is above 350 °C and 19% above 250°C. Considering DPF company recommended operable situation (30% above 250°C), beside high idle working time (72%) during this period, it could be concluded this DPF operation was fantastic during this period.

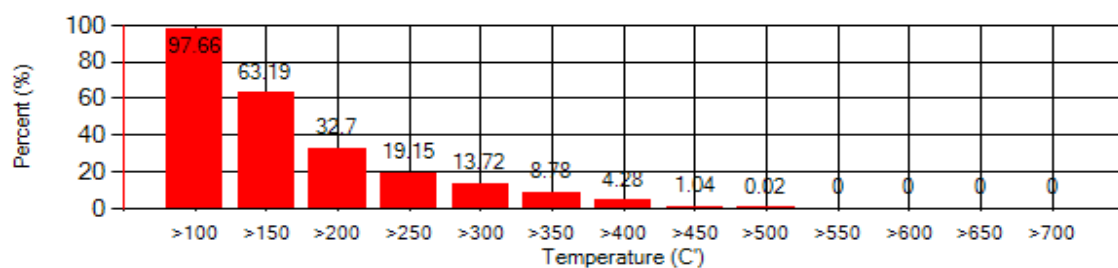
Figure 17. Cumulative diagram of exhaust gas temperature

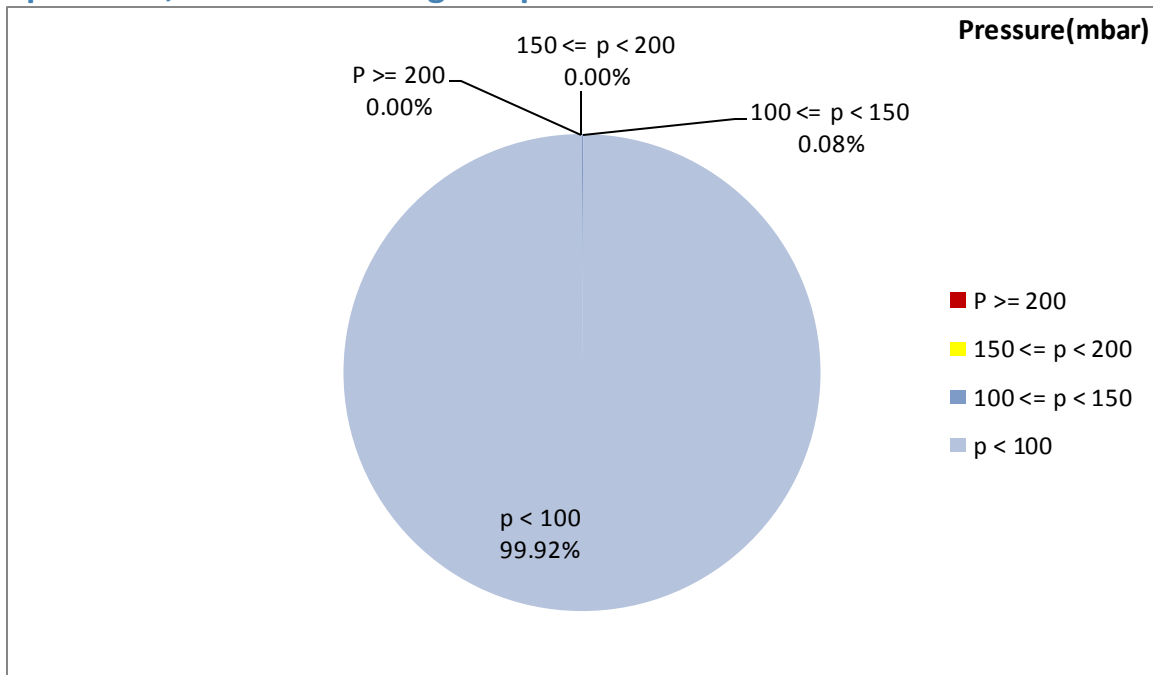
Figure 1- Pressure distribution over the working hours

- As depicted in figure 1, only 0.08% of working time pressure was above 100 mbar during this period.
- Figure 2, 17 display flow temperature distribution for DPF's upstream. It can be obviously observed that 11% of total working-time temperature is above 350 °C and 24.5% above 250°C. Considering DPF company recommended operable situation (30% above 250°C), temperature profile distribution was relatively suitable for the DPF excellent operation.

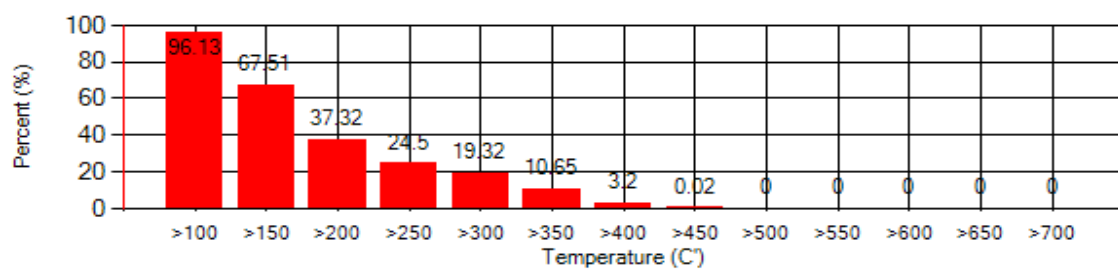
Figure 17. Cumulative diagram of exhaust gas temperature
