# Diesel Particulate Filters' Feasibility Study Report

Report's Period:

2015/11/01 - 2015/11/30

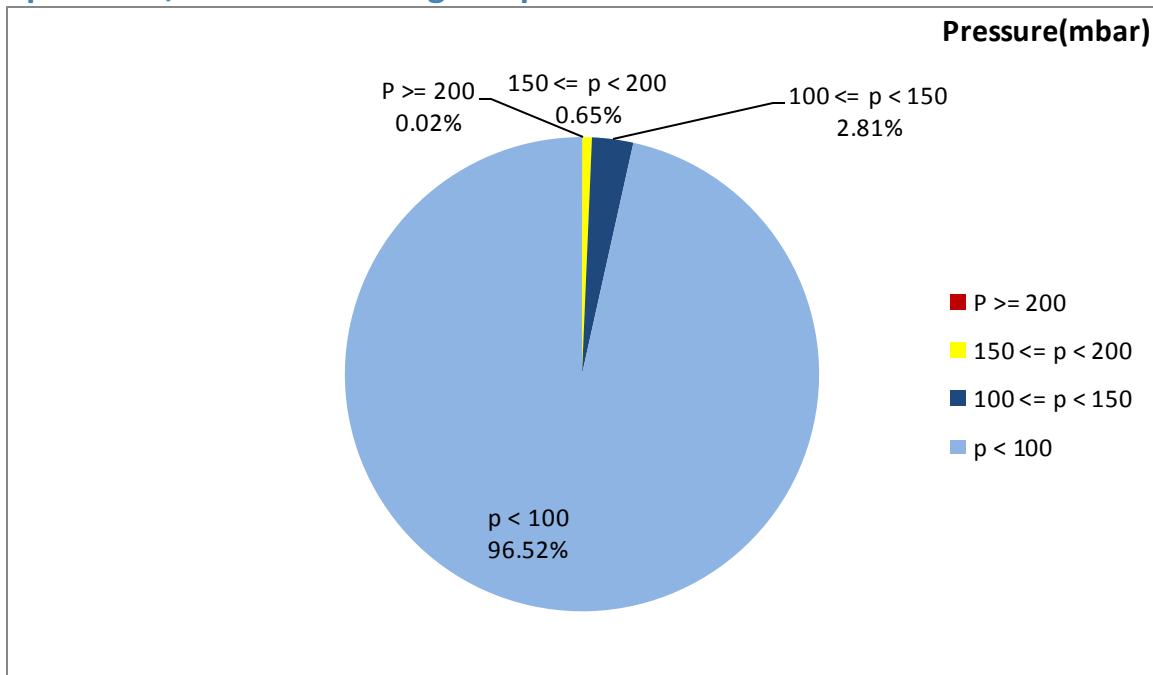
Figure 1- Pressure distribution over the working hours

- As depicted in Figure 1, 0.02% of total working time pressure is above 200 mbar and 0.67% above 150 mbar.
- Figure 2 displays flow temperature before the DPF. It can be obviously observed that 6% of total working time temperature is above 400 °C and 12% above 350°C. This high temperature distribution is one of the important factors for filter excellent operation during the period.

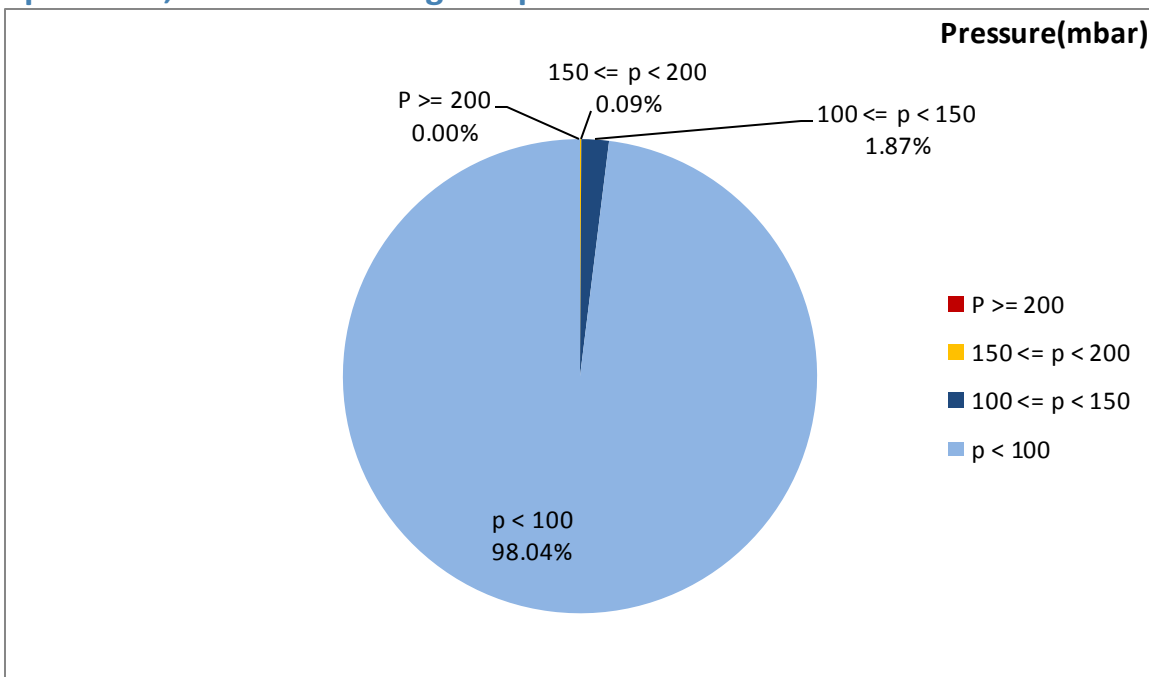
Figure 1- Pressure distribution over the working hours

- As depicted in Figure 1, pressure above 200 mbar wasn't observed during this period and only 0.09% of operation time pressure was above 150 mbar.
- Figure 2 displays flow temperature before the DPF. It can be obviously observed that 6% of total working time temperature is above 400 °C and 12% above 350°C.

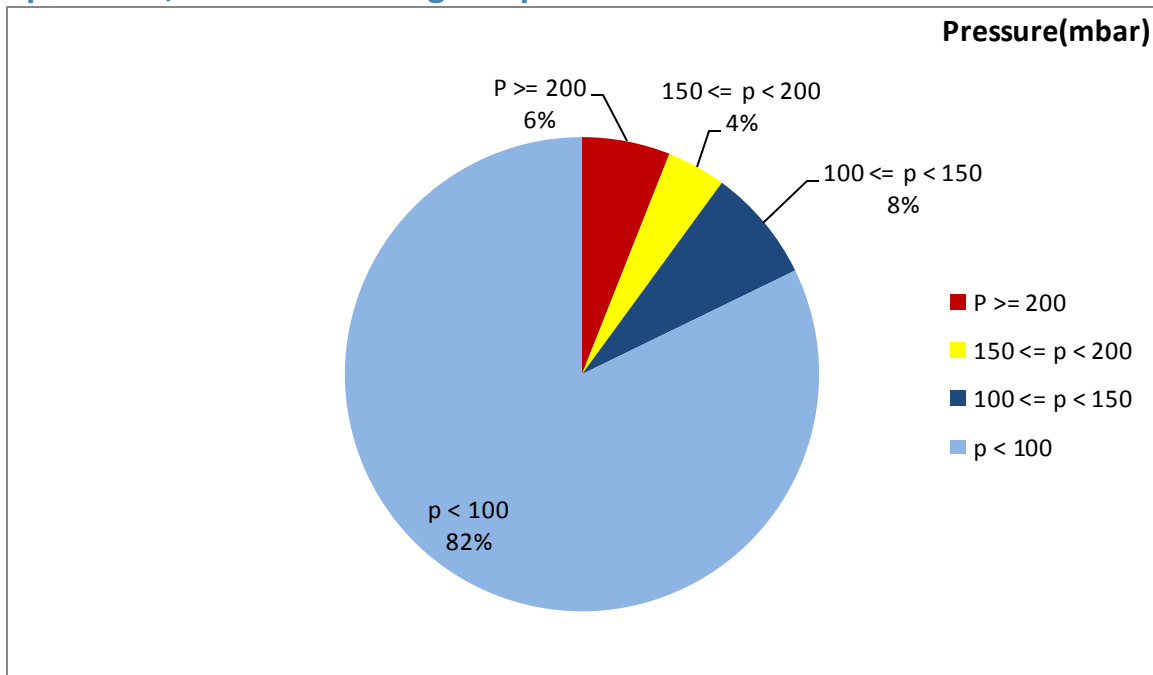
Figure 1- Pressure distribution over the working hours

- As depicted in figure 1, 6% of working time pressure was above 200 mbar and only 10% above 150mbar.
- Figure 2 displays flow temperature distribution for DPF’s upstream. It can be obviously observed that 11% of total working time, temperature is above 400 °C and 17% above 350°C.
- Two cleaning for 8 days working was unacceptable for this DPF operation.

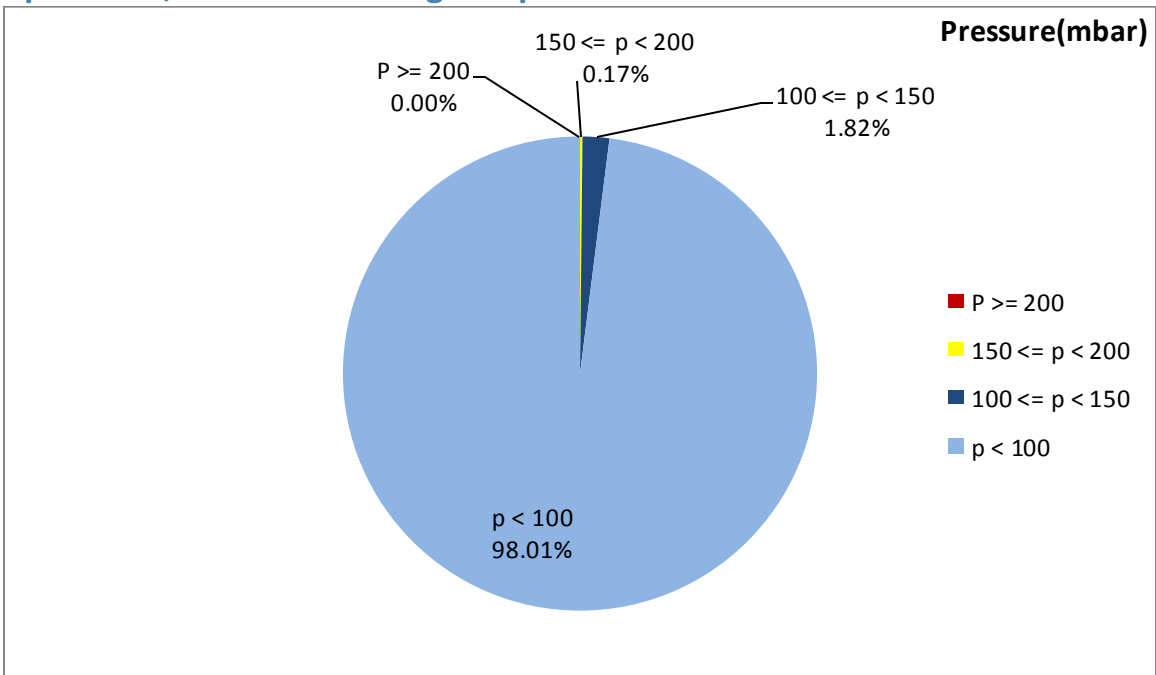
Figure 1- Pressure distribution over the working hours

- As depicted in figure 1, only 0.17% of time pressure was above 150 mbar and pressure above 200 can't be seen.
- Figure 2 displays flow temperature distribution for DPF's upstream. It can be obviously observed that 10% of total working-time temperature is above 400 °C and 16% above 350°C.

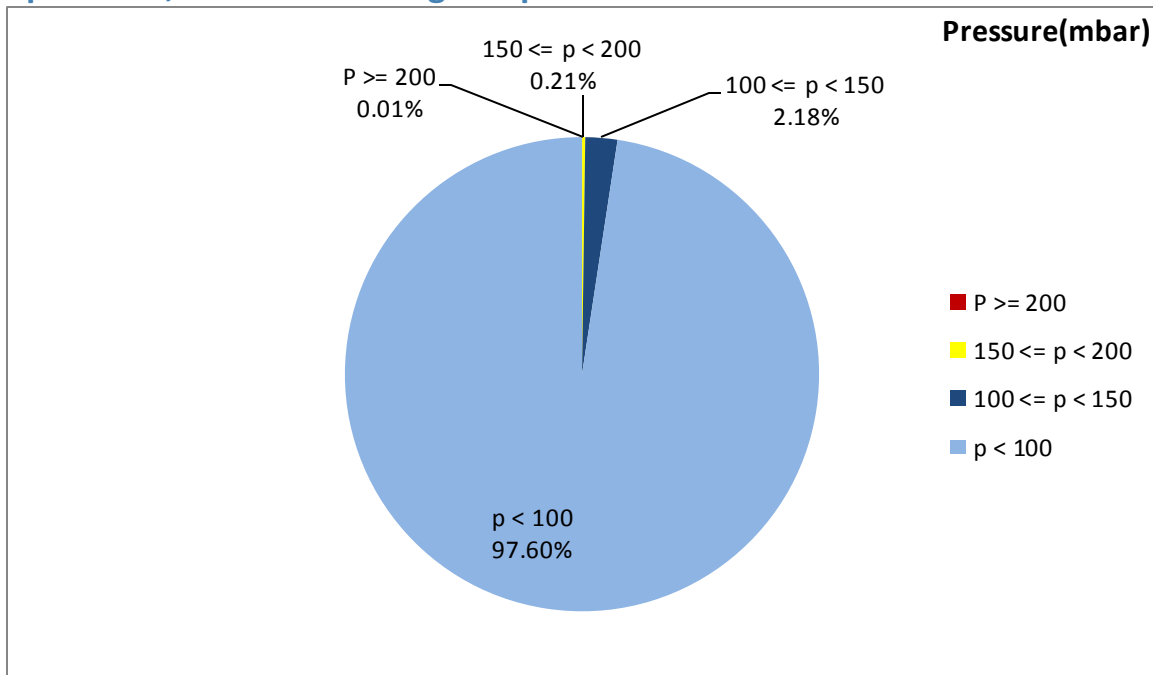
Figure 1- Pressure distribution over the working hours

- As depicted in figure 1, only 0.01% of time pressure was above 200 mbar and 0.22% above 150 mbar.
- Figure 2 displays flow temperature distribution for DPF's upstream. It can be obviously observed that 9% of total working-time temperature is above 400 °C and 15% above 350°C.

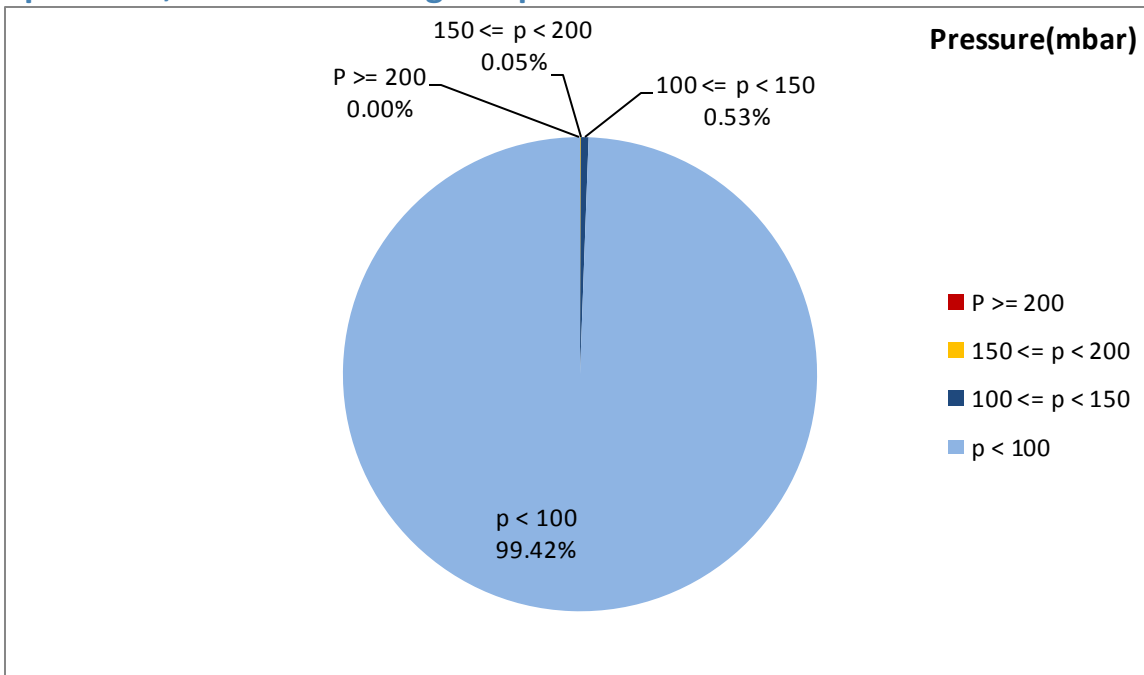
Figure 1- Pressure distribution over the working hours

- As depicted in figure 1, only 0.05% of total working time pressure was above 150 mbar during this period. This low pressure distribution was due to filter cleaning on Oct 5<sup>th</sup>.
- Figure 2 displays flow temperature distribution for DPF's upstream. It can be obviously observed that 1% of total working time temperature is above 350°C.

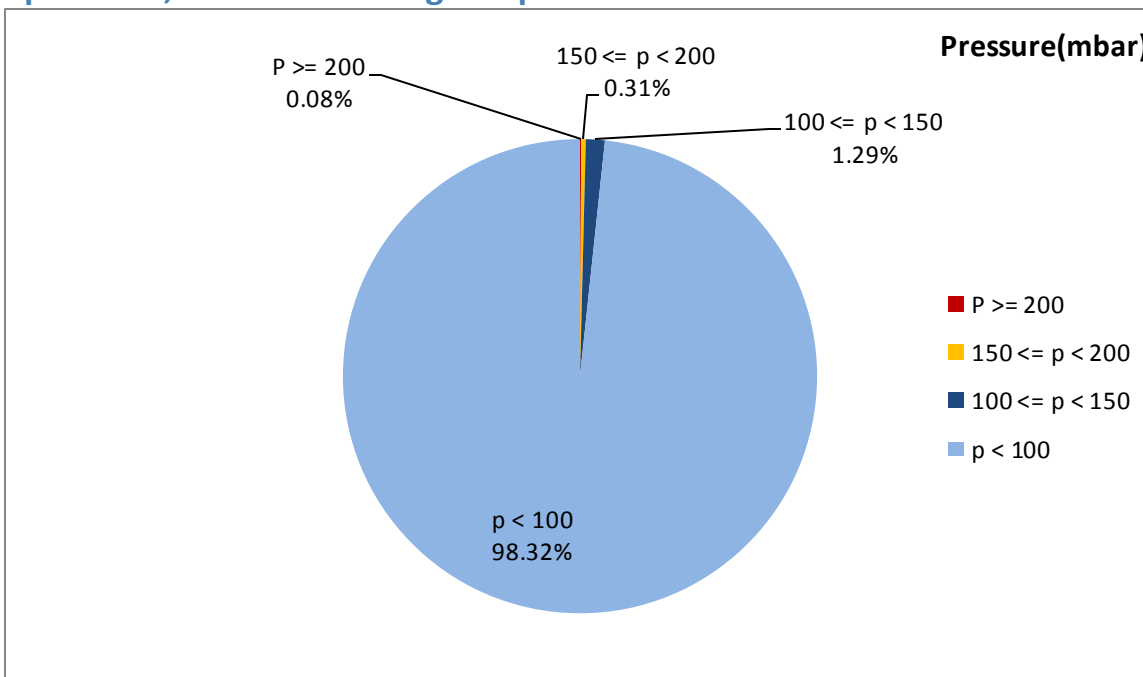
Figure 1- Pressure distribution over the working hours

- As depicted in figure 1, 0.08% of total working time pressure is above 200 mbar and 0.39% above 150 mbar during this period. Comparing pressure values with first half of Nov, shows sharp increment. This sharp variation during this period was because of additive system's problem.
- Figure 2 displays flow temperature distribution for DPF's upstream. It can be obviously observed only 0.01% of total working time temperature is above 350°C. This low temperature distribution was other effective parameter on pressure increment.

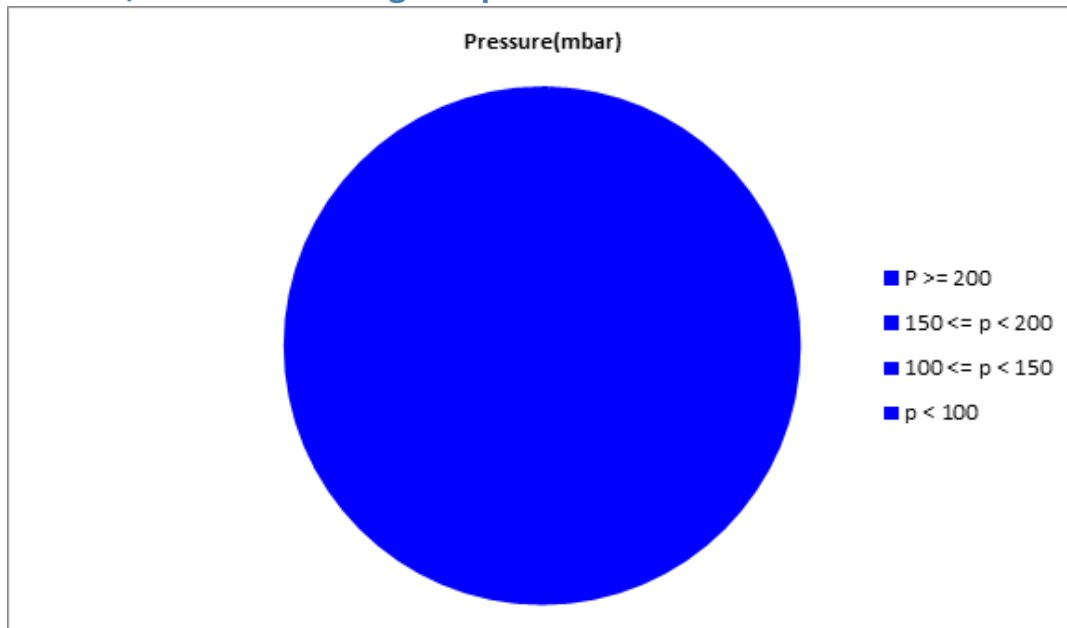
Figure 1- Pressure distribution over the working hours

Notice: Pressure sensor got problem on Nov 11th and was not fixed until the end of this period. Considering this problem besides data logger problem, pressure pie diagram was left blank due to data leakage.

- As depicted in figure 1, there wasn't enough data to evaluate DPF operation status exactly because of pressure sensor and data logger problem (**excellent or good**).
- it can be obviously observed that 7% of total working-time temperature is above 400 °C and 15% above 350°C.

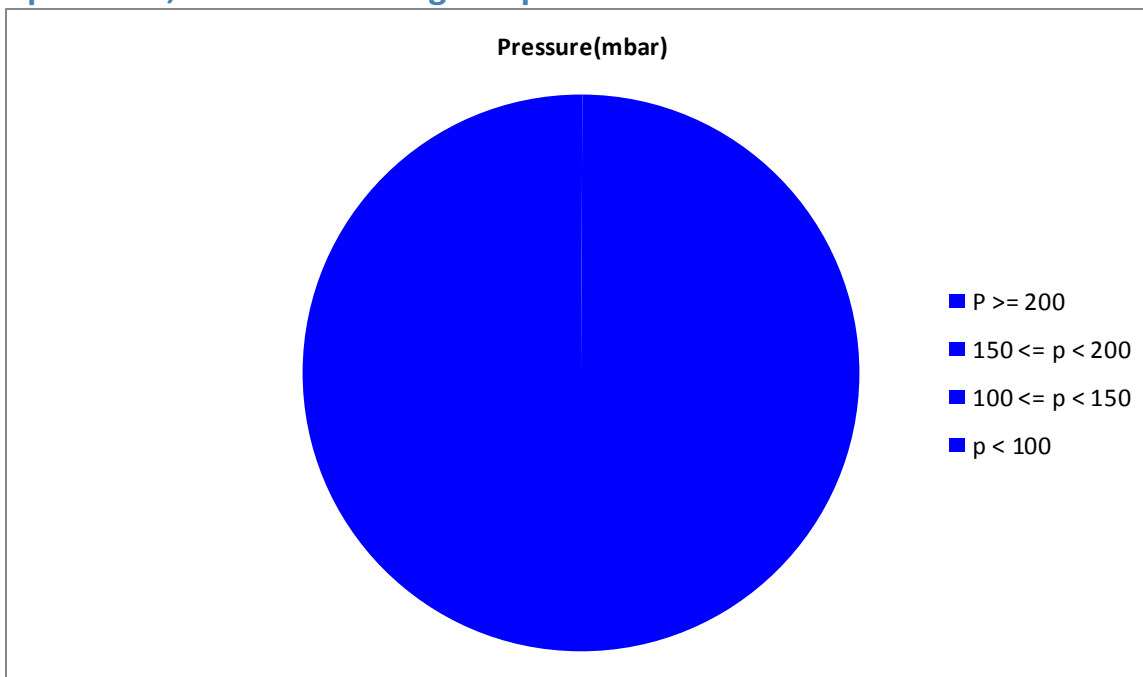
Figure 1- Pressure distribution over the working hours

Notice: Pressure sensor got problem on Nov 11th and was fixed on Nov 29<sup>th</sup>. So pressure pie diagram was left blank due to data leakage.

- As depicted in figure 1, there wasn't enough data to evaluate DPF operation status exactly because of pressure sensor problem (**excellent or good**).
- Considering October last ten days (figure 2), it can be obviously observed that 6% of total working-time temperature is above 400 °C and 13% above 350°C.

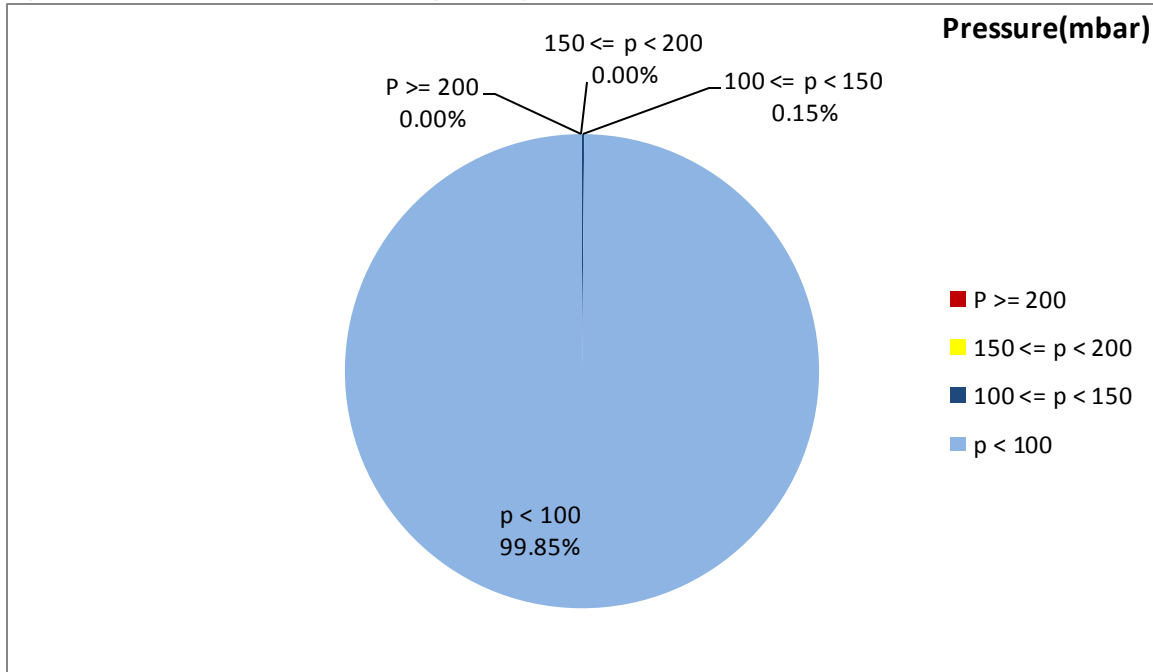
Figure 1- Pressure distribution over the working hours

- As depicted in figure 1, only 0.15% of working time pressure was above 100 mbar during this period.
- Figure 2, 17 display flow temperature distribution for DPF's upstream. It can be obviously observed that 10% of total working-time temperature is above 350 °C and 25.6% above 250°C. Considering DPF company recommended operable situation (30% above 250°C), temperature profile distribution was relatively suitable for the DPF excellent operation.
