Diesel Particulate Filters' Feasibility Study Report

Report's Period:

2016/01/01- 2016/01/31

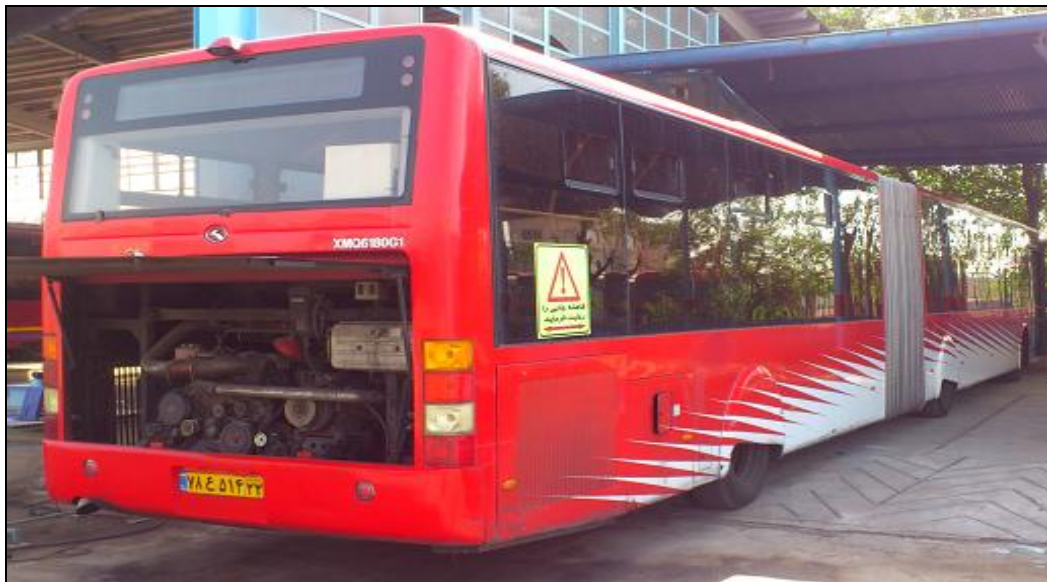
Vehicle plate number	78514
Bus line	Number 4 (south to north bus line)
DPF producer company	HJS_01 (Passive system with FBC)

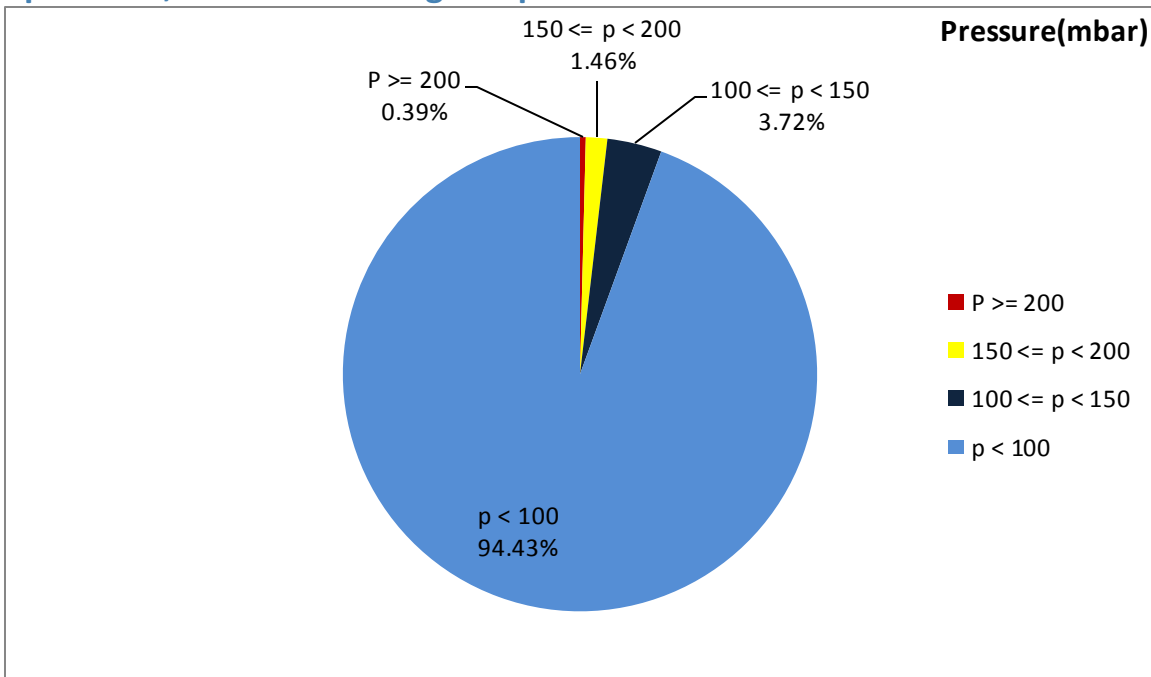
Figure 1- Pressure distribution over the working hours

- As depicted in Figure 1, 0.39% of working time, pressure was above 200 mbar and 1.85% above 150 mbar.
- Figure 2 displays flow temperature before the DPF. It can be obviously observed that 5.7% of total working time temperature is above 400 °C and 10.9% above 350°C.

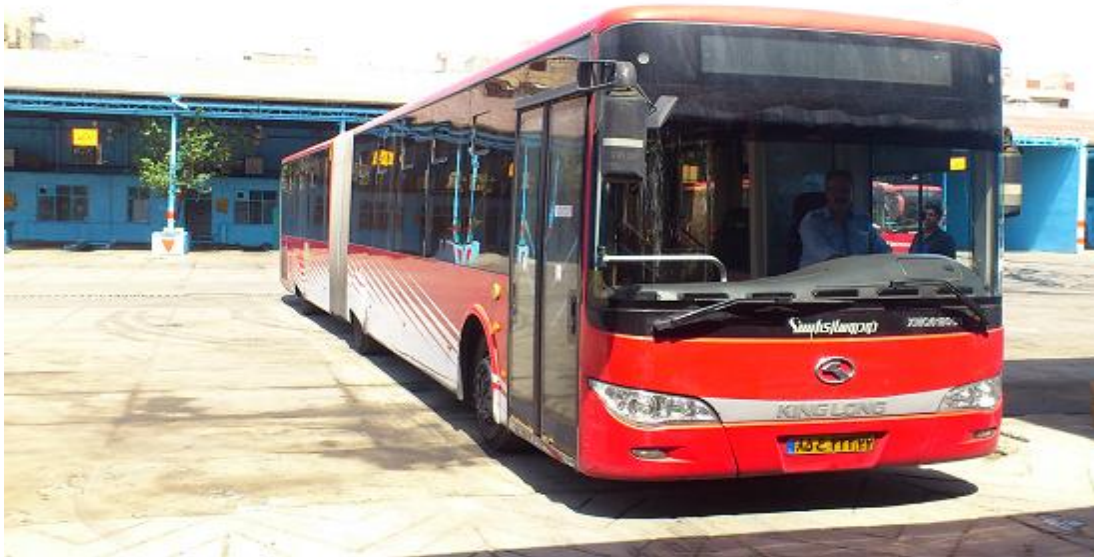
Vehicle plate number	85423
Bus line	Number 4 (south to north bus line)
DPF producer company	HJS_02 (active system with FBC – electrical heater)

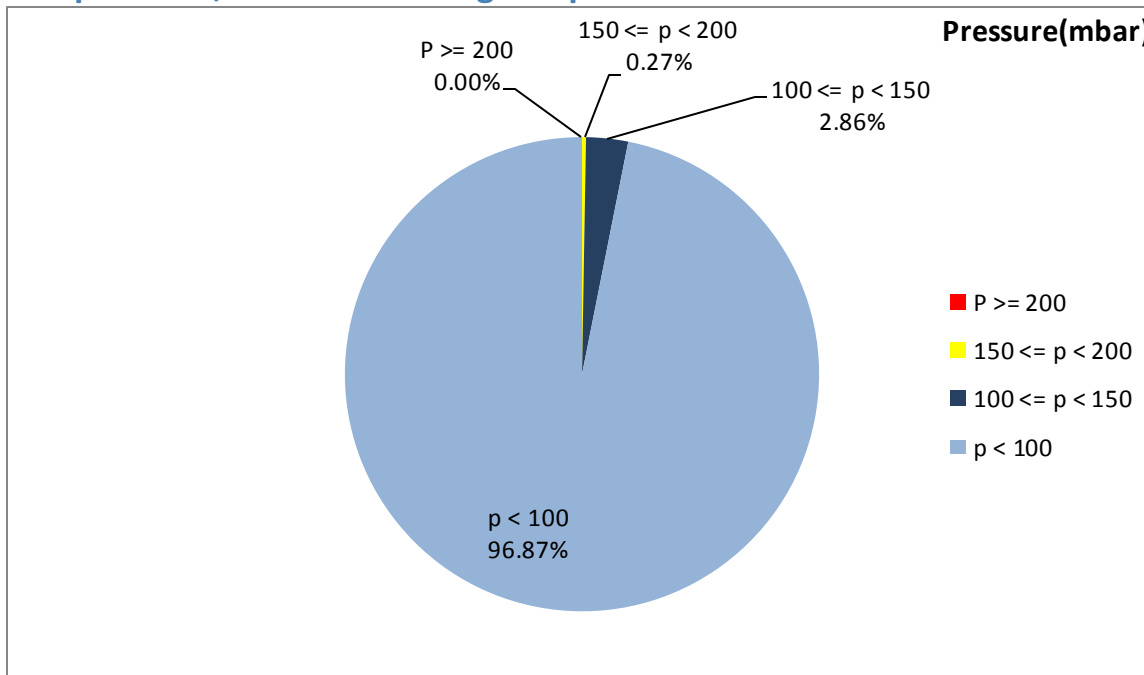
Figure 1- Pressure distribution over the working hours

- As depicted in figure 1, only 0.27% of time pressure was above 150 mbar and pressure above 200 mbar was not observed.
- Figure 2 displays flow temperature distribution for DPF's upstream. It can be obviously observed that 7.6% of total working-time temperature is above 400 °C and 12.3% above 350°C.

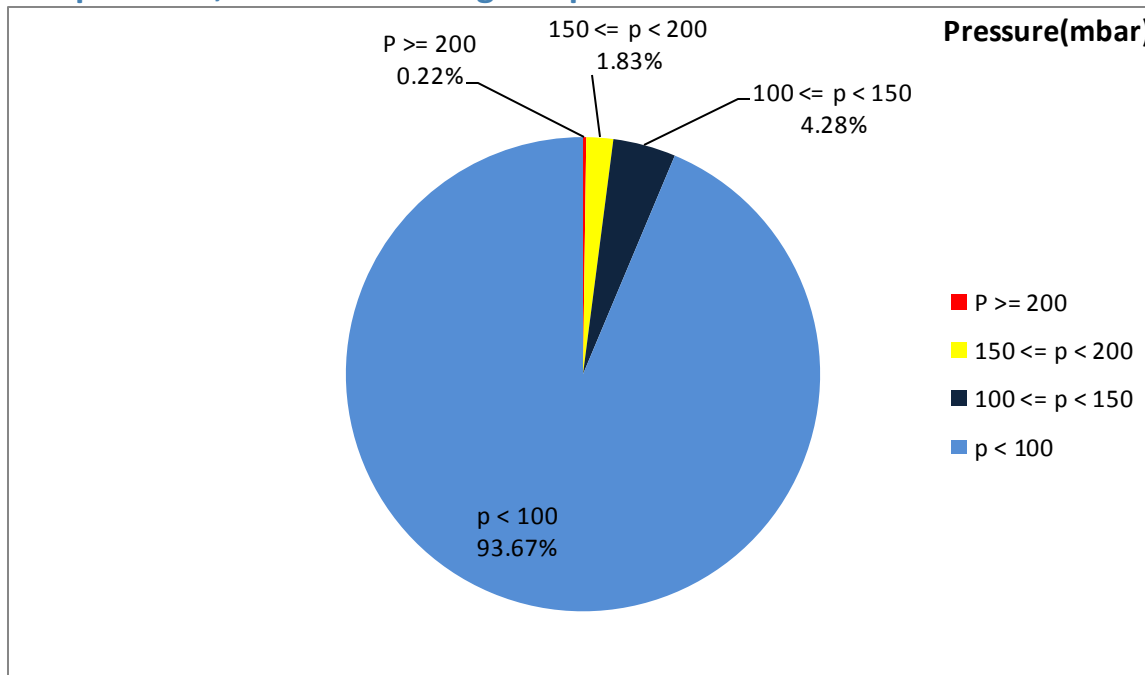
Figure 1- Pressure distribution over the working hours

- As depicted in figure 1, only 0.22% of time pressure was above 200 mbar and 2.05% of time above 150 mbar
- Figure 2 displays flow temperature distribution for DPF's upstream. It can be obviously observed that 10.3% of total working-time temperature is above 400 °C and 16.2% above 350°C.

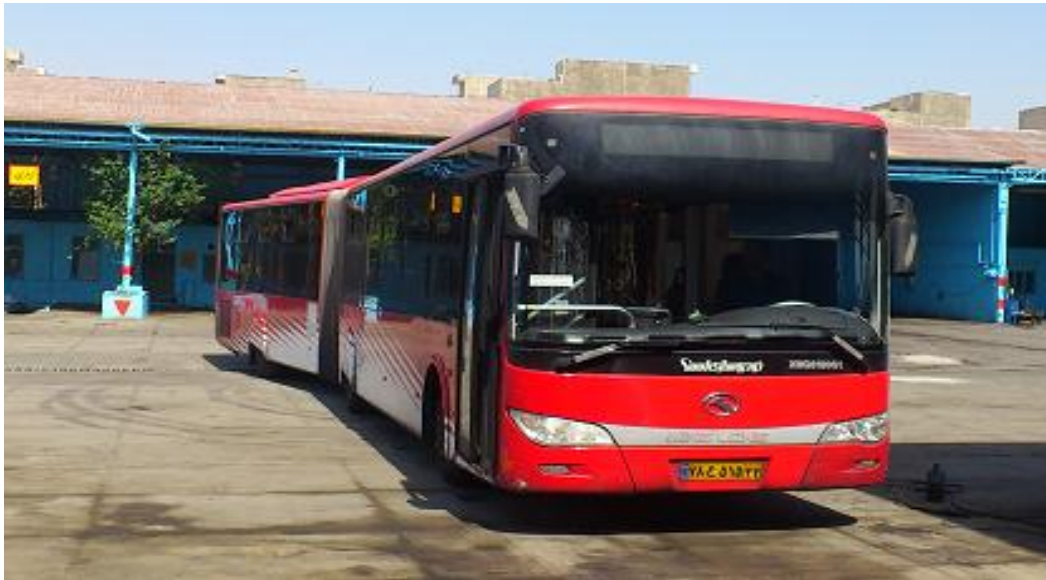
Vehicle plate number	78515
Bus line	Number 4 (south to north bus line)
DPF producer company	Dinex_01 (Passive system with FBC)

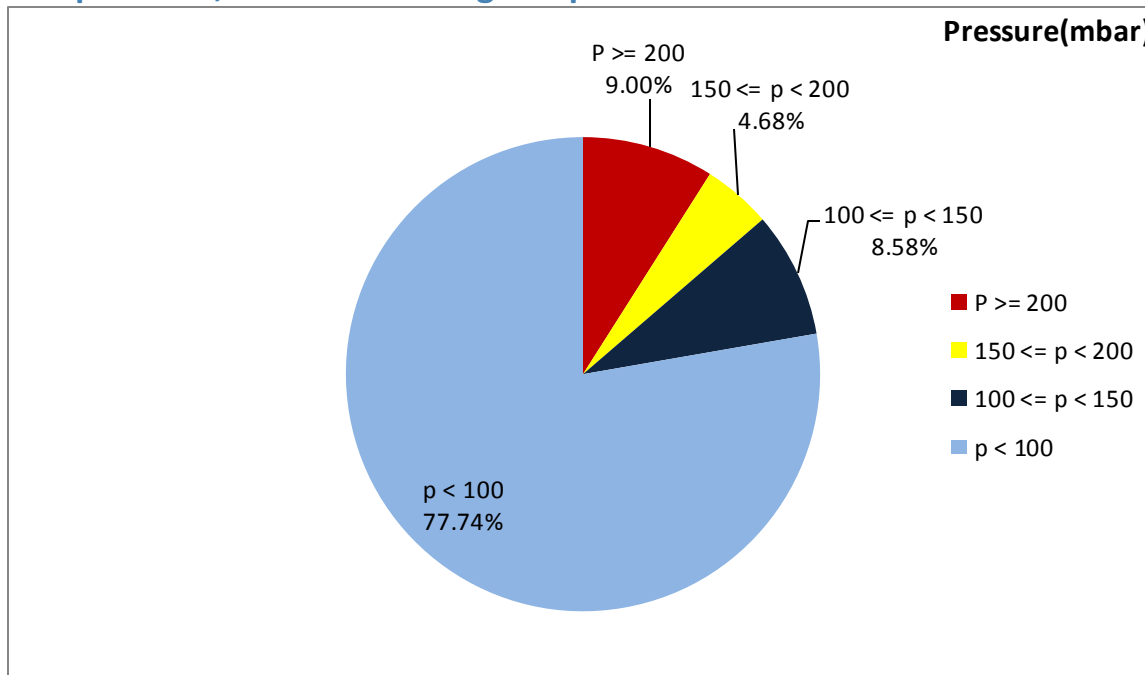
Figure 1- Pressure distribution over the working hours

- As depicted in Figure 1, 9% of working time, pressure was above 200 mbar. This high pressure distribution during early three days after DPF cleaning is unacceptable.
- Figure 2 displays flow temperature before the DPF. It can be obviously observed that 12.5% of total working time temperature is above 400 °C and maximum temperature was 714 °C during this period.
- Considering all these data, Cleaning was unsuccessful like last two cleaning.

Filter operation status	Excellent <input type="checkbox"/>	Good <input type="checkbox"/>
	Maintenance required <input checked="" type="checkbox"/>	Failed <input type="checkbox"/>

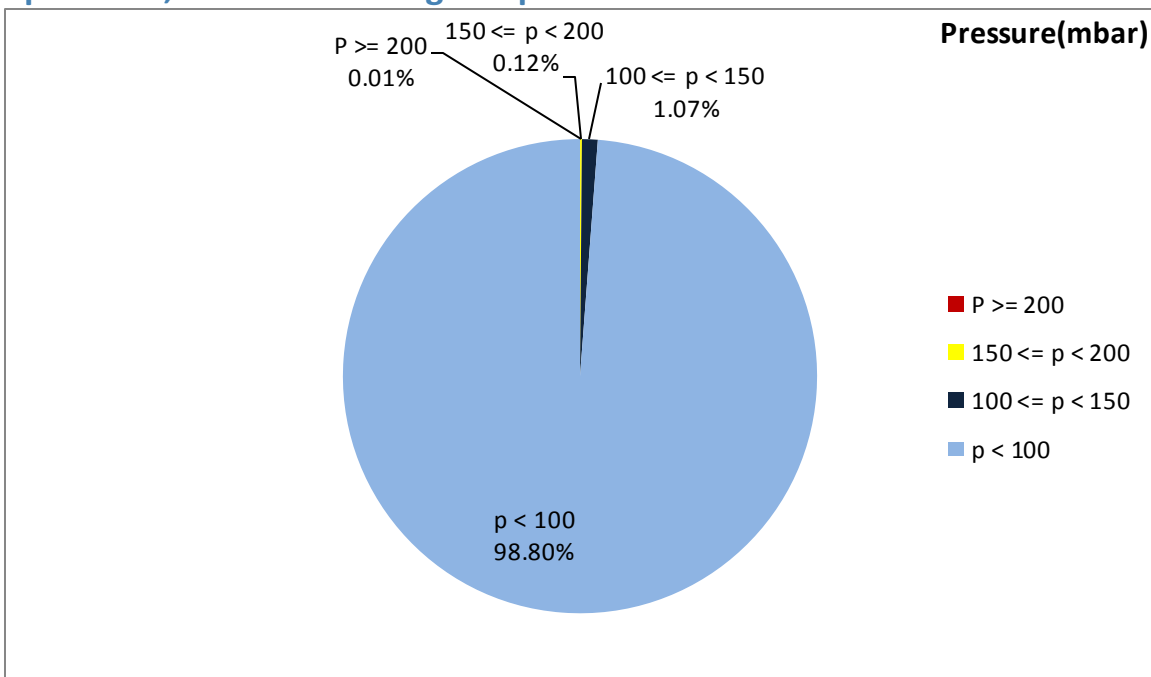
Figure 1- Pressure distribution over the working hours

- As depicted in figure 1, 0.01% of total working time pressure is above 200 mbar and 0.13% above 150 mbar during this period. This low pressure distribution was because of the cleaning issue which was done on Dec 19th.
- Figure 2 displays flow temperature distribution for DPF's upstream. It can be obviously observed 1% of total working time temperature is above 350°C.

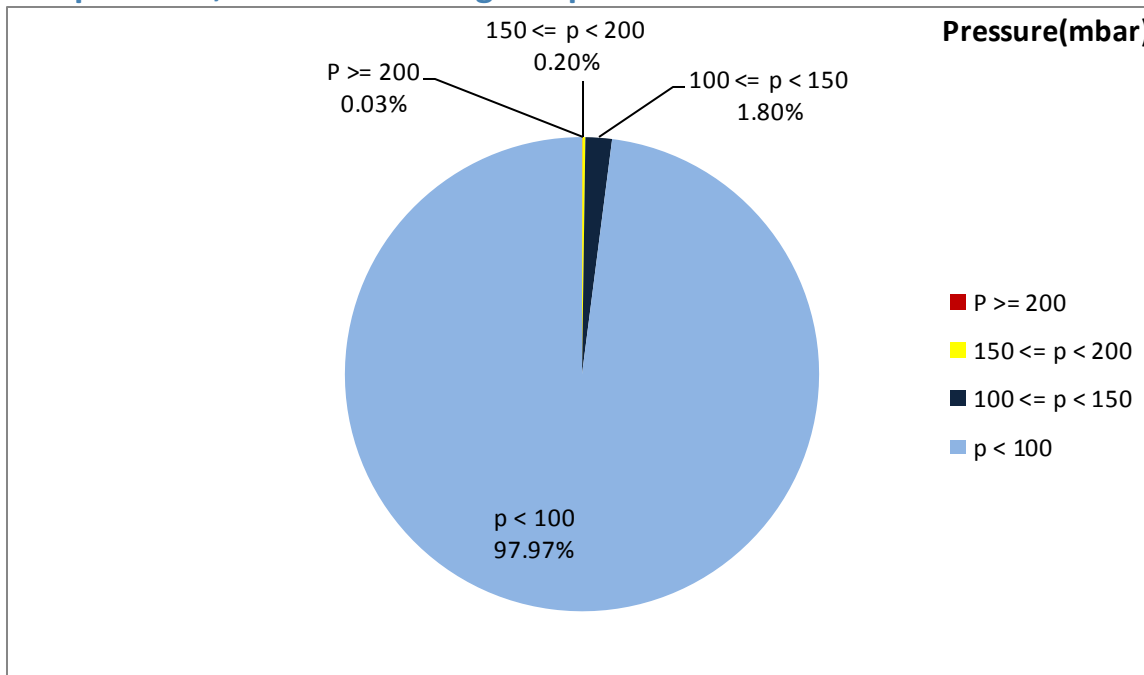
Figure 1- Pressure distribution over the working hours

- As depicted in figure 1, 0.03% of total working time pressure is above 200 mbar and 0.23% above 150 mbar during this period. This low pressure distribution was because of the cleaning issue which was done on Dec 19th.
- Figure 2 displays flow temperature distribution for DPF's upstream. It can be obviously observed 1.3% of total working time temperature is above 350°C.

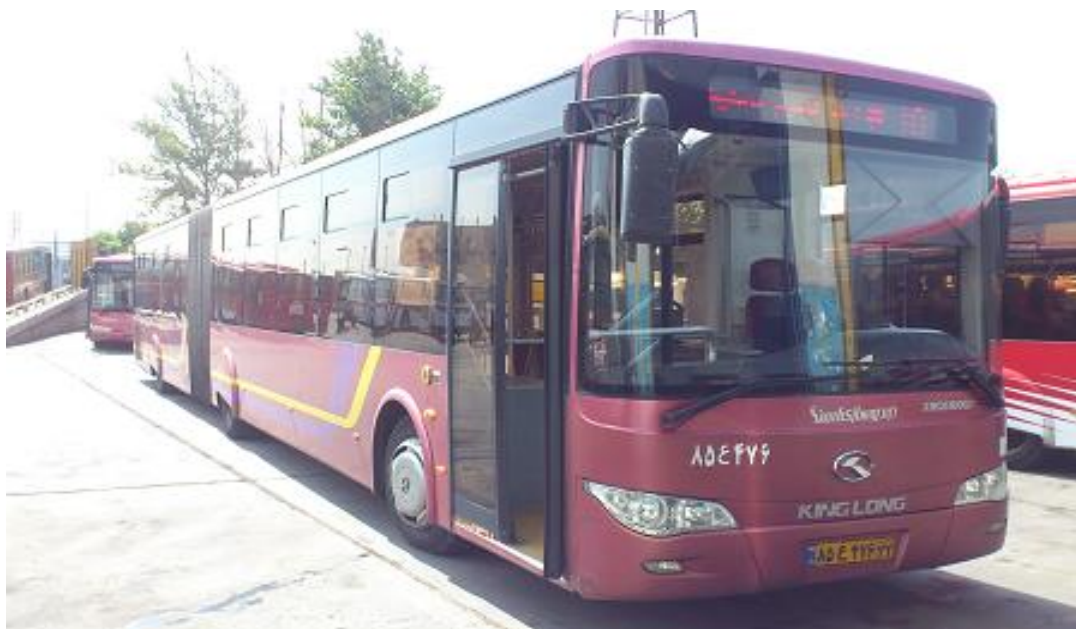
Vehicle plate number	85476
Bus line	Number 10 (south to north Bus line)
DPF producer company	HJS_04 (Passive system with FBC)

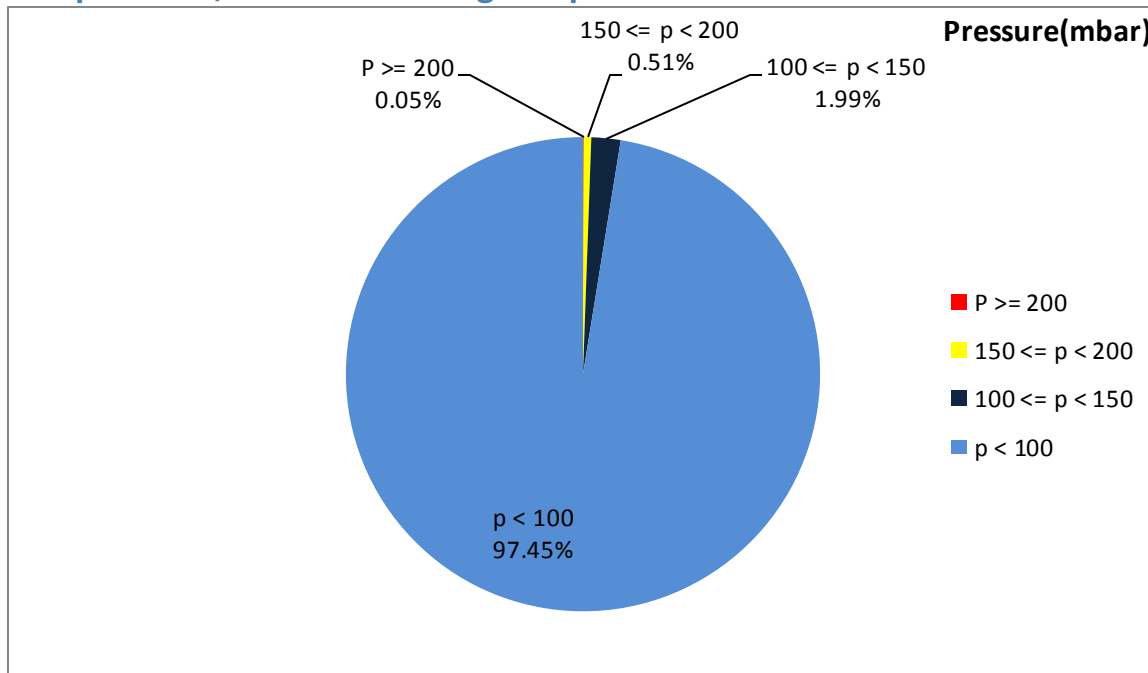
Figure 1- Pressure distribution over the working hours

- As depicted in figure 1, only 0.05% of working time pressure was above 200 mbar and 0.56% above 150 mbar.
- It can be obviously observed that 10.4% of total working-time temperature is above 400 °C and 16.7% above 350°C.

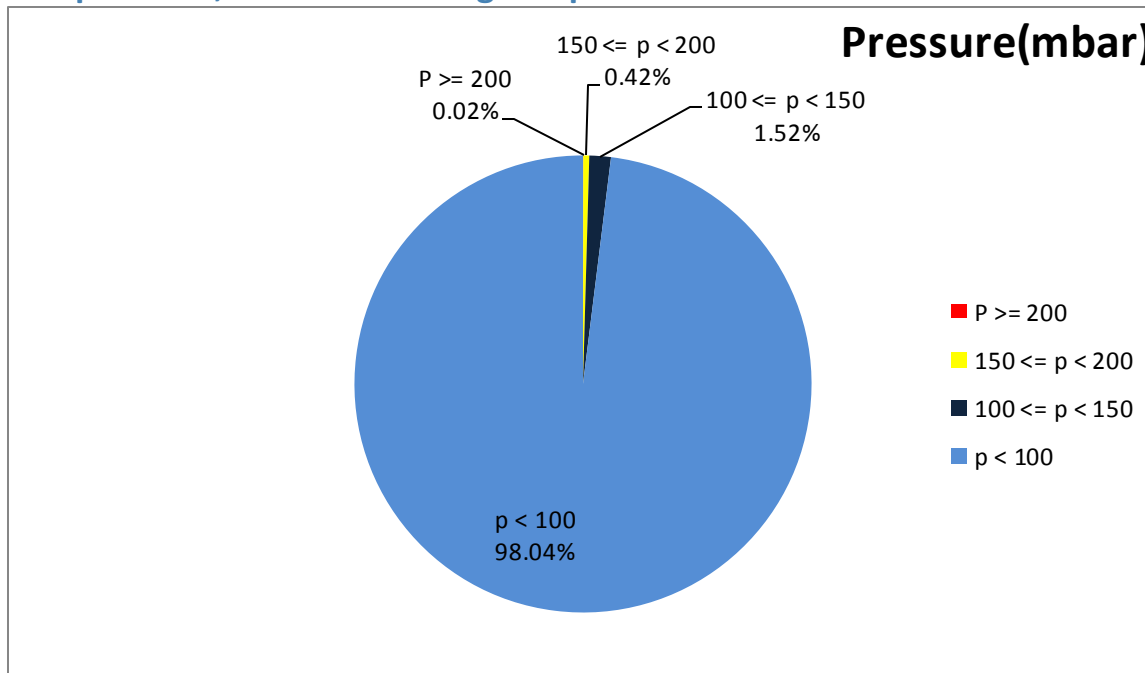
Figure 1- Pressure distribution over the working hours

- As depicted in figure 1, only 0.02% of working time pressure was above 200 mbar and 0.44% above 150 mbar.
- It can be obviously observed that 6.2% of total working-time temperature is above 400 °C and 11.4% above 350°C.

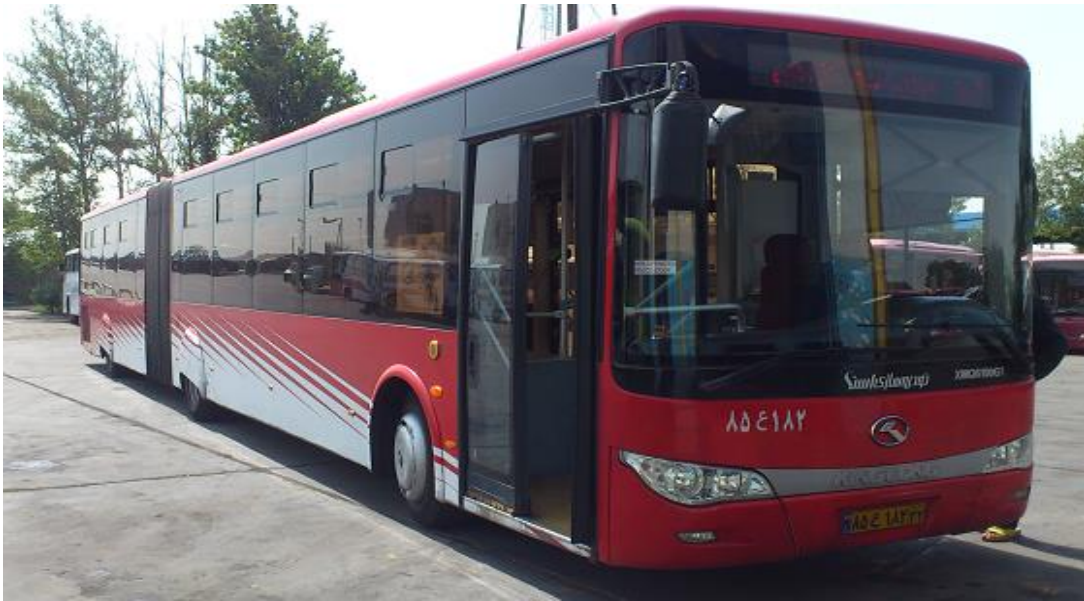
Vehicle plate number	85182
Bus line	Number 10 (south to north Bus line)
DPF producer company	Tehag_01 (Catalyzed DPF)

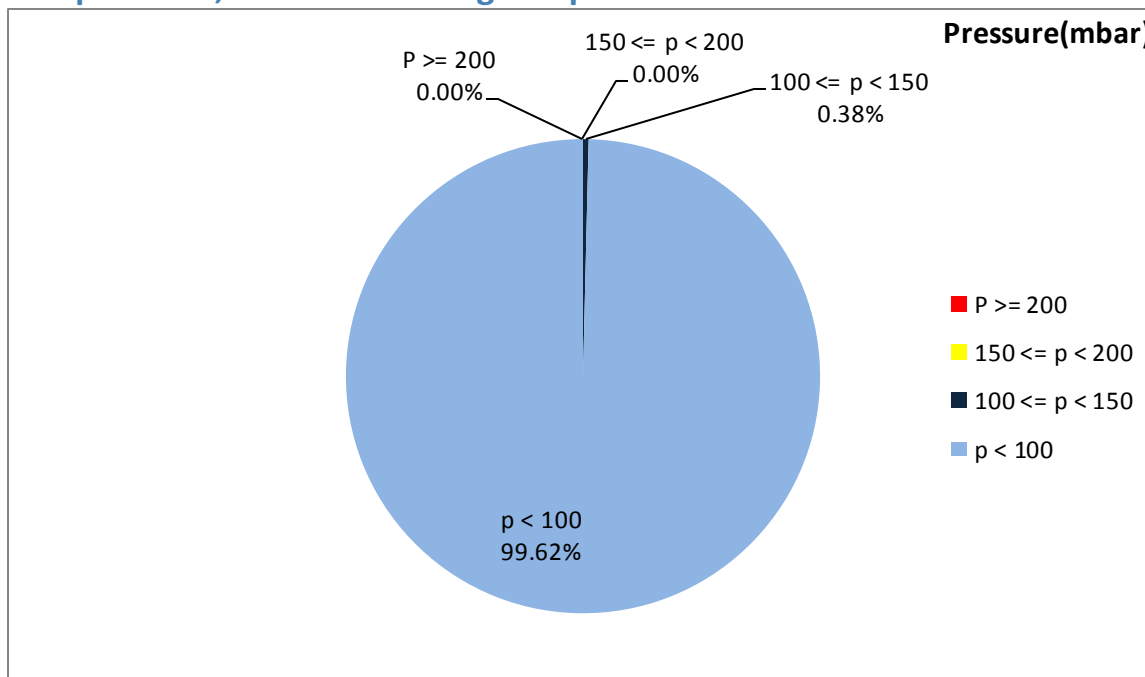
Figure 1- Pressure distribution over the working hours

- As depicted in figure 1, only 0.38% of working time pressure was above 100 mbar during this period.
- Figure 2, 17 display flow temperature distribution for DPF’s upstream. It can be obviously observed that 4.7% of total working-time temperature is above 350 °C and 12.2% above 250°C. Considering DPF company recommended operable situation (30% above 250°C), beside high idle working time (79%) during this period, which was because of bus accident, it could be concluded this DPF operation was fantastic during this period.

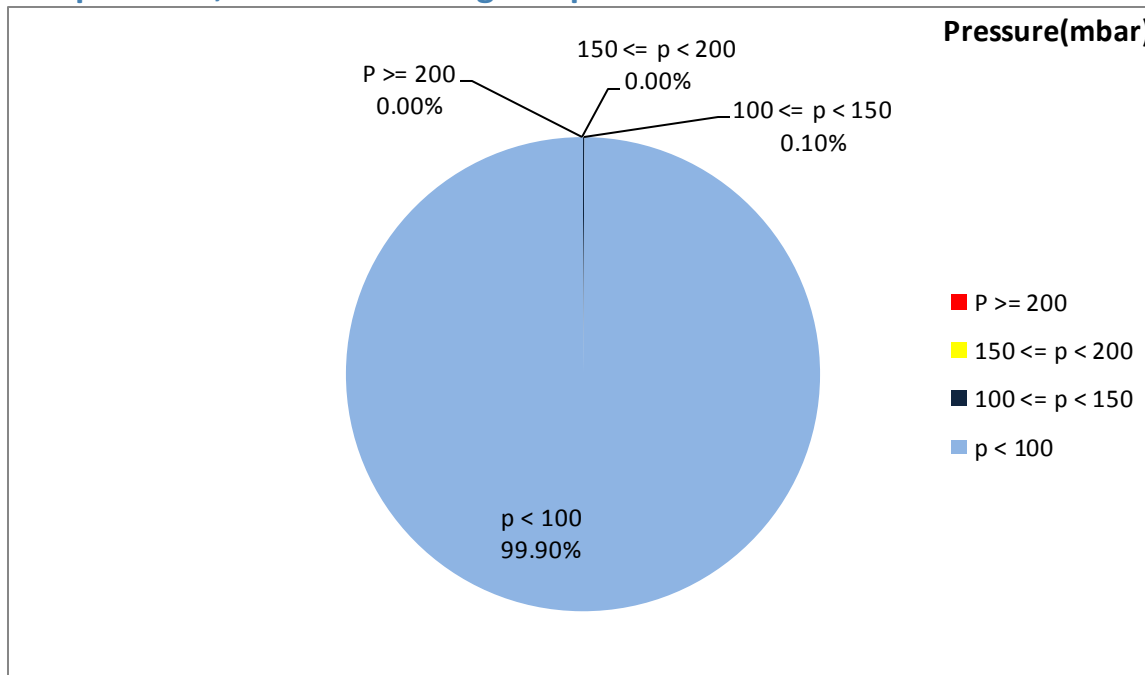
Figure 1- Pressure distribution over the working hours

- As depicted in figure 1, only 0.1% of working time pressure was above 100 mbar during this period.
- Figure 2, 17 display flow temperature distribution for DPF’s upstream. It can be obviously observed that 4.46% of total working-time temperature is above 350 °C and 16.12% above 250°C.

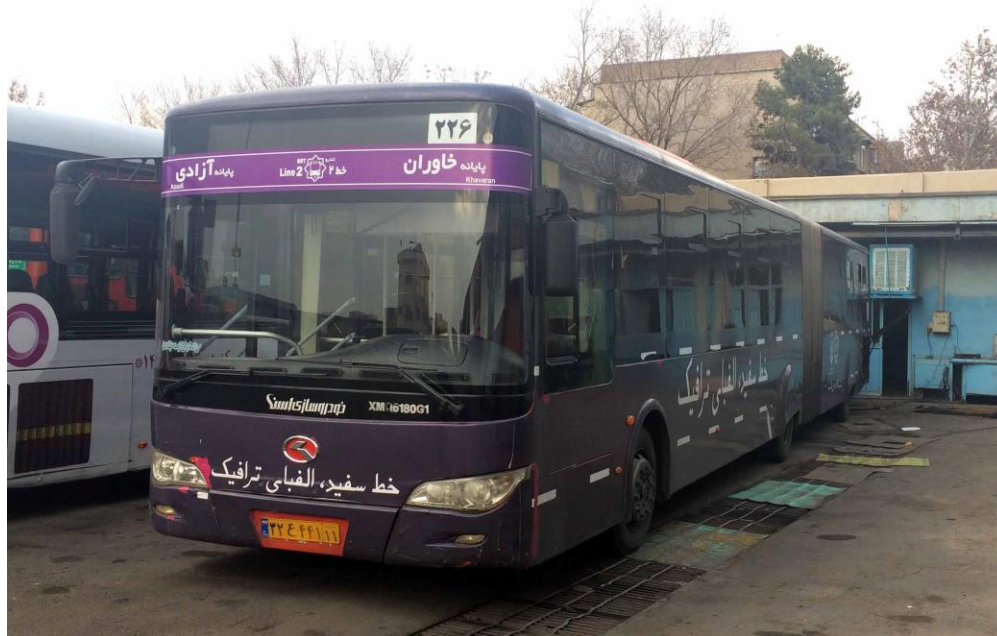
Vehicle plate number	33592 (32441)
Bus line	Number 2 (west to east bus line)
DPF producer company	Tehag_02 (CDPF)
