Diesel Particulate Filters' Feasibility Study Report

Report's Period:

2016/02/01-2016/02/29

Tehran - Iran

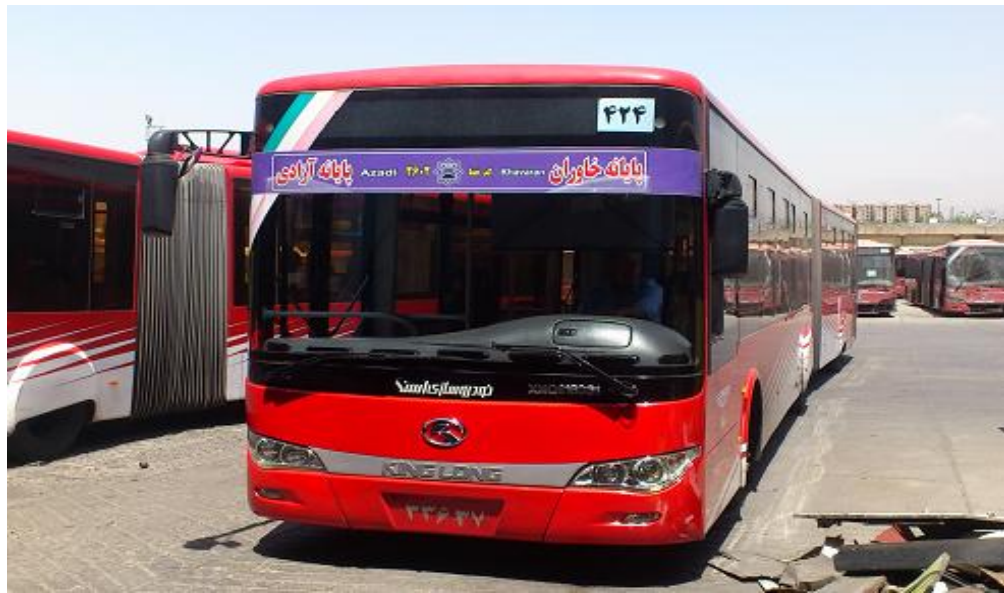
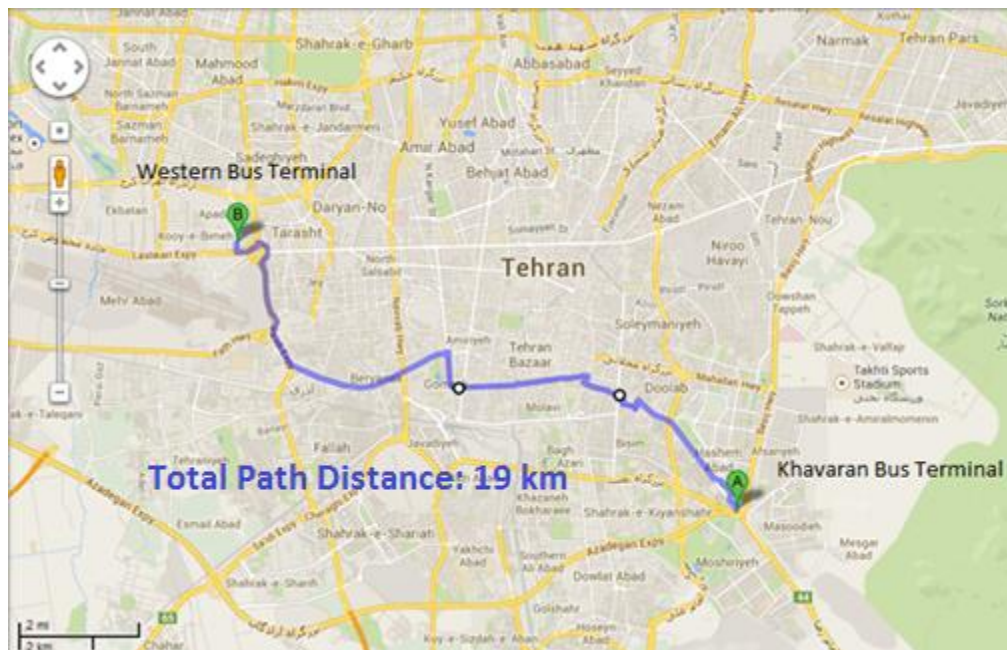
Vehicle plate number	33637 (34119)
Bus line	Number 2 (west to east bus line)
DPF producer company	Dinex_02 (Passive system with FBC)

Notice: System was working over this period without DPF.
