Diesel Particulate Filters' Feasibility Study Report

Report's Period:

2016/07/01 - 2016/07/31

Tehran - Iran

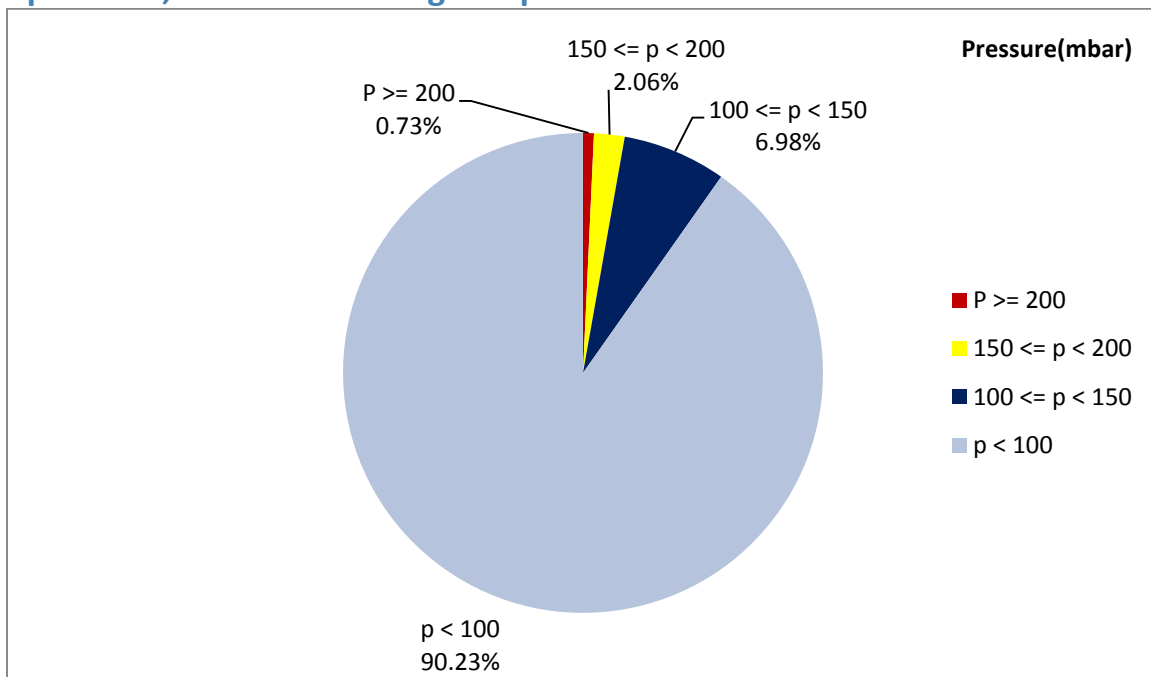
Figure 1- Pressure distribution over the working hours

- As depicted in figure 1, 0.73% of total working time pressure is above 200 mbar and 2.79% above 150 mbar during this period.
- Figure 2 displays flow temperature distribution for DPF's upstream. It can be obviously observed 19.8% of total working time temperature is above 350°C.

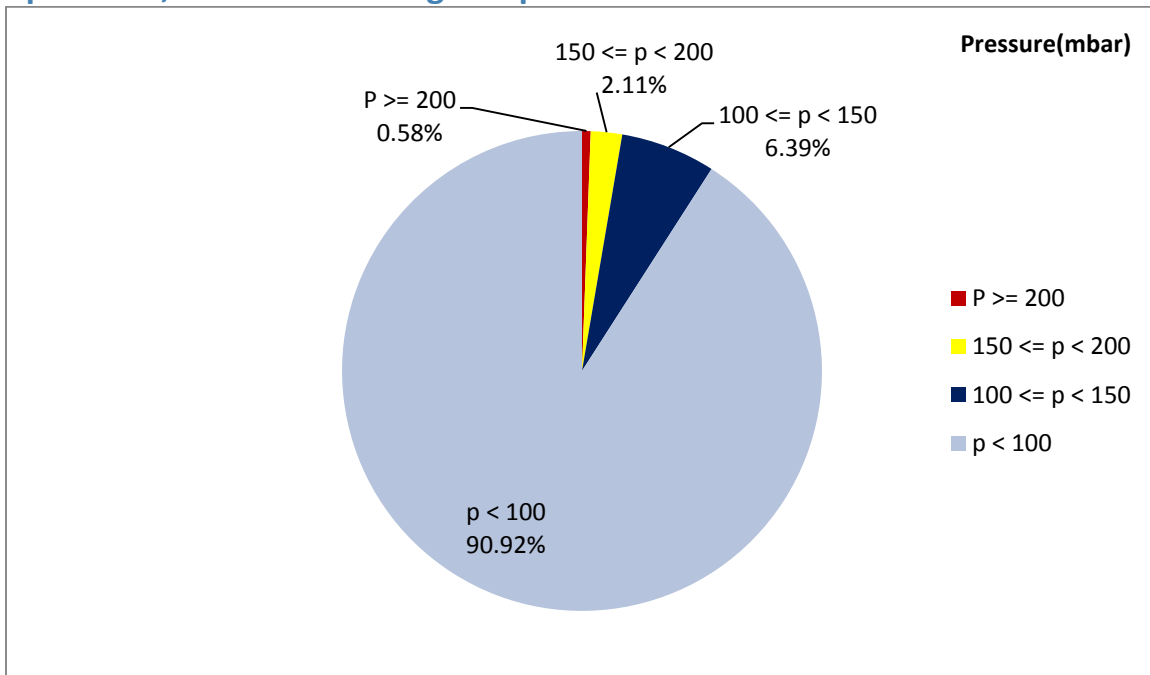
Figure 1- Pressure distribution over the working hours

- As depicted in figure 1, 0.58% of total working time pressure is above 200 mbar and 2.69% above 150 mbar during this period.
- Figure 2 displays flow temperature distribution for DPF's upstream. It can be obviously observed 23.8% of total working time temperature is above 350°C.

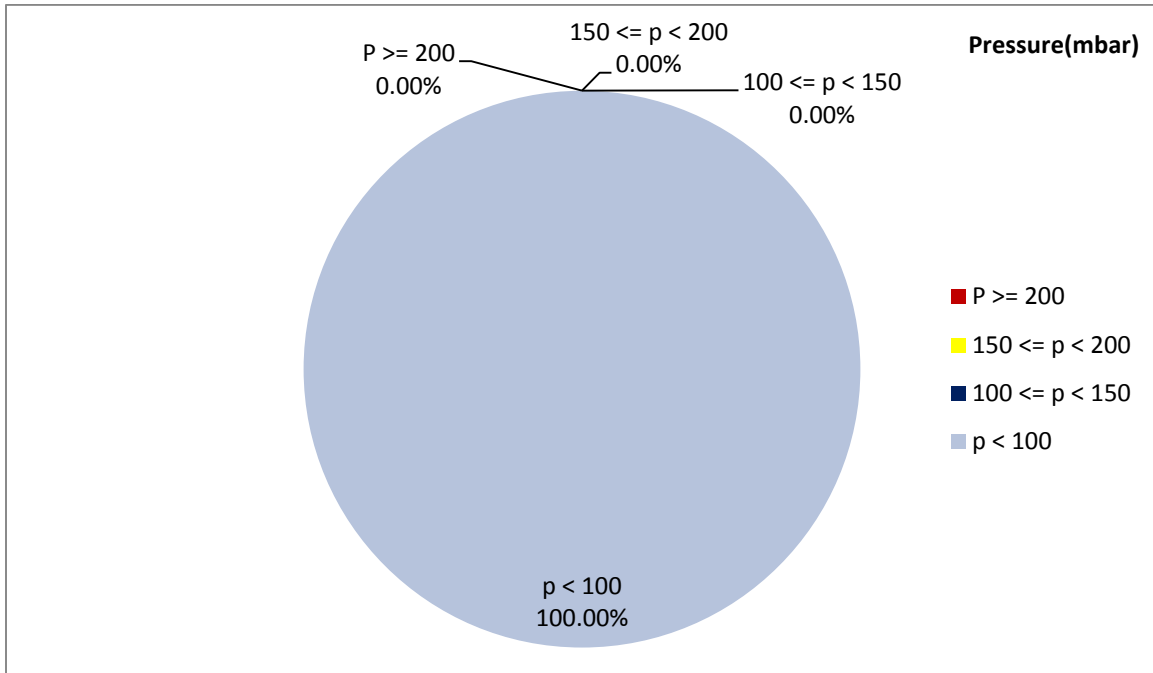
Figure 1- Pressure distribution over the working hours

- As depicted in figure 1, all of working time pressure was below 100 mbar during this period.
- Figure 2 display flow temperature distribution for DPF's upstream. It can be obviously observed that 14.1% of total working-time temperature is above 350 °C and 63.7% above 250°C.

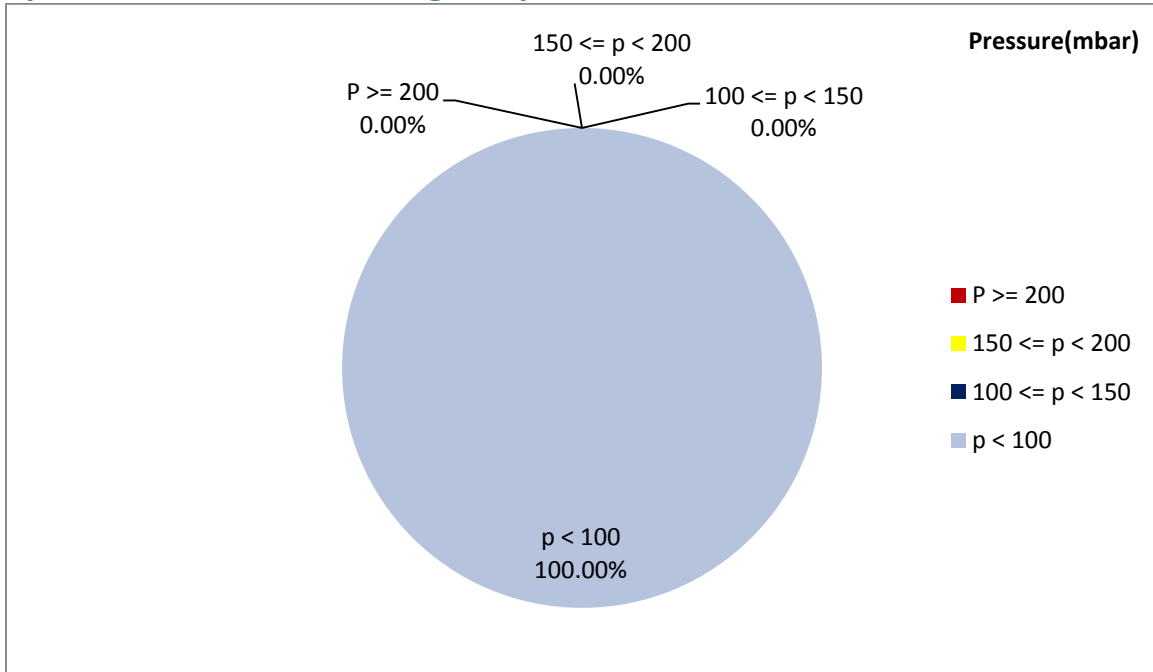
Figure 1- Pressure distribution over the working hours

- As depicted in figure 1, all of working time pressure was below 100 mbar during this period.
- Figure 2 display flow temperature distribution for DPF's upstream. It can be obviously observed that 5% of total working-time temperature is above 350 °C and 43.3% above 250°C.

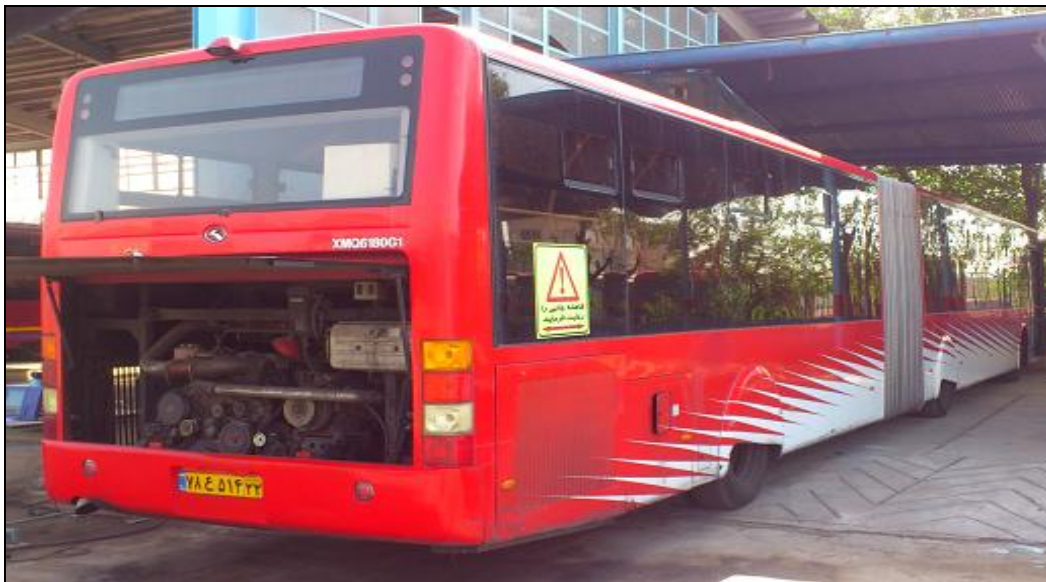
Vehicle plate number	78514
Bus line	Number 4 (south to north bus line)
DPF producer company	HJS_01 (Passive system with FBC)

Filter maintenance date	DPF core was cleaned on 2015/Jun/13 for the first time. The second cleaning was done on 2016/Jul/11. Due to some wiring problems, the DPF core was replaced with muffler on Jul 13 th .
Dosing status	Dosing value has been kept constant from installation date until now.

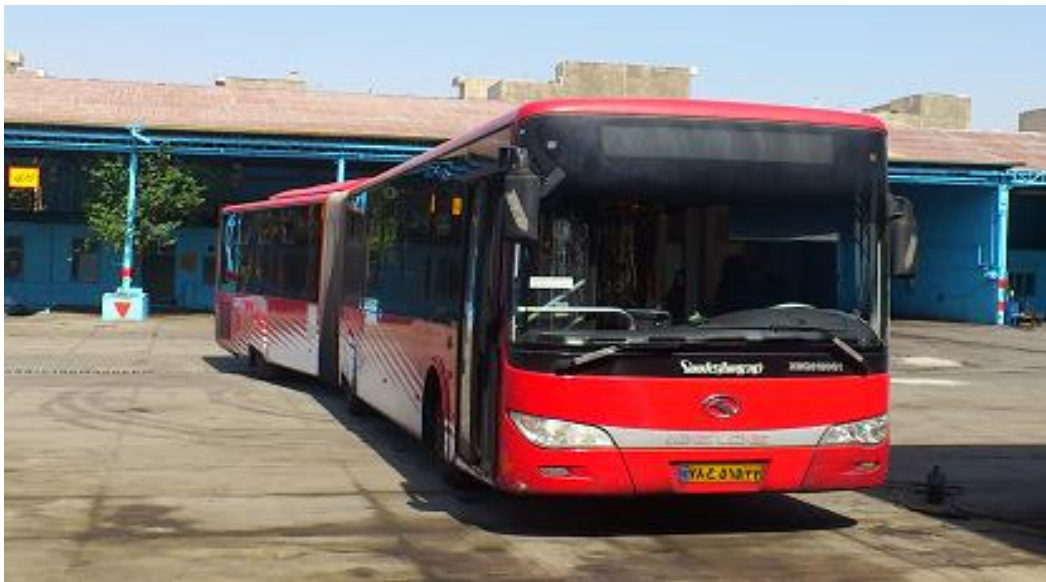
Vehicle plate number	78515
Bus line	Number 4 (south to north bus line)
DPF producer company	Dinex_01 (Passive system with FBC)

Notice: Bus has been stopped from Sep 18th until now due to technical problems (related to Bus Company).

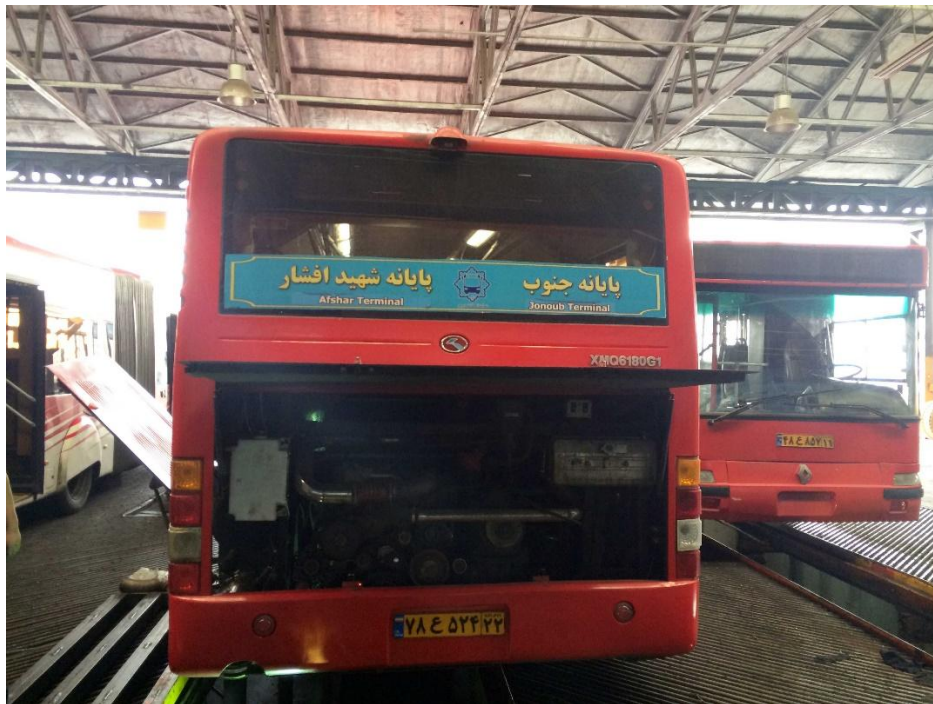
Vehicle plate number	78524
Bus line	Number 4 (south to north Bus line)
DPF producer company	PURltech (Passive system with FBC)

Filter maintenance date	<p>DPF core was removed on Jul 22nd and was cleaned on Aug 12th for the first time. Considering system relatively high backpressure, filter isolation defect and air filter's deformation, DPF core was removed on Sep 16th and installed on Nov 17th.</p> <p>The third cleaning was unavoidable after only 6 days working and was done on 29th Nov. System only worked for two days and DPF was replaced by muffler on Nov 30th.</p> <p>DPF was installed for the fourth time on Jan/19/2016 and was replaced by muffler after only three days working because of high backpressure.</p> <p>A new DPF core was installed on May/14/2016 and was cleaned on 2016.06.25.</p> <p>The DPF core was replaced by muffler on Jul/10/2016 due to high backpressure.</p>
Dosing status	Dosing value has been kept constant from installation date until now.

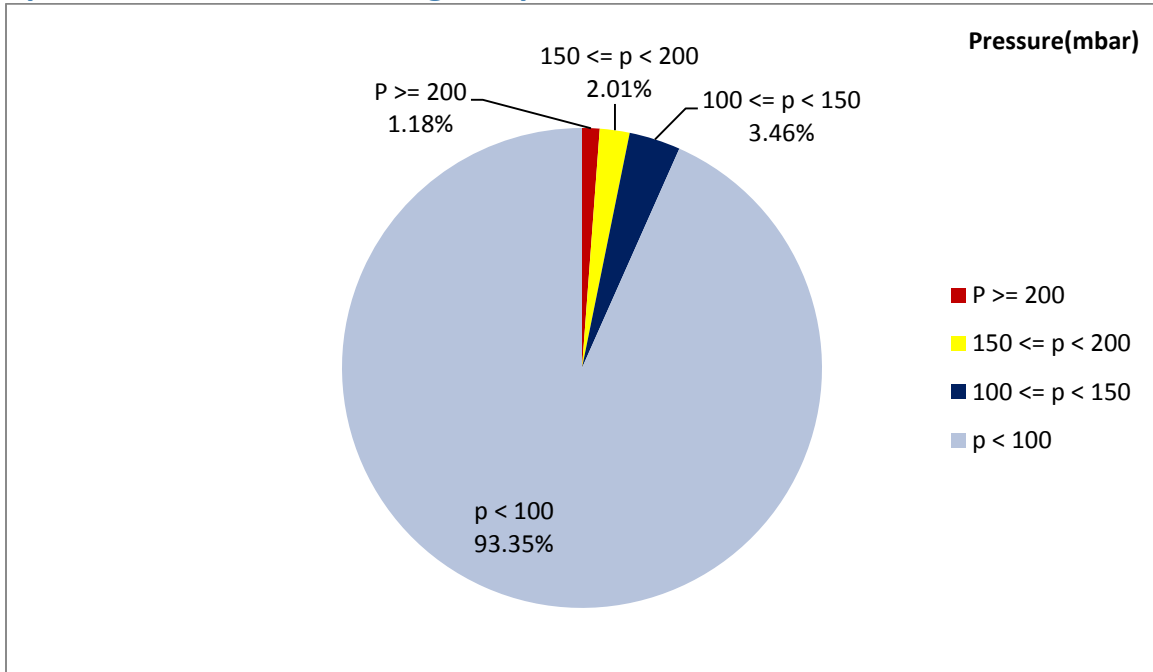
Figure 1- Pressure distribution over the working hours

- As depicted in Figure 1, 1.18% of working time, pressure was above 200 mbar and 3.19% was above 150 mbar.
- Figure 2 displays flow temperature before the DPF. It can be obviously observed that 19.6% of total working time temperature is above 400 °C and 28.5% above 350°C.

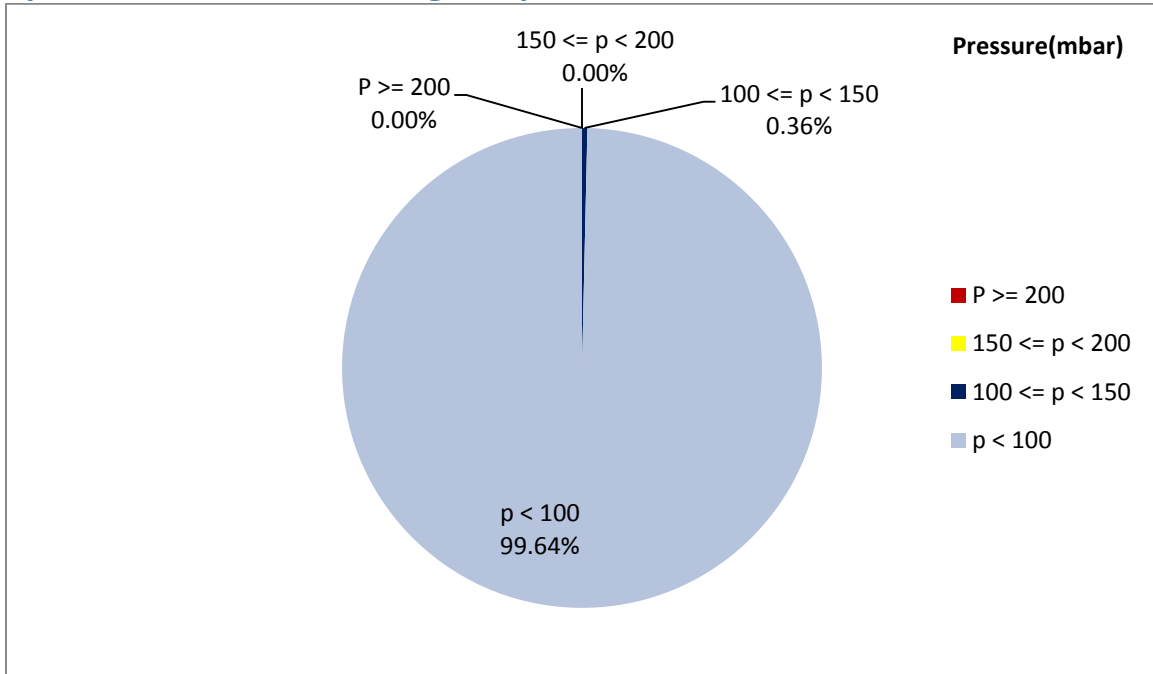
Figure 1- Pressure distribution over the working hours

- As depicted in figure 1, 0.36% of working time pressure was above 100 mbar during this period.
- Figure 2 display flow temperature distribution for DPF's upstream. It can be obviously observed that 18.2% of total working-time temperature is above 350 °C and 36.7% above 250°C.

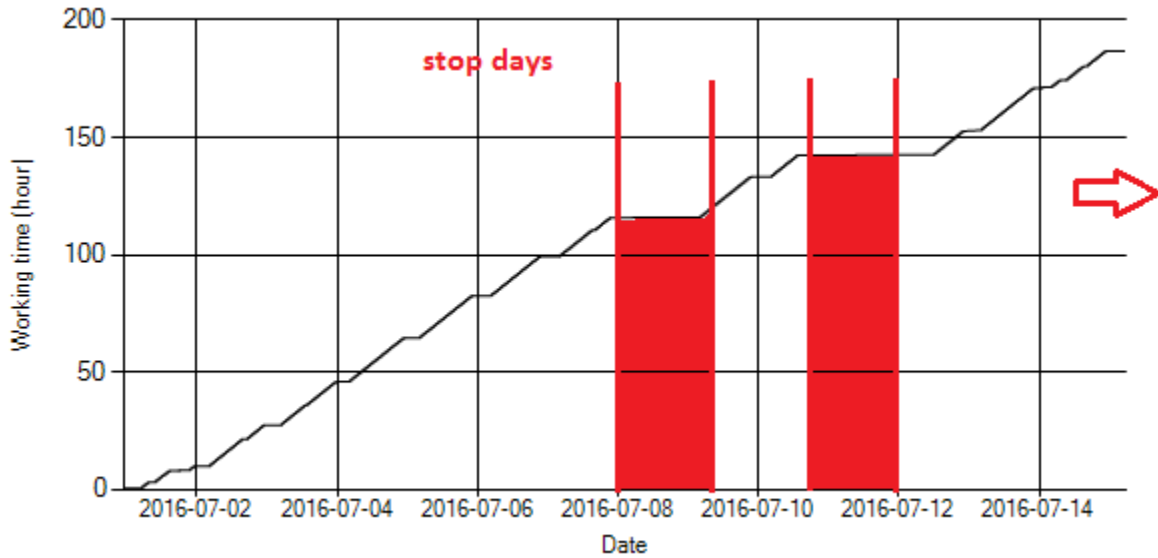
Figure 12- Time diagram for calculating CPK's working days

Notice: Data logger sampling time can be calculated from Figure 12. The lines parallel with Date axis show days without data logger data. As depicted in Figure 12 system was stationary for 3 days.

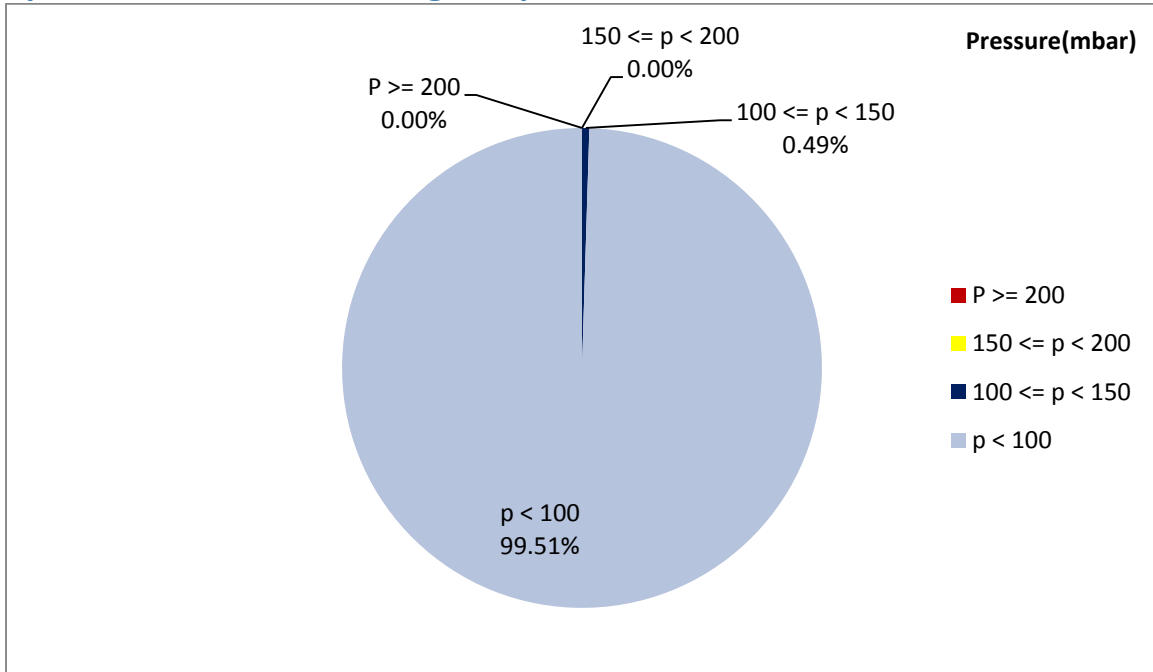
Figure 1- Pressure distribution over the working hours

- As depicted in figure 1, 0.49% of working time pressure was above 100 mbar during this period.
- Figure 2 display flow temperature distribution for DPF's upstream. It can be obviously observed that 15.5% of total working-time temperature is above 350 °C and 35% above 250°C.

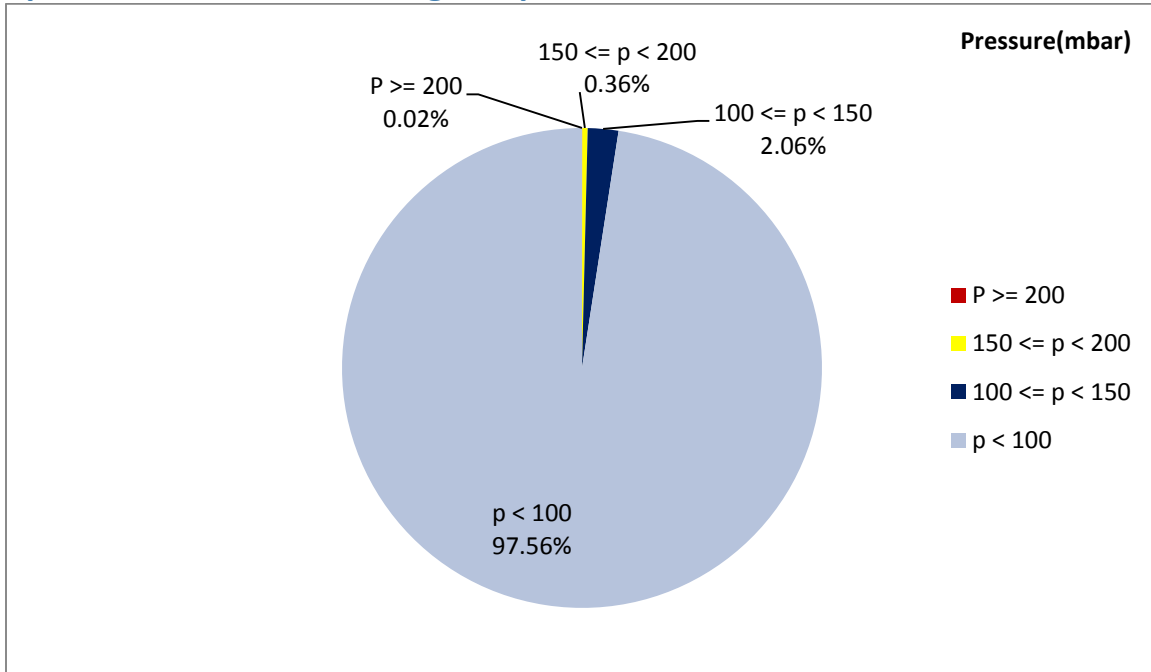
Figure 1- Pressure distribution over the working hours

- As depicted in Figure 1, 0.02% of working time, pressure was above 200 mbar and 0.38% above 150 mbar.
- Figure 2 displays flow temperature before the DPF. It can be obviously observed that 15% of total working time temperature is above 400 °C and 21.2% above 350°C.

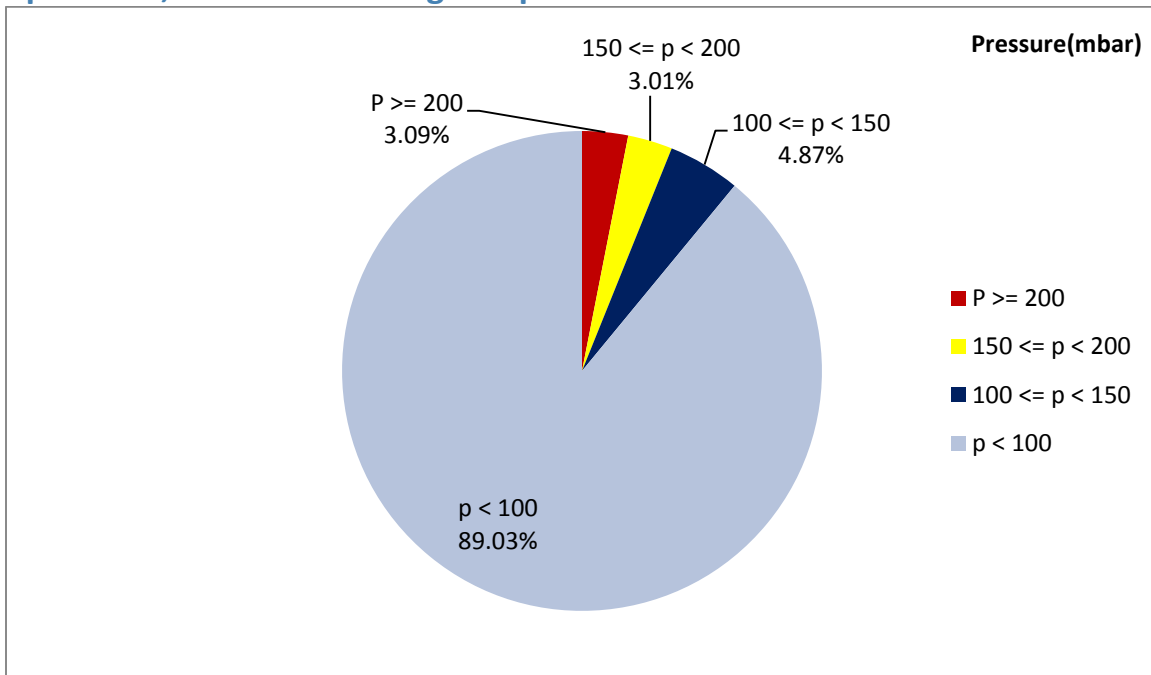
Figure 1- Pressure distribution over the working hours

- As depicted in Figure 1, 3.09% of working time, pressure was above 200 mbar and 6.1% above 150 mbar.
- Figure 2 displays flow temperature before the DPF. It can be obviously observed that 13.4% of total working time temperature is above 400 °C and 19.6% above 350°C.

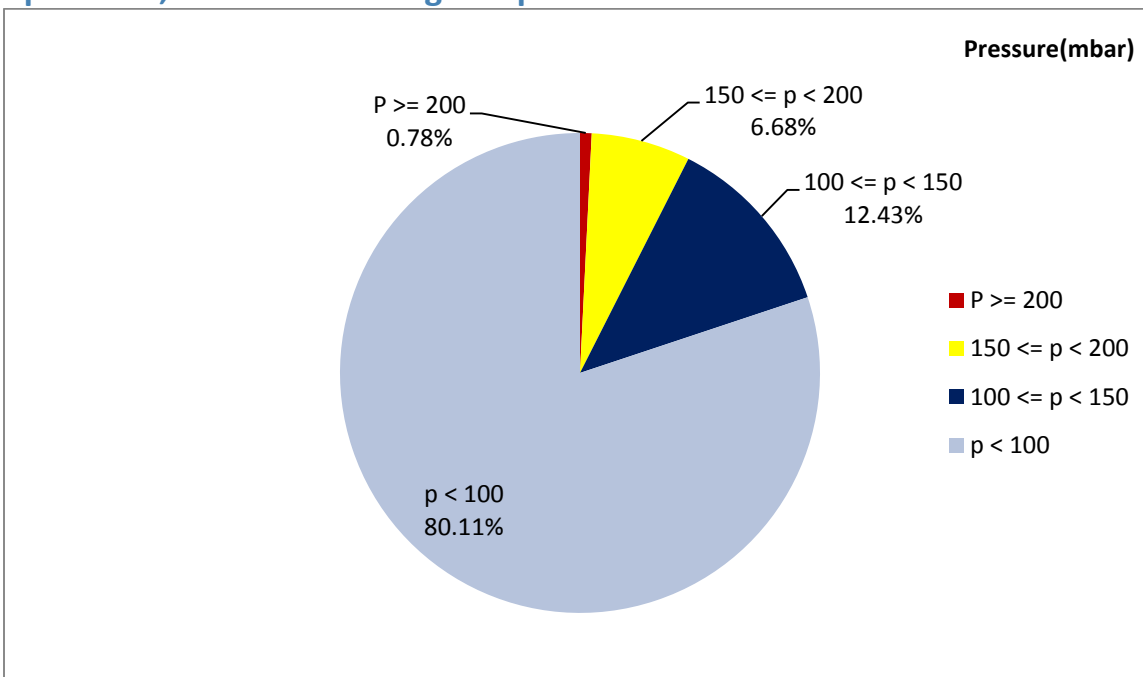
Figure 1- Pressure distribution over the working hours

- As depicted in Figure 1, 0.78% of working time, pressure was above 200 mbar and 7.46% was above 150 mbar.
- Figure 2 displays flow temperature before the DPF. It can be obviously observed that 37.1% of total working time temperature is above 400 °C and 47.2% above 350°C.

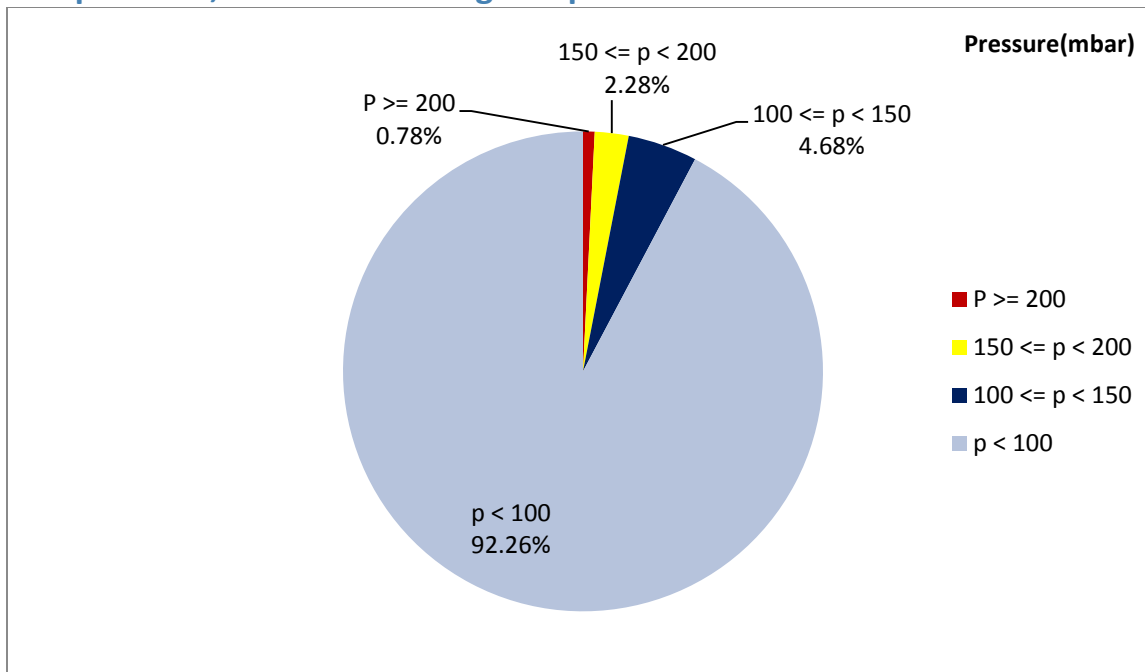
Figure 1- Pressure distribution over the working hours

- As depicted in Figure 1, 0.78% of working time, pressure was above 200 mbar and 3.06% was above 150 mbar.
- Figure 2 displays flow temperature before the DPF. It can be obviously observed that 14% of total working time temperature is above 400 °C and 17.4% above 350°C.
