Diesel Particulate Filters' Feasibility Study Report

Report's Period: 2016/08/01 - 2016/08/31

Tehran - Iran

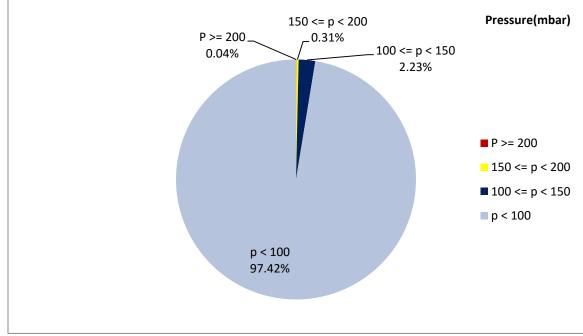
Figure 1- Pressure distribution over the working hours

- As depicted in figure 1, 0.04% of total working time pressure is above 200 mbar and 0.35% above 150 mbar during this period.
- Figure 2 displays flow temperature distribution for DPF's upstream. It can be obviously observed 11.9% of total working time temperature is above 350°C.

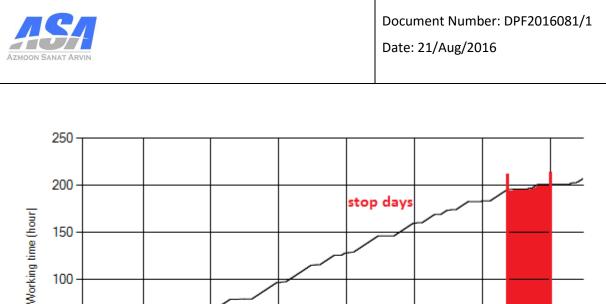
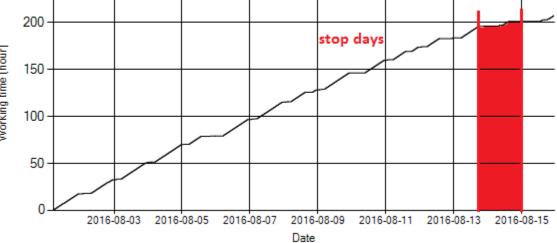
Figure 10- Time diagram for calculating CPK's working days

Notice: Data logger sampling time can be calculated from Figure 10. The lines parallel with Date axis show days without data logger data. As depicted in Figure 10 system was stationary for 1 day.
