DPF FEASIBILITY STUDY REPORT

TEHRAN-IRAN

DPFs' Monthly Operation Report

Report Period:
01/Jul/2015 –
31/Jul/2015

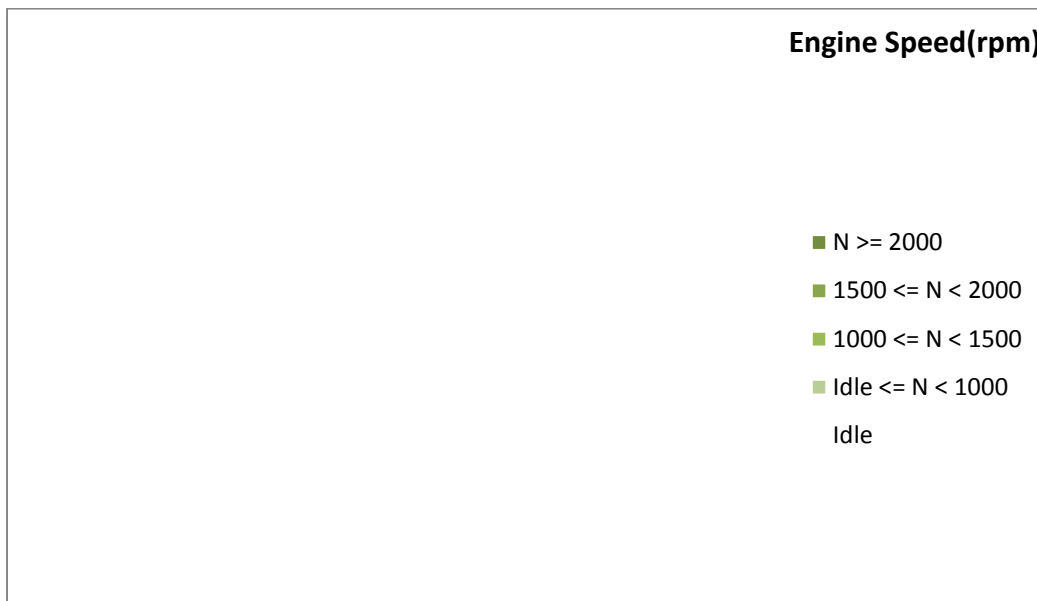
Figure 3- Engine speed distribution over the working hours

Notice: RPM sensor problem that happened on Jul 7th, so all data about engine speed missed. Due to data logger and RPM sensor problems, engine speed data missed.

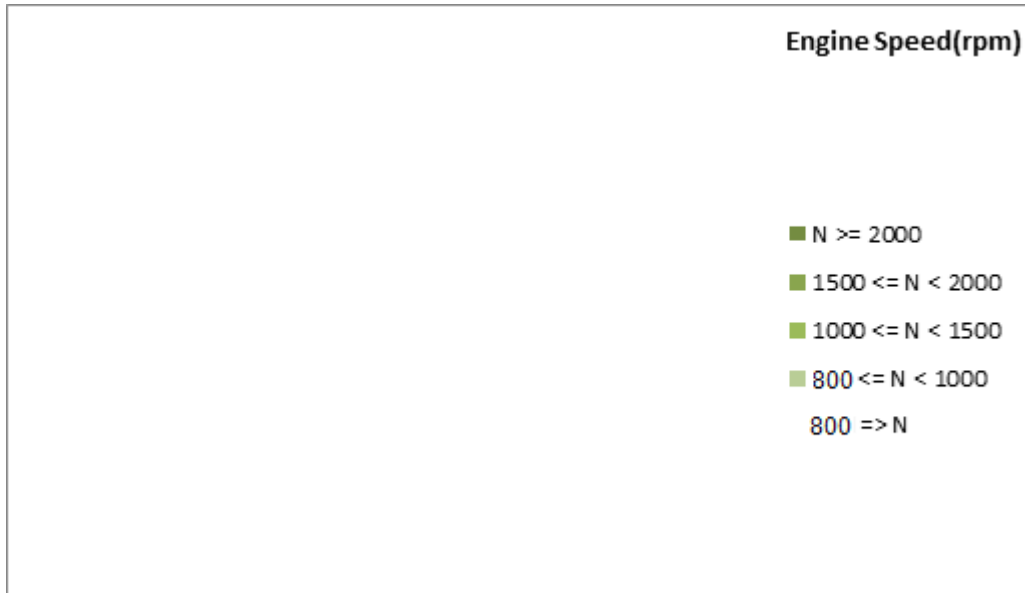
Figure 3- Engine speed distribution over the working hours

Notice: All engine speed data missed due to rpm sensor problem.
