# Diesel Particulate Filters' Feasibility Study Report

Report's Period:

2015/12/01 - 2015/12/31

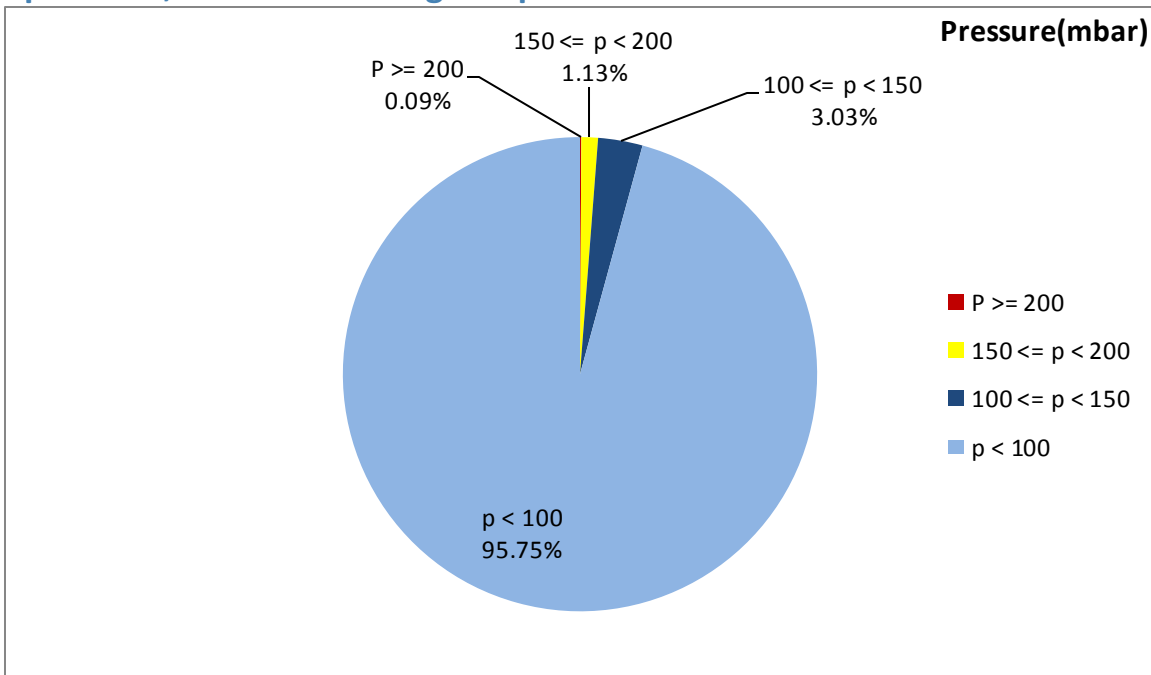
Figure 1- Pressure distribution over the working hours

- As depicted in Figure 1, only 0.09% of working time, pressure was above 200 mbar and 1.23% above 150 mbar.
- Figure 2 displays flow temperature before the DPF. It can be obviously observed that 5% of total working time temperature is above 400 °C and 10% above 350°C.

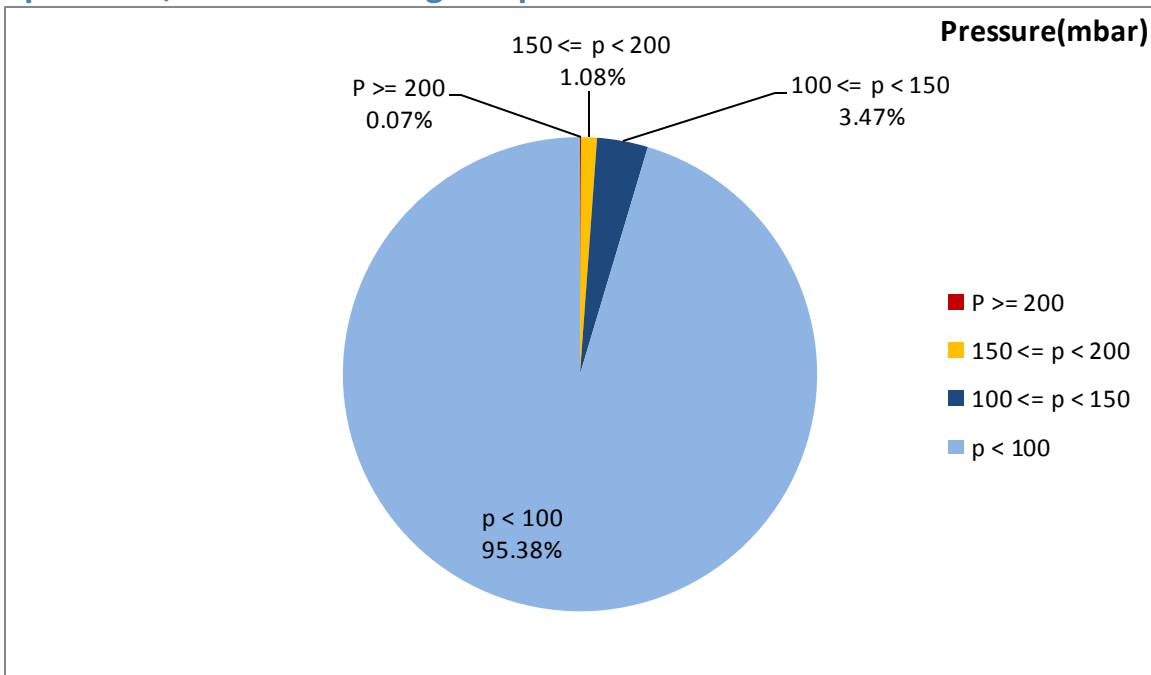
Figure 1- Pressure distribution over the working hours

- As depicted in Figure 1, only 0.07% of working time, pressure was above 200 mbar and 1.15% above 150 mbar.
- Figure 2 displays flow temperature before the DPF. It can be obviously observed that 6% of total working time temperature is above 400 °C and 11% above 350°C.

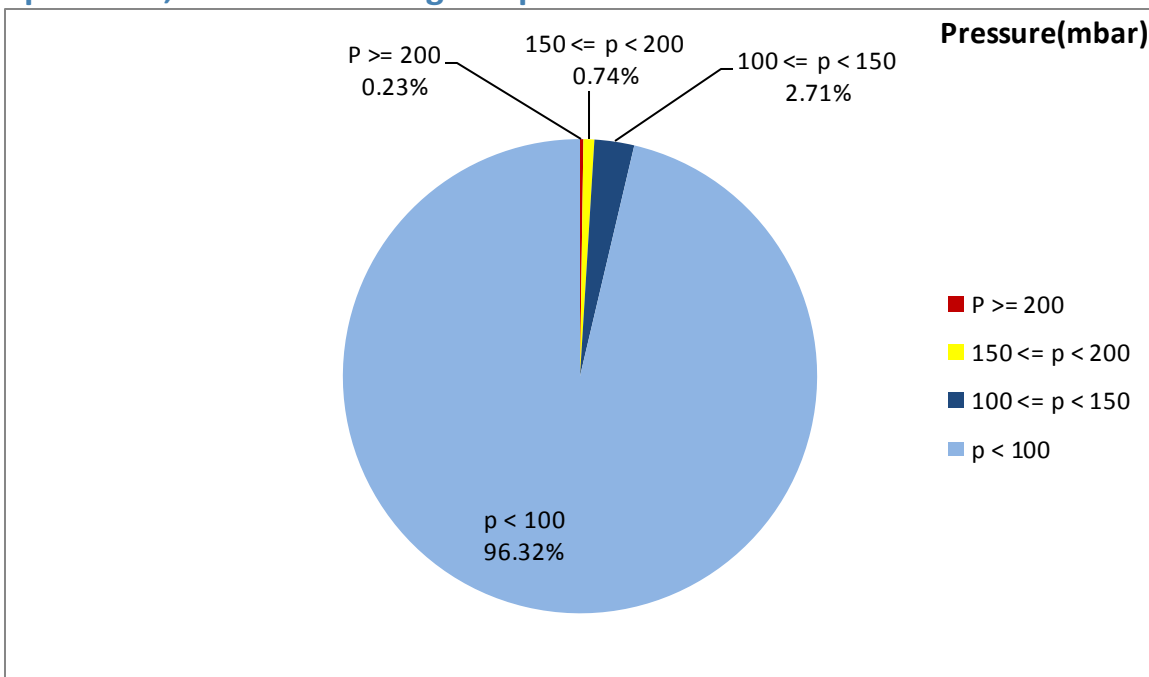
Figure 1- Pressure distribution over the working hours

- As depicted in figure 1, 0.23% of time pressure was above 200 mbar and 0.97% above 150 mbar.
- Figure 2 displays flow temperature distribution for DPF's upstream. It can be obviously observed that 9% of total working-time temperature is above 400 °C and 14% above 350°C.

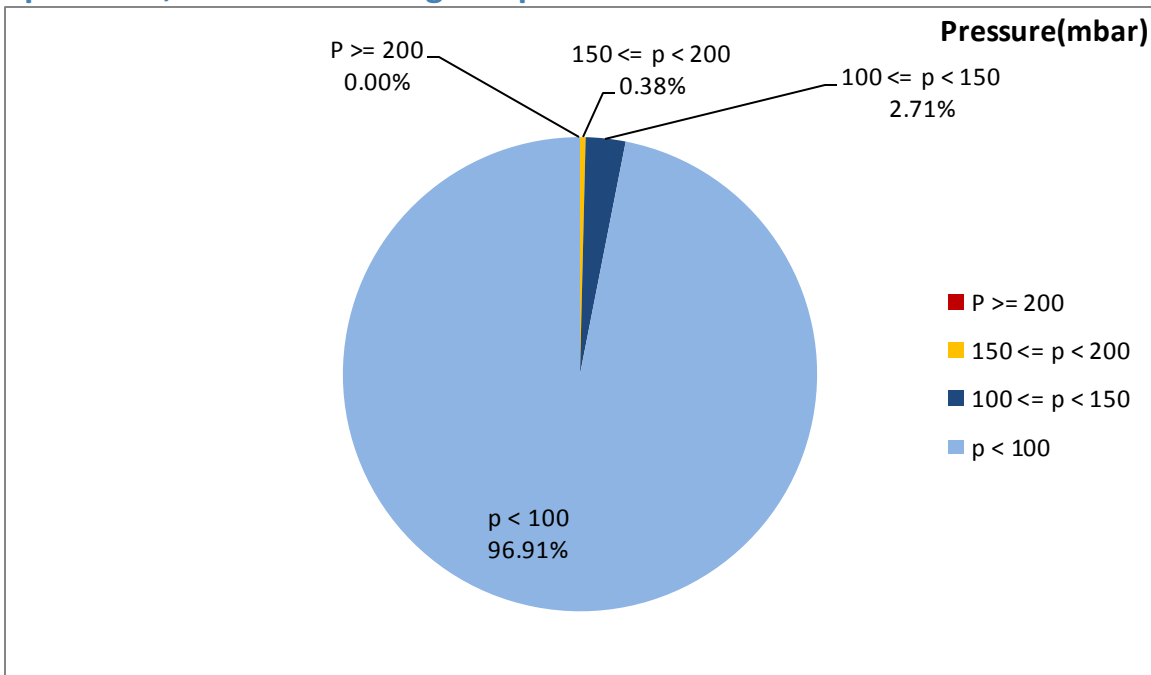
Figure 1- Pressure distribution over the working hours

- As depicted in figure 1, only 0.38% of time pressure was above 150 mbar and pressure above 200 mbar was not observed.
- Figure 2 displays flow temperature distribution for DPF's upstream. It can be obviously observed that 10% of total working-time temperature is above 400 °C and 16% above 350°C.

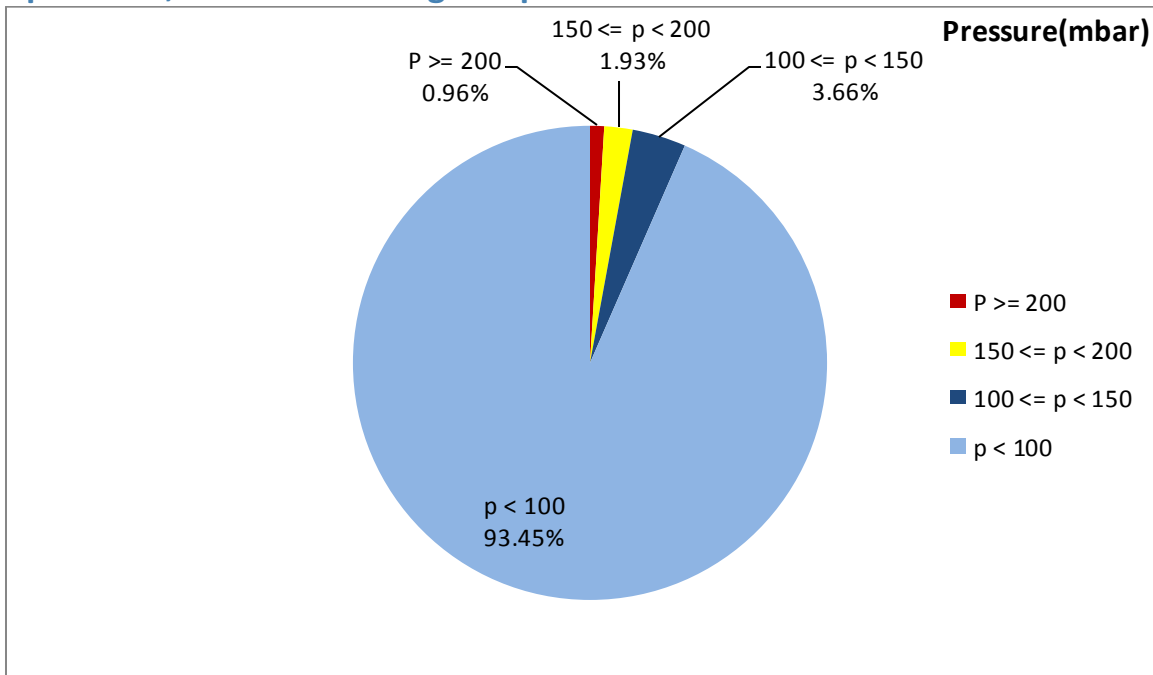
Figure 1- Pressure distribution over the working hours

- As depicted in figure 1, 0.96% of total working time pressure is above 200 mbar and 2.89% above 150 mbar during this period. This high pressure distribution was because of additive system problem and unusual driving profile for this line.
- Figure 2 displays flow temperature distribution for DPF's upstream. It can be obviously observed 3% of total working time temperature is above 350°C.

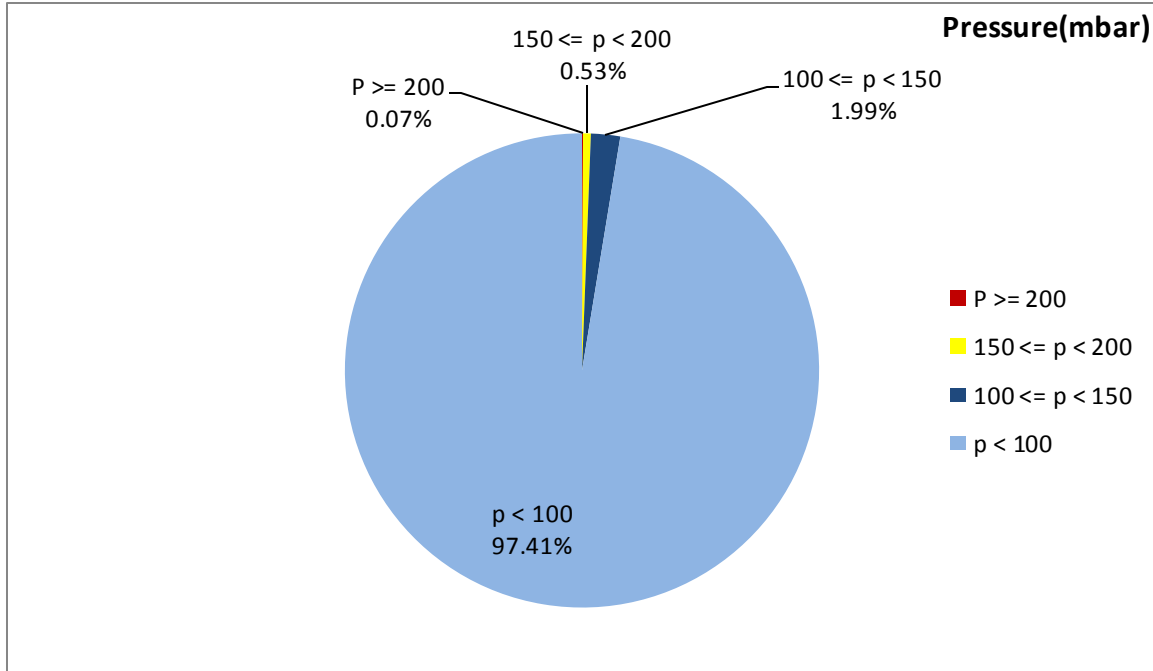
Figure 1- Pressure distribution over the working hours

- As depicted in figure 1, only 0.07% of working time pressure was above 200 mbar and 0.6% above 150 mbar.
- It can be obviously observed that 7% of total working-time temperature is above 400 °C and 14% above 350°C.
- Despite the excellent operation for the first 8 days of the month, system ECU warned cleaning time arrival which might be due to additive system problem. So DPF was cleaned on Dec 15<sup>th</sup> for the second time.

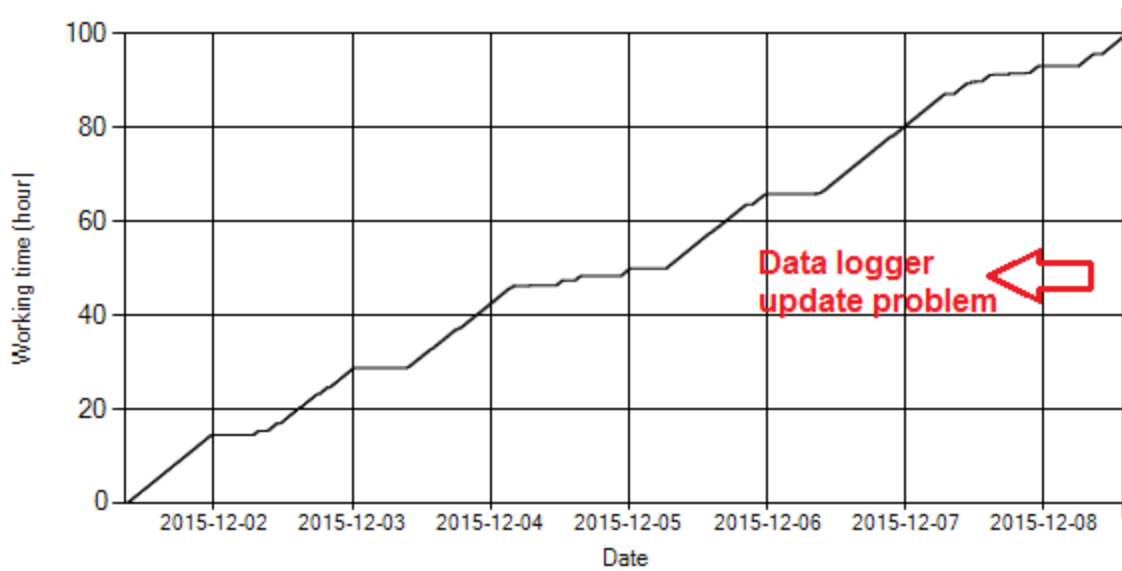
Figure 12- Time diagram for calculating CPK's working days

Notice: Data logger sampling time can be calculated from Figure 12. The lines parallel with Date axis show days without data logger data. As depicted in Figure 12, data logger got problem on Dec 8<sup>th</sup>.

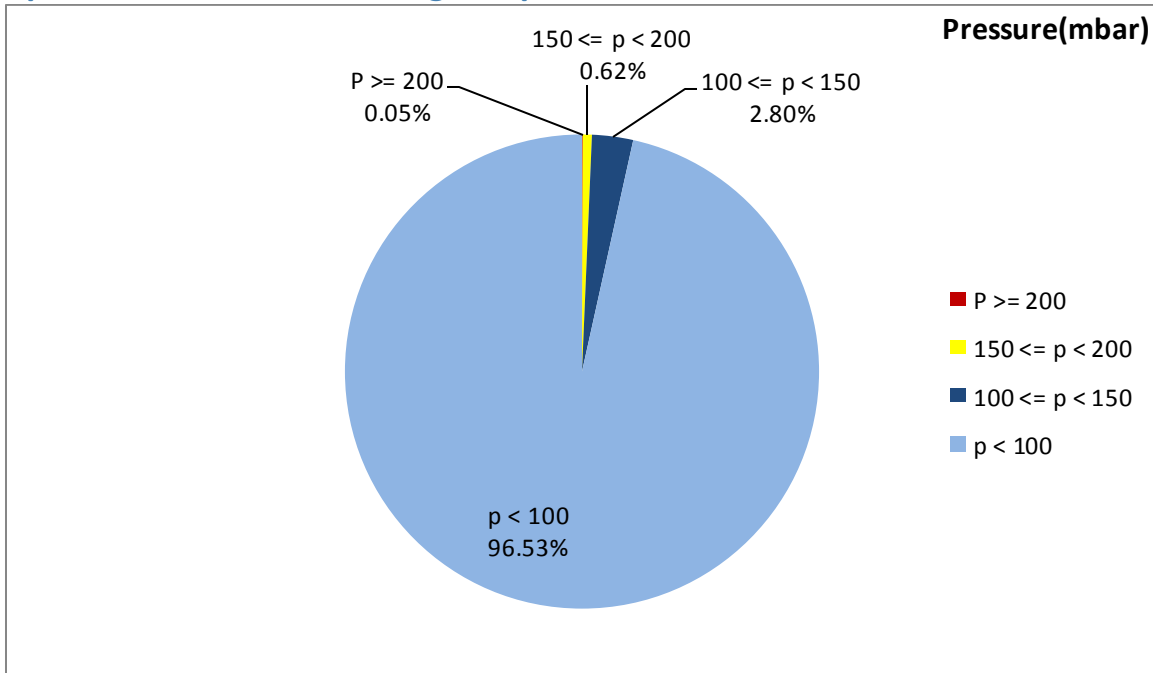
Figure 1- Pressure distribution over the working hours

- As depicted in figure 1, only 0.05% of working time pressure was above 200 mbar and 0.67% above 150 mbar.
- It can be obviously observed that 10% of total working-time temperature is above 400 °C and 16% above 350°C.
