Diesel Particulate Filters' Feasibility Study Report

Report's Period:

2016/04/01 - 2016/04/30

Tehran - Iran

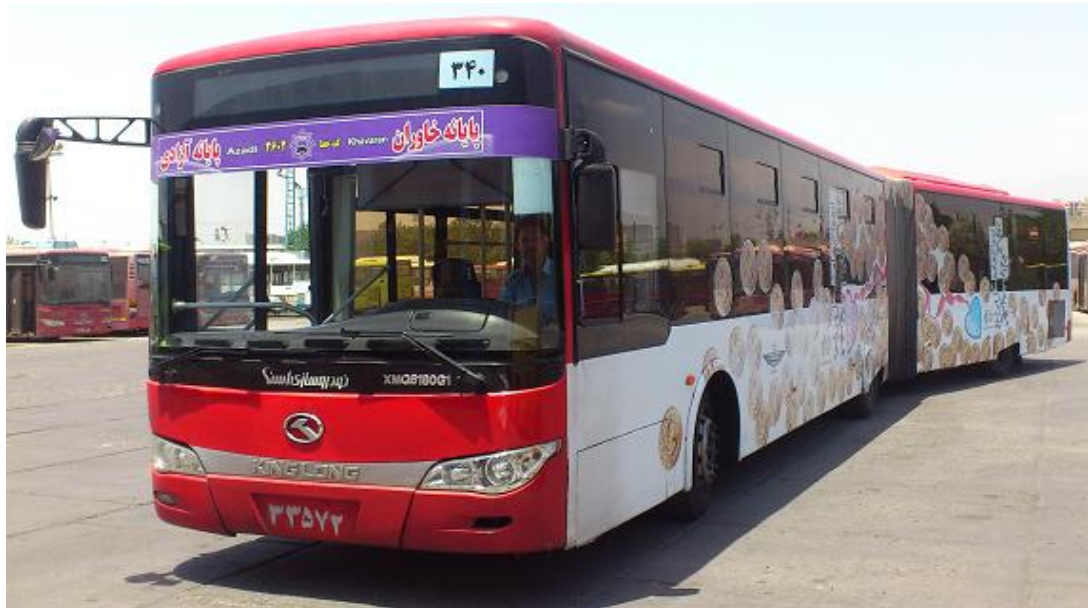
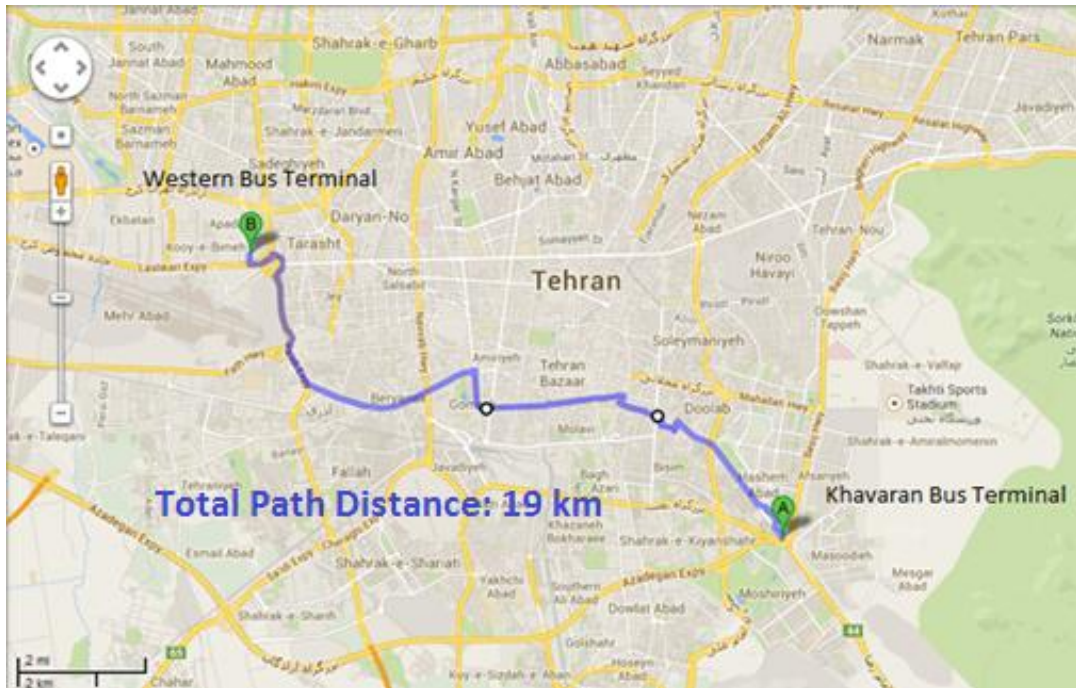
Vehicle plate number	33572 (28958)
Bus line	Number 2 (west to east bus line)
DPF producer company	HJS_03 (active system with FBC – electrical heater)
