# DPF FEASIBILITY STUDY REPORT

## TEHRAN-IRAN

## DPFs' Monthly Operation Report

Report Period:  
01/Aug/2015 –  
31/Aug/2015

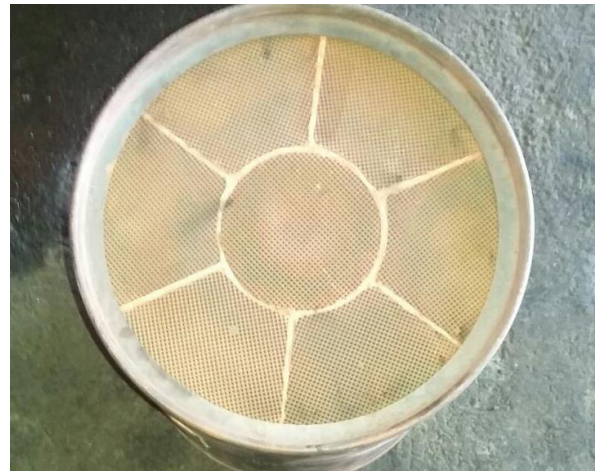
Figure 18. After Cleaning

- As depicted in figure 1, 1.14% of total working time pressure is above 200 mbar and 3.26% above 150mbar.
- Figure 2 displays flow temperature before the DPF. It can be obviously observed that 3% of total working time temperature is above 400 °C. Considering temperature distribution of this line's buses ( $T_{400} \ll 1\%$ ), it is clear this distribution was because of high back pressure.

Filter operation status	Excellent <input type="checkbox"/>	Good <input type="checkbox"/>
	Maintenance required <input checked="" type="checkbox"/>	Failed <input type="checkbox"/>
