Overall Information

Vehicle plate number	33637 (34119)
CPK data logger number	LN: 001492, DN: 1933, Sim +989210000000
Bus line	Number 2 (west to east bus line)
Bus Terminals	Khavaran Bus Terminal - Western Bus Terminal
Total path distance	19 km
DPF producer company	Dinex_02 (Passive system with FBC)
Installation date	2/Jun/2015
Report period	3/Jun/2015 – 17/Jun/2015 (fifteen days)
K value – DPF's upstream	1.9 [<i>m</i> ⁻¹]
K value – DPF's downstream	$0.09 \ [m^{-1}]$

Date: 20/Aug/2015

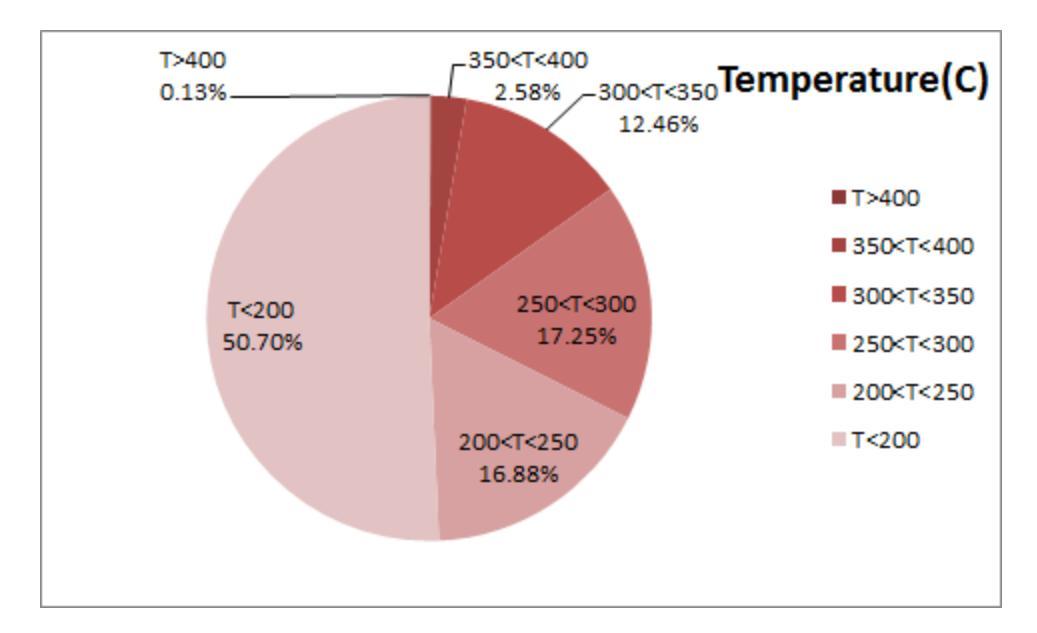
Figure 3-Temperature² distribution over the working hours (after DPF installation)

² - Flow temperature (DPF's upstream)

- As depicted in Figure 1, 4% of total working time pressure is above 200 mbar and pressure above 600 mbar can be seen during this period.
- Figure 3 displays flow temperature distribution for DPF's upstream. It can be obviously observed that 4 % of total working time, temperature is above 400°C. Considering Figure 3 it can be obtained that, high temperature distribution in figure 2 was the result of high backpressure. So this deceptive temperature distribution can't guarantee passive filter operation.
- The signed area in Figure 9 is a good reason to claim that this DPF need cleaning.
- Considering low additive dosing value for this period, cleaning and testing this system with more additive dosing can be valuable test.

Note:	Other parameters like additive consumption system and engine operation were checked.	
Filter operation status	Excellent 🗆	Good □
	Maintenance required ■	Failed□
